An Investigation of Enhanced Soot Deposition on Smoke Alarm Horns

A Thesis

Submitted to the Faculty of  
Worcester Polytechnic Institute  
In partial fulfillment of a  
Master of Science Degree  
In Fire Protection Engineering

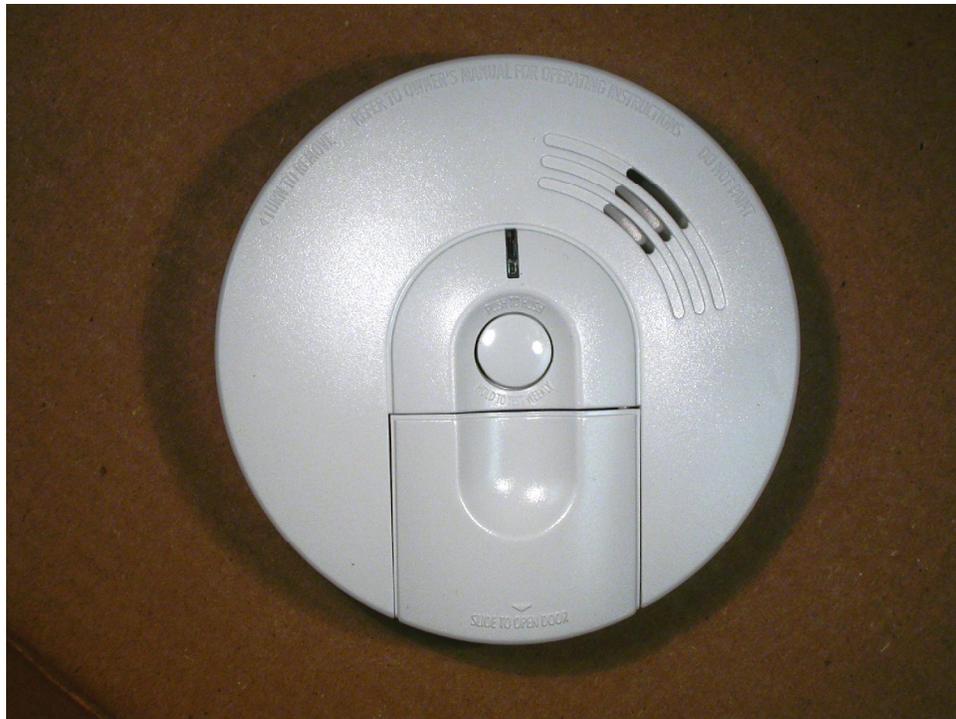
**Figure 0.3 FACS style alarm typical of those used in this study.**

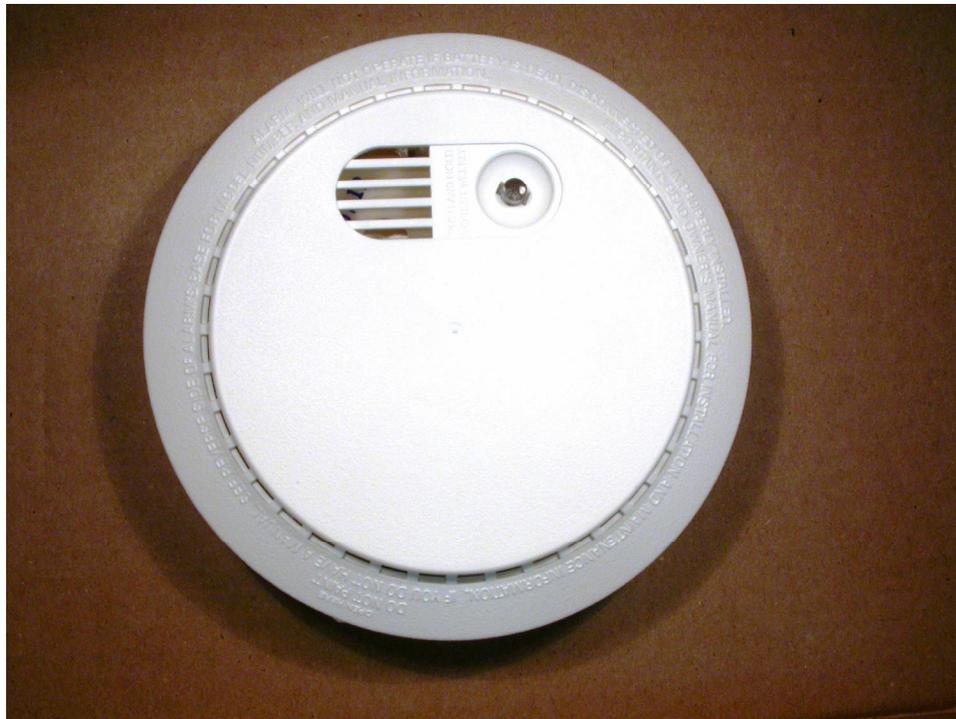
**Figure 0.9 FGBI style alarm typical of those used in this study.**

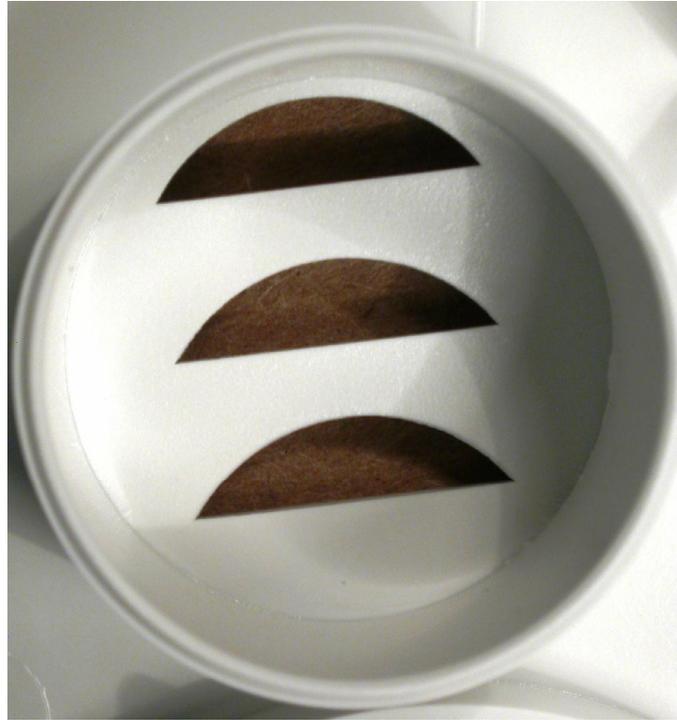
**Figure 0.15 Internal Face of a smoke alarm horn opening**

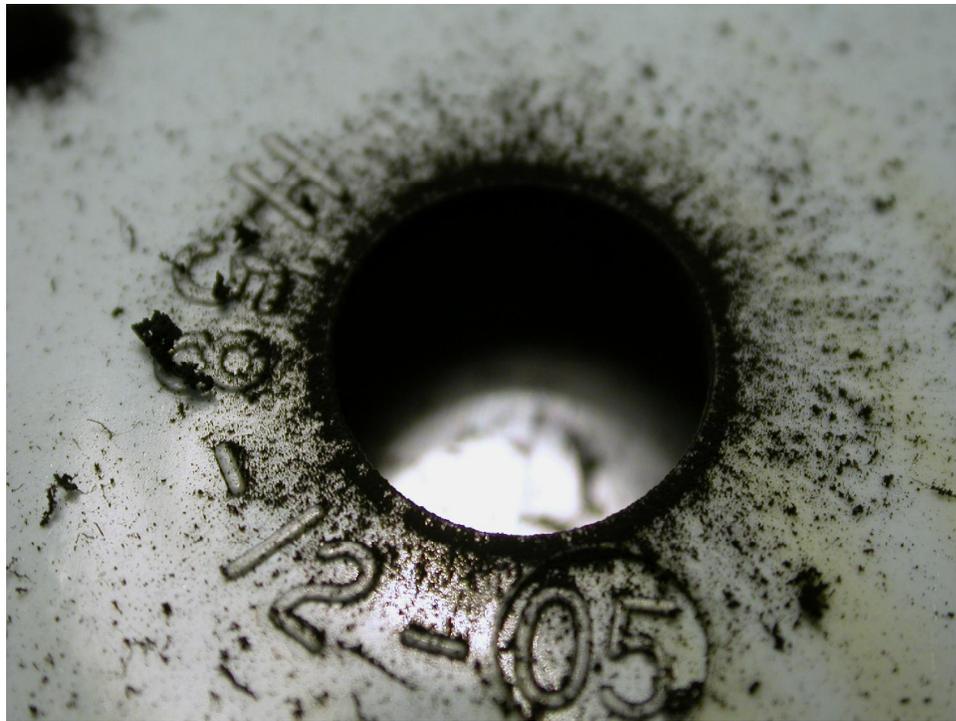
**Figure 0.17 Radial Pattern on the exterior face of an FACI horn opening.**

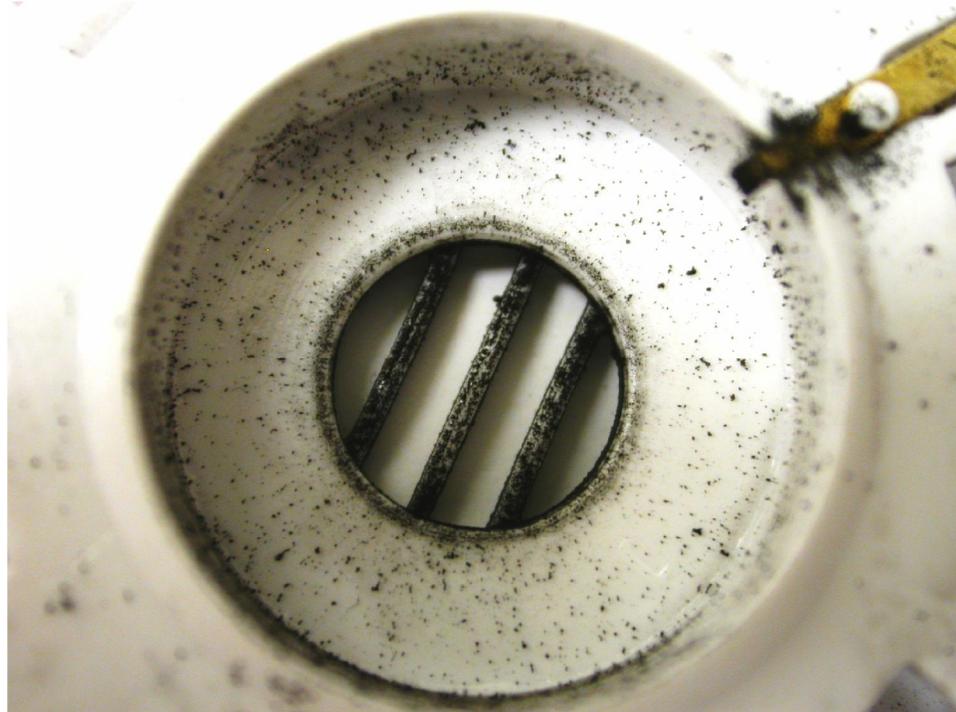
**Figure 0.18 Ring Pattern.**

**Ring Pattern** - Continuous band of soot deposition around a smoke alarm horn opening (see Figure 0.18)

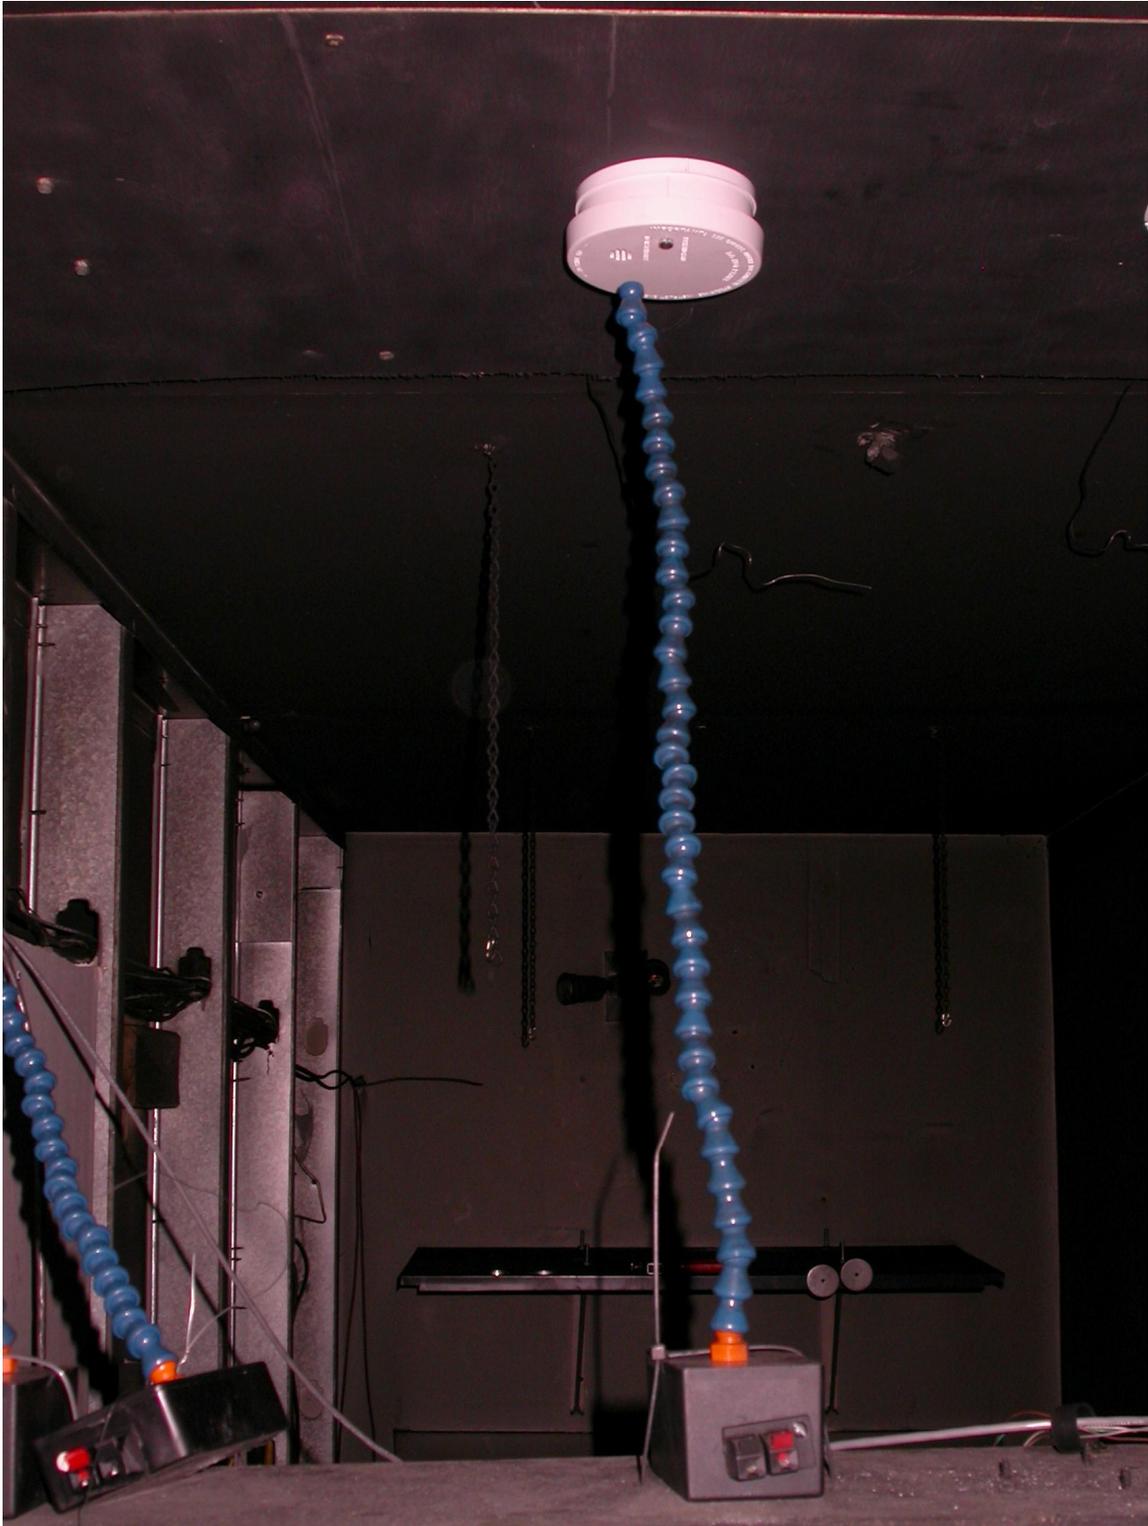
**Figure 5.1 Acoustic Monitor.**

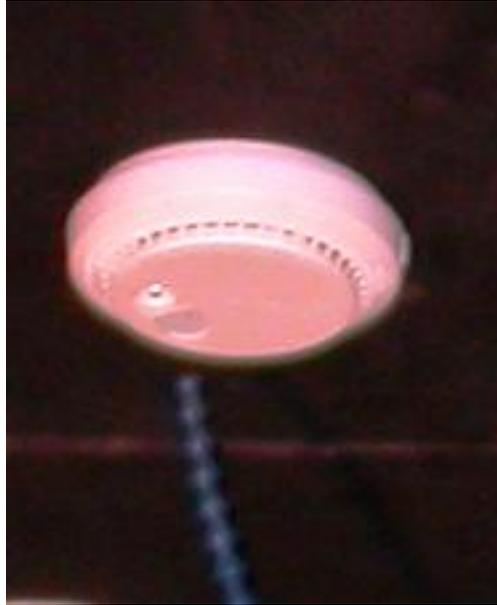
**Figure 5.2 Loc-Line Hose oriented approximately 1 and 1/2 inches from the smoke alarm.**

Through experimentation it was determined that the line could be positioned up to three inches from the alarm horn opening and still register the sounding of the horn without interference of

other nearby alarms. At greater than 1 1/2 inches from the horn opening it was estimated from the Worrell et al. results that the Loc-Line would not interfere with the pulsed flow phenomenon previously discussed

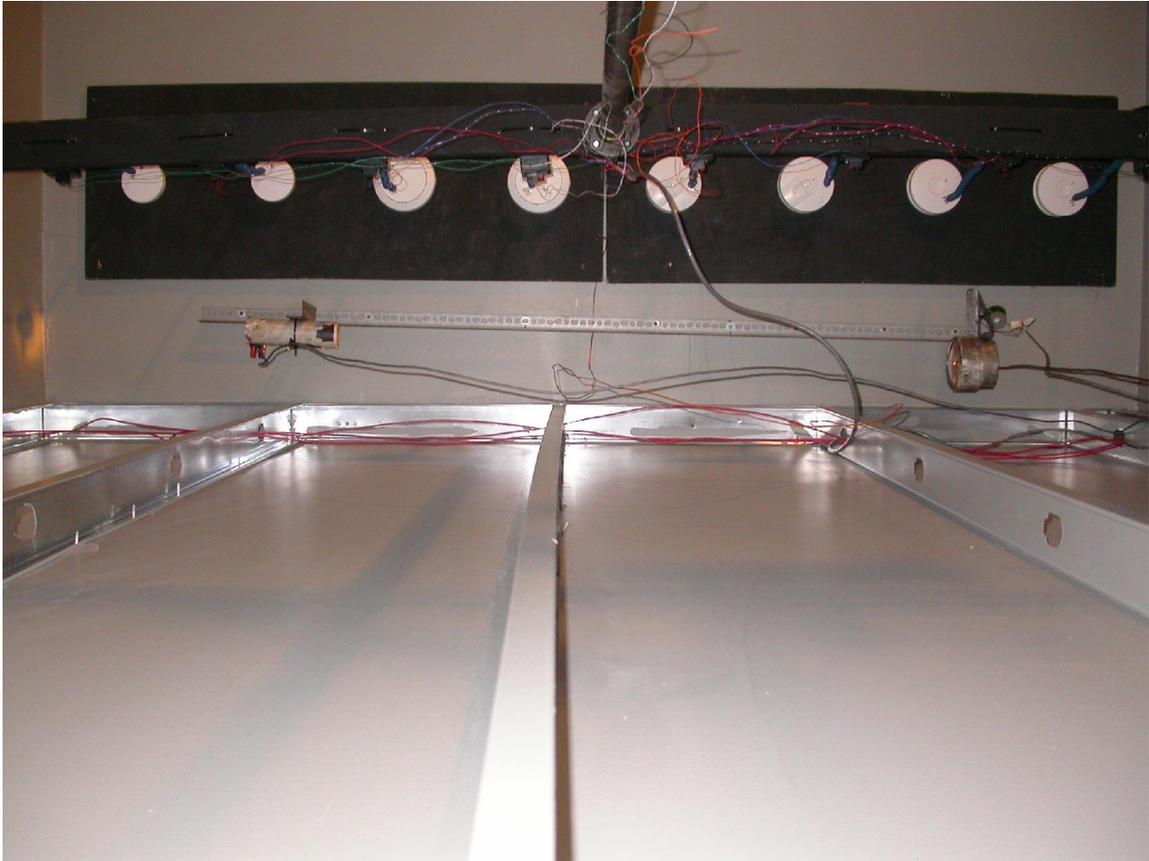
**Figure 5.3 Ceiling ODM in the small room.**

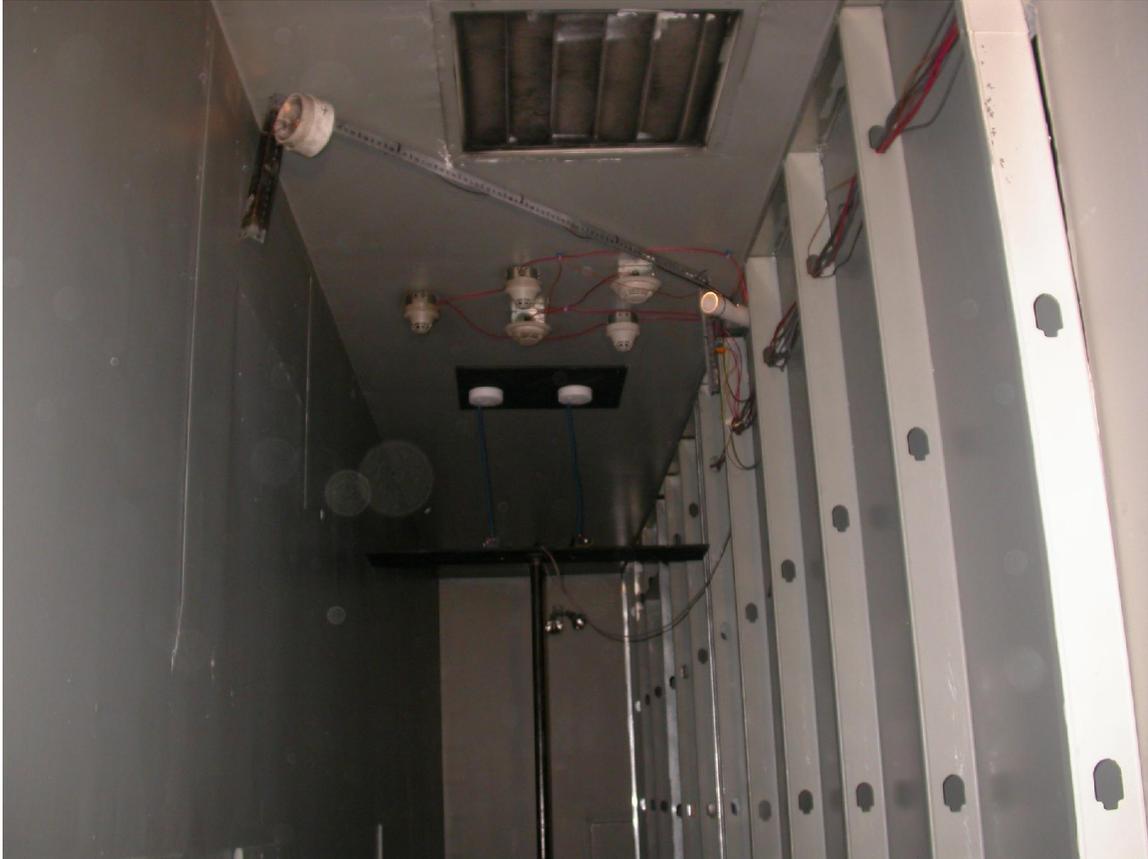
**Figure 5.5 Hallway ODM at ceiling level.**

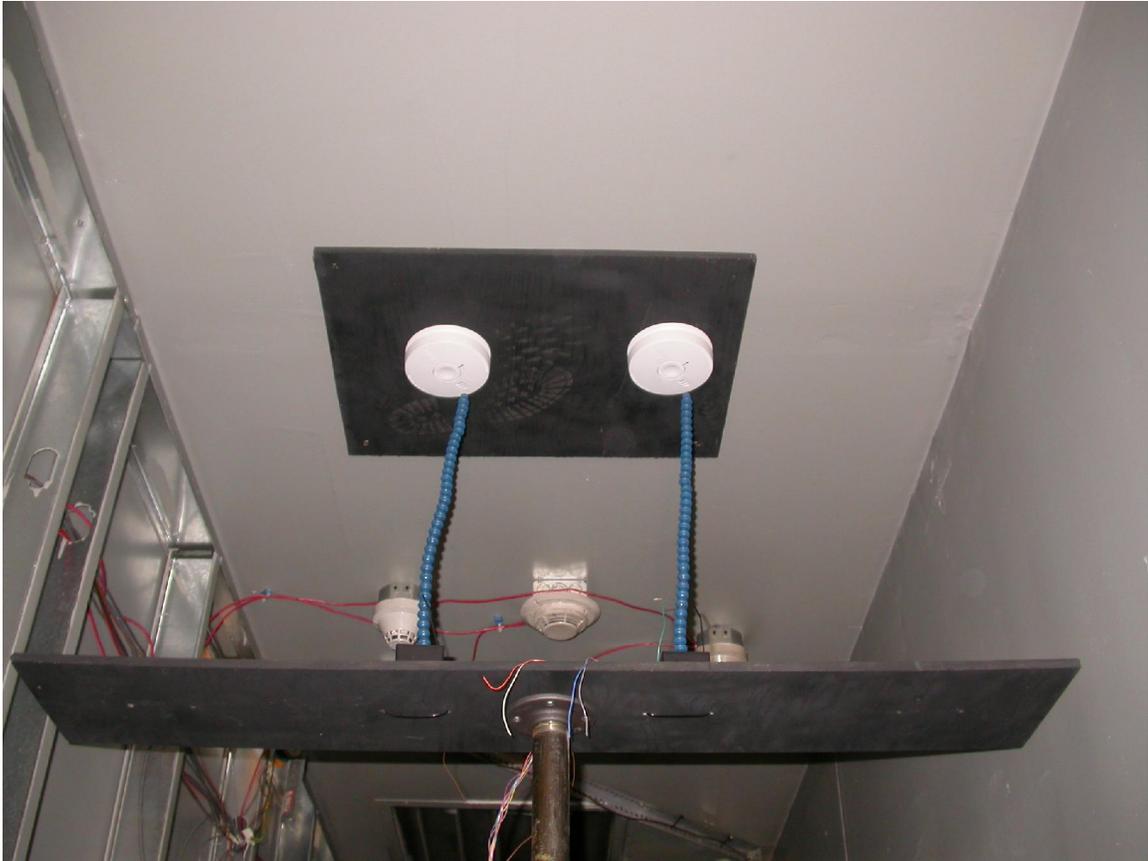
**Figure 6.2 The bank of alarms mounted in the hallway for Test Series 1. The bank consisted of one pair of new FBI alarms, one enabled and one disabled.**

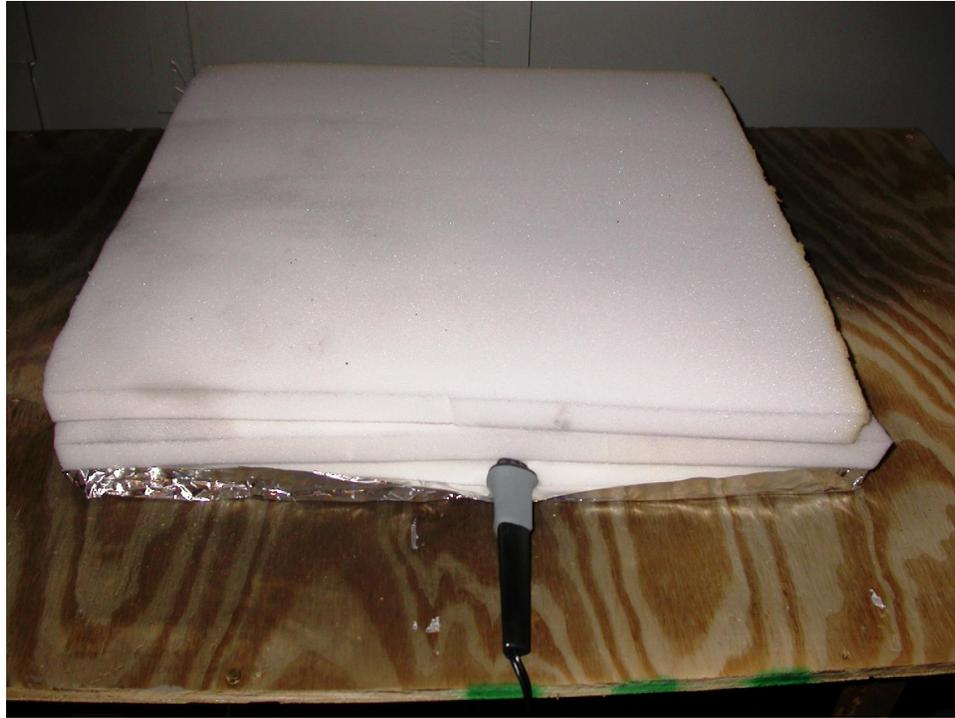
**Figure 6.3 Original smoldering polyurethane source prior to Experiment 1.1.**

Worrell, et al., used two 8-inch by 8-inch by 4-inch-thick sheets of polyurethane fastened together using a metal wire tie. The entire metal tip of a 30 W pen style soldering iron was inserted between the two sheets to initiate smoldering. There is no EN54 procedure for smoldering polyurethane. For the current study, the same foam was used as in the flaming tests. In Test 1.1 three sheets measuring 20 inches by 20 inches by 3/4 inch polyurethane were fastened together using a metal wire tie. The entire metal tip of a 30 W pen-style soldering iron was inserted between the bottom two sheets to initiate smoldering. During Test 1.1 no alarms sounded because the fuel was only consumed in a few inch radius around the pen tip, (see Figure 6.3), affecting an area approximately one-half of the 20 inch by 20 inch sheets.

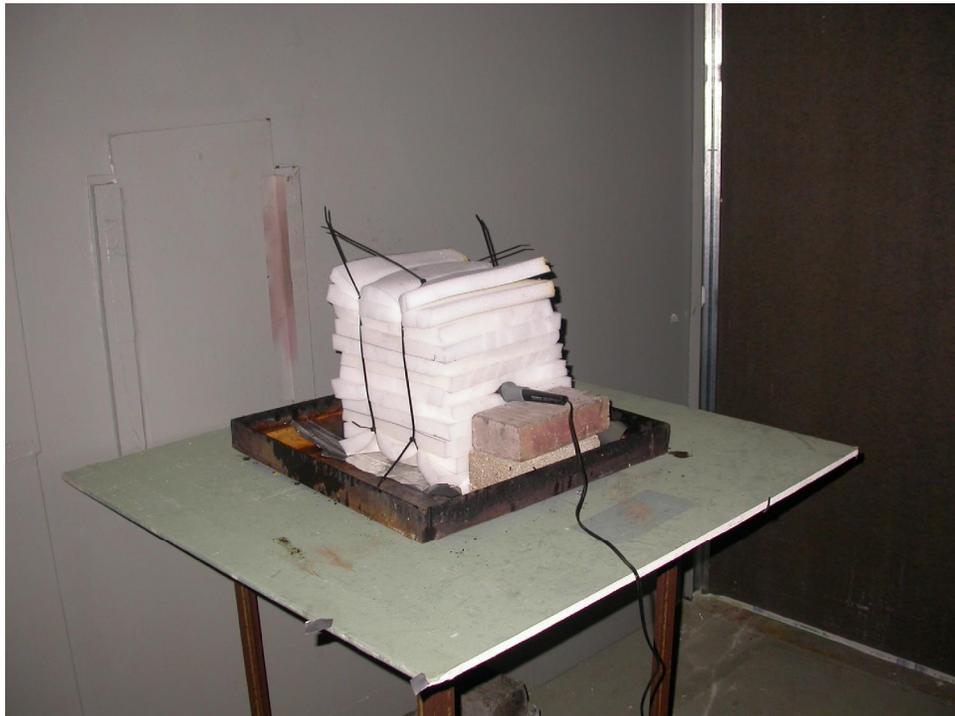
**Figure 6.4 Reformatted polyurethane source before Experiment 1.2.**

The area of the sheets was reduced by one-half and twice the number were used (see Figure 6.4). This supplied the same amount of fuel but allowed for a much greater portion to be consumed and activate alarms. Test 1.2 utilized six 10 inch by 10 inch by 3/4 inch sheets of the same polyurethane foam with the 30 W soldering iron tip placed between the third and fourth sheets from the bottom.

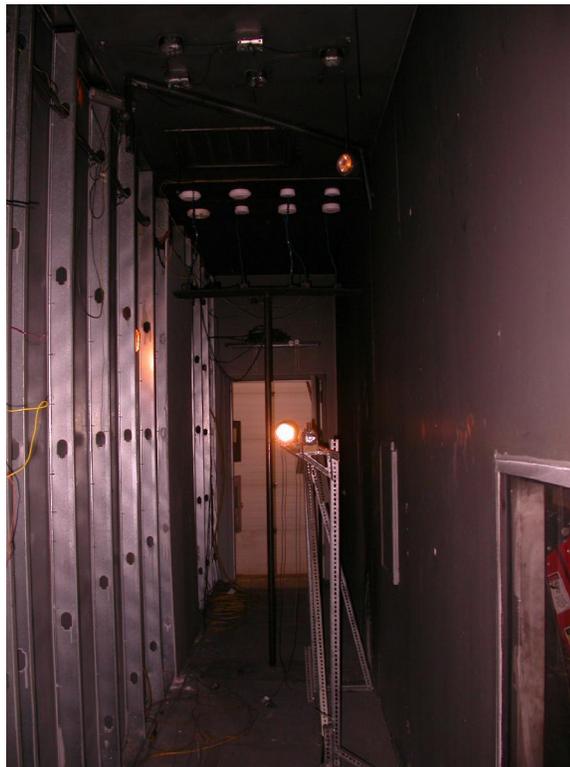
**Figure 6.11** The bank of smoke alarms typical of the arrangement of alarms in the hallway for Test Series 3. The bank consisted of eight new alarms, one pair of enabled and disabled alarms each of new FBI, FGBI, FSBI, and FACI alarms.

Test Series 3 was conducted entirely within the hallway; as such, all alarms were mounted therein. The alarms were mounted on 3/8-inch plywood at ceiling level approximately midway within the hallway. Each experiment included eight alarms, enabled/disabled pairs of new FBI, FGBI, FACI, and FSBI alarms. They were mounted as shown in Figure 6.11, two rows of four spaced 12 inches on center.

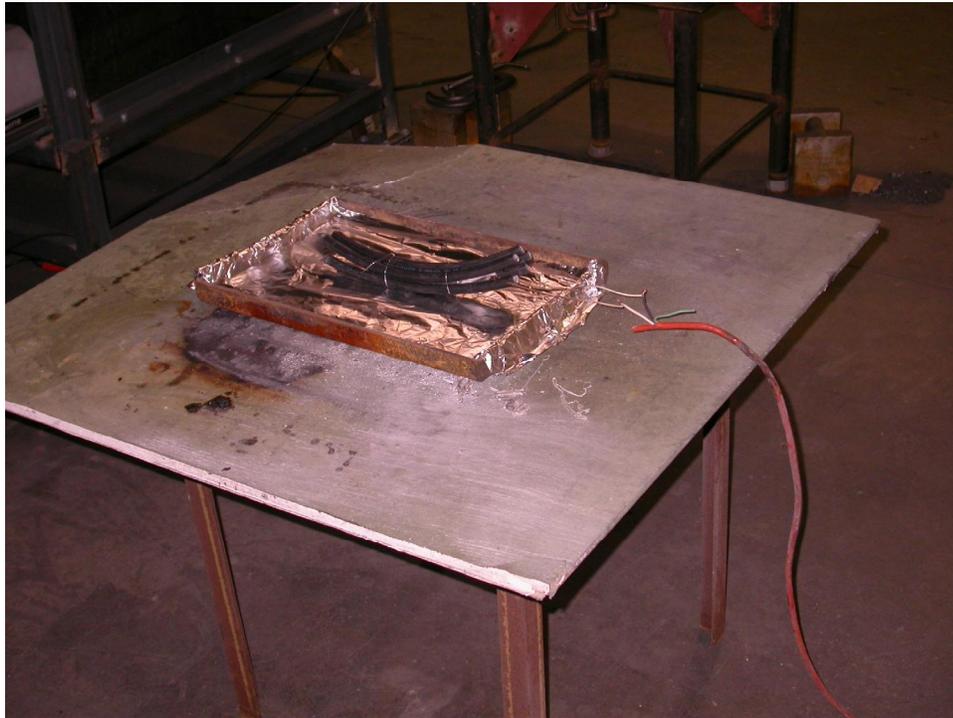
**Figure 6.12 A Cable bundle typical of that used for smoldering and flaming cable fires for Test Series 3.**

As Seen in Figure 6.12, a bundle of cable consisting of 5 pieces, each one foot in length (Monroe Cable Co., LSTSGU-9, M24643/16-03UN XLPOLYO), surrounding one 500 W

cartridge heater (Vulcan, TB507A) was used to create a smoldering source. The heater was energized using a variac set at 96 VAC (80% of 120 V max).

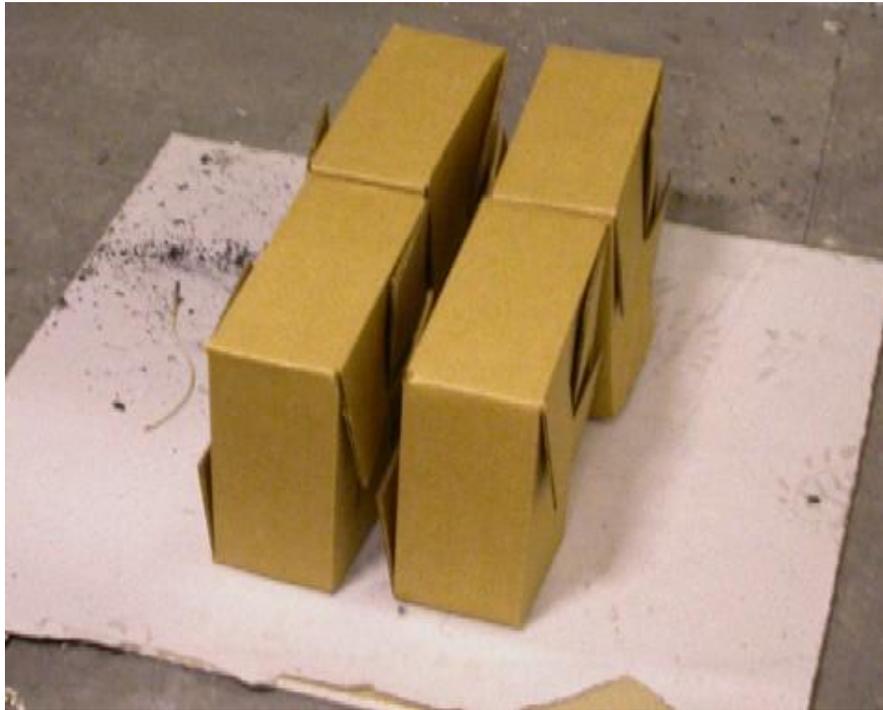
**Figure 6.13 Arrangement of boxes for the boxes filled with paper experiment in Test Series 3. The boxes were ignited with a butane lighter in the central flue space.**

A total of four boxes measuring 10 inches by 10 inches by 4.5 inches were loosely filled with crumpled brown paper and positioned in two rows side by side with a one inch flue space between the rows. The boxes were oriented in each row so that the longer sides faced the opposite row across the flue space; See Figure 6.13. A butane lighter was used to ignite a

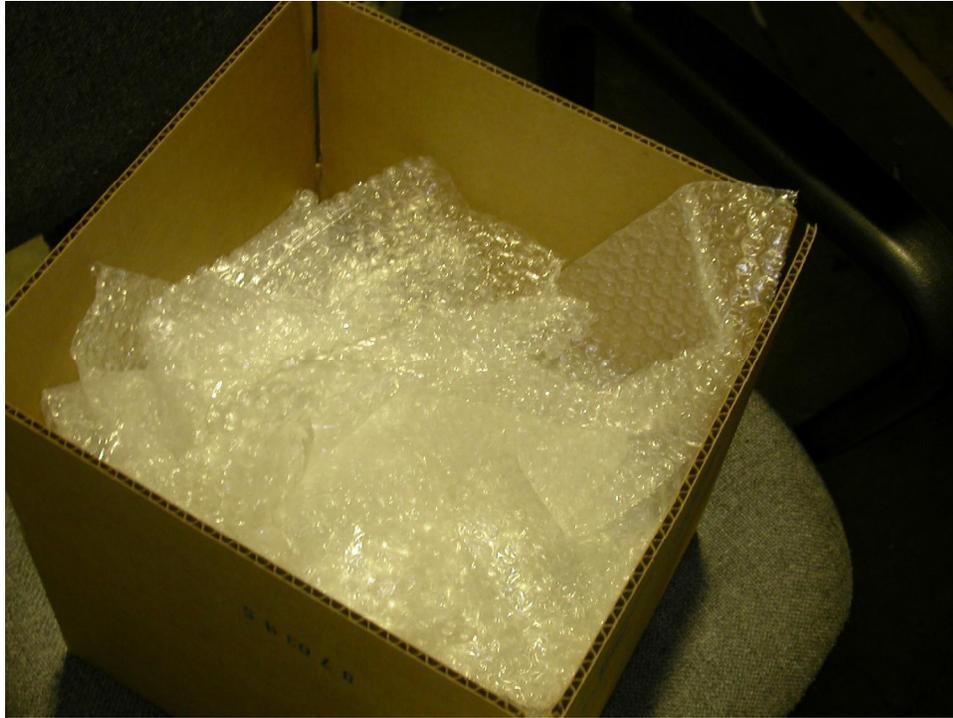
**Figure 6.14 One of the boxes with cups and bubble wrap that was burned in the flaming box with cups test fire in Test Series 3.**

Two boxes measuring 10 inches by 10 inches by 4.5 inches were loosely filled with plastic cups and bubble wrap and positioned in two rows side by side with a one-inch flue space. The boxes were oriented end to end so that the longer sides faced the opposite box. A butane lighter was used to ignite a bottom corner of a box in the flue space so that flames propagated up the flue space and involved both boxes; See Figures 6.14 and 6.15

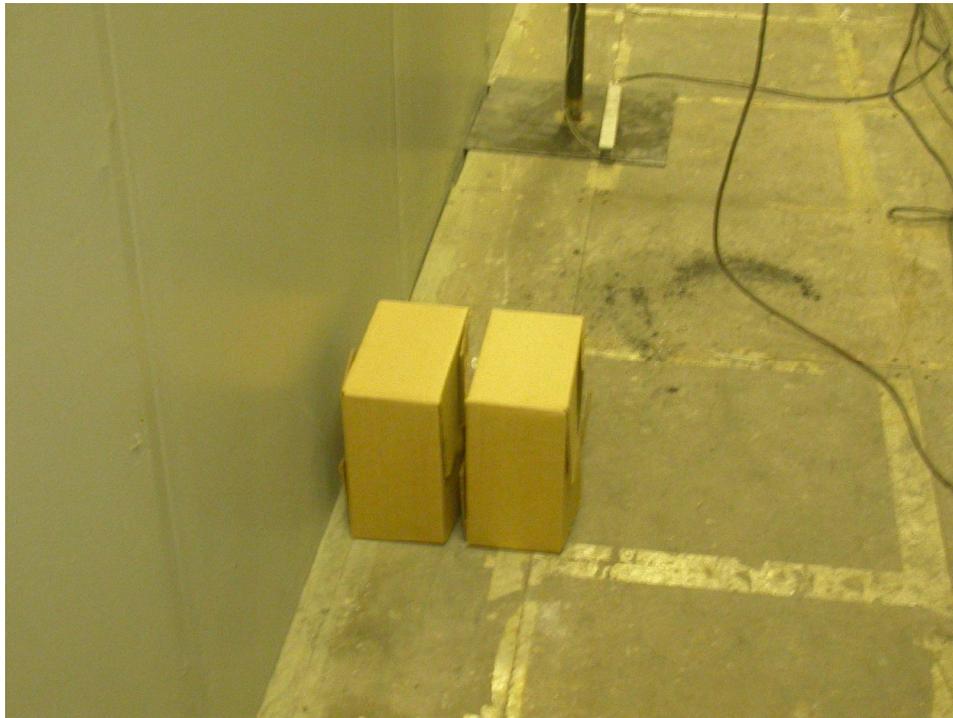
**Figure 6.15 The arrangement of the boxes with cups used in Test Series 3. The boxes were ignited in the central flue space with a butane lighter.**

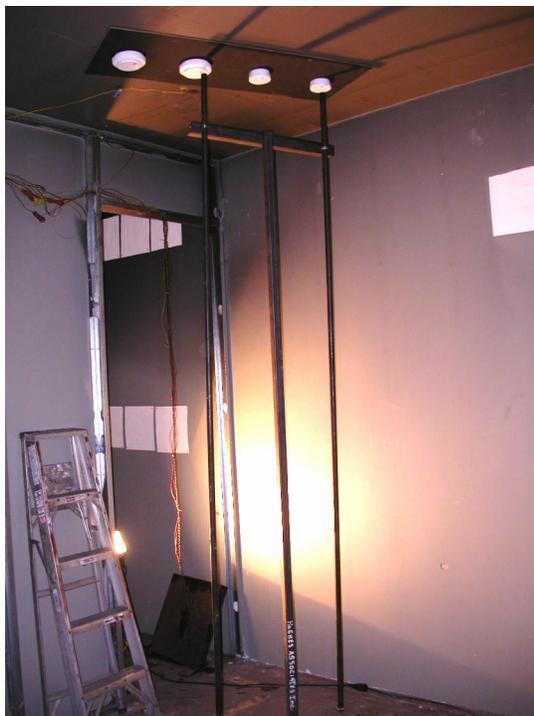
**Figure 6.16 Alarms mounted in the fire room for Test Series 4. The plastic Loc-Line hose was replaced for these alarms with 1 ¼” metal pipe due to the high temperatures expected at the detectors. The bank consists of two pairs of new alarms enabled and disabled.**

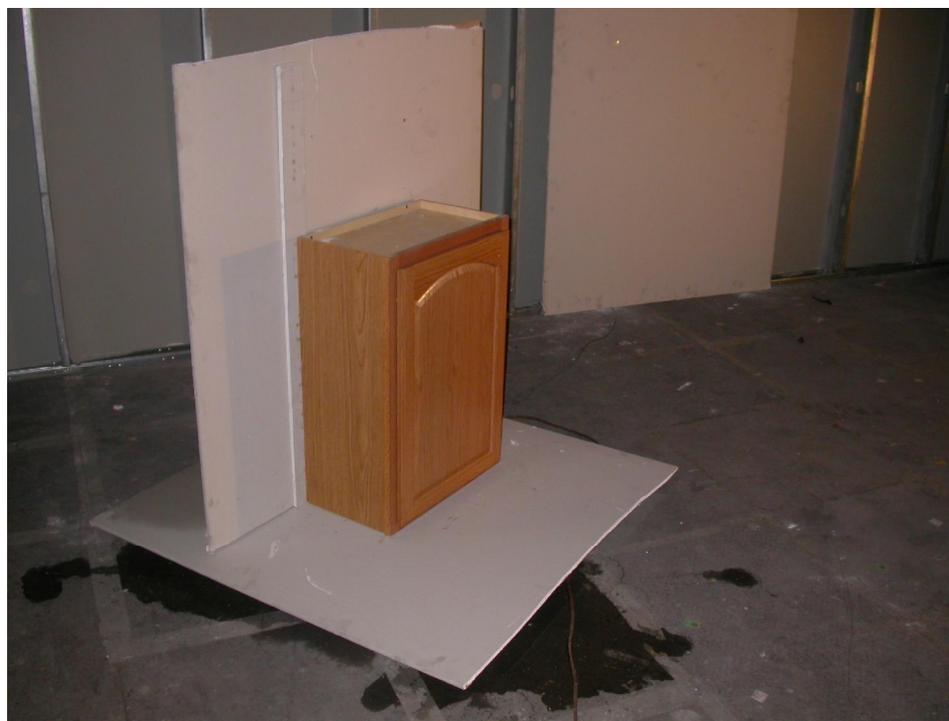
**Figure 6.19 Pre-test Cabinet Assembly burned in Test 4.1. A 500W cartridge heater was placed six inches from the floor between the dry-wall and the cabinet back. The assembly smoldered, finally transitioning to flames**

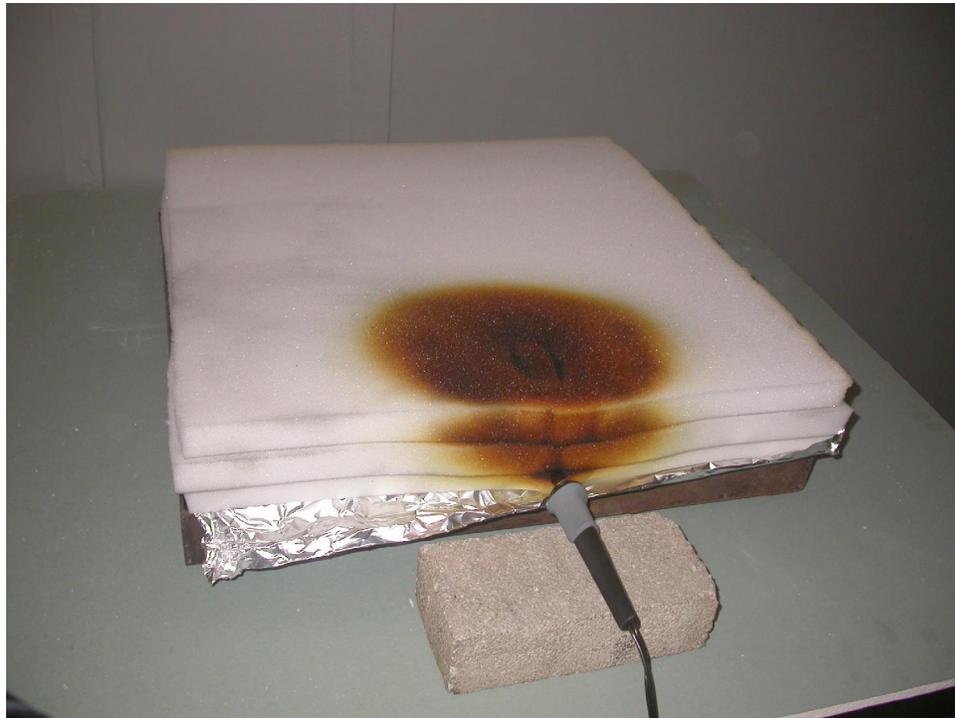
**Figure 7.1 This figure shows a smoldering polyurethane source from Experiment 1.1 post-test. No alarms sounded when exposed to this source.**

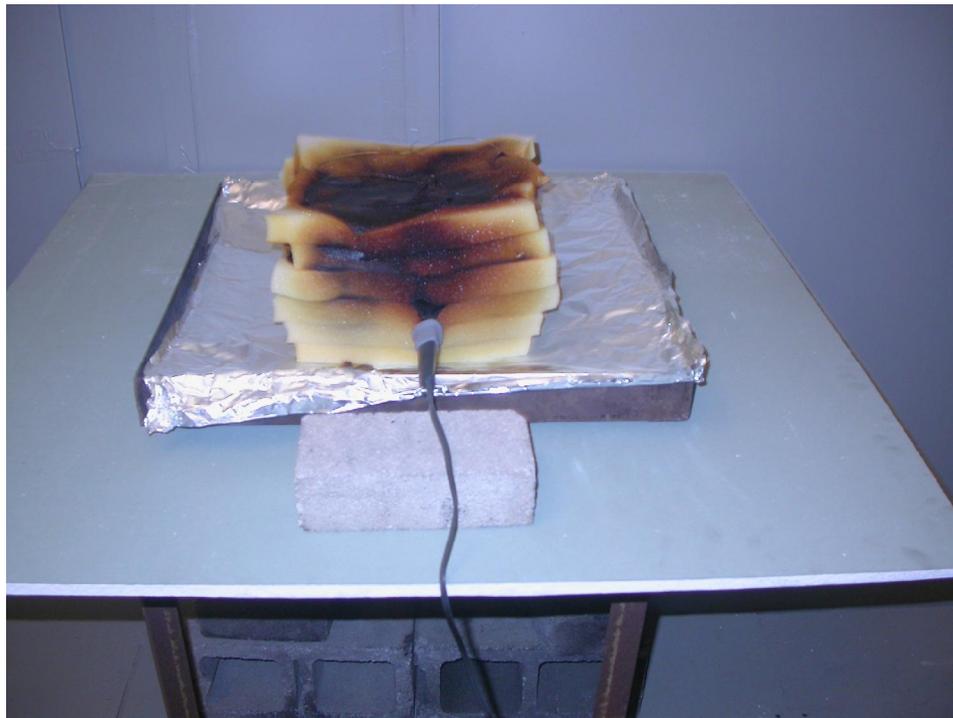
**Figure 7.2 Smoldering polyurethane source from Experiment 1.2 post-test. This reformatted source caused all 5 of the enabled alarms to sound.**

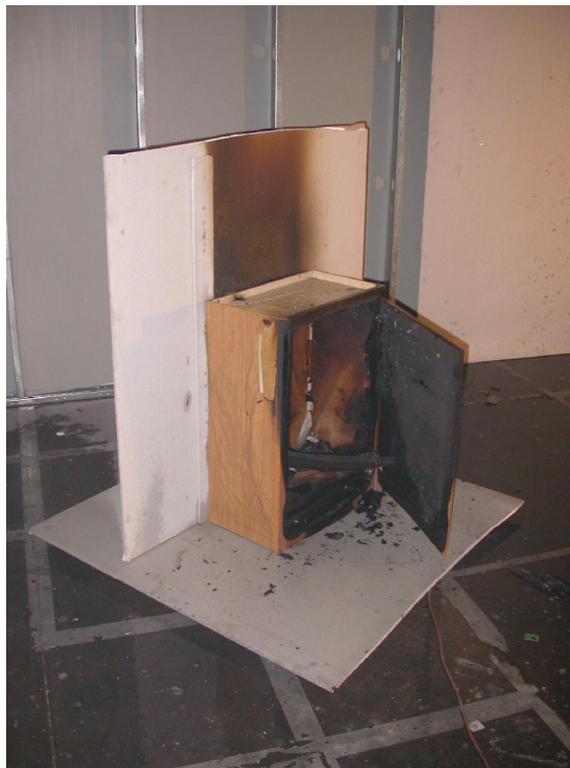
**Figure 7.3 Cabinet assembly post-test.**

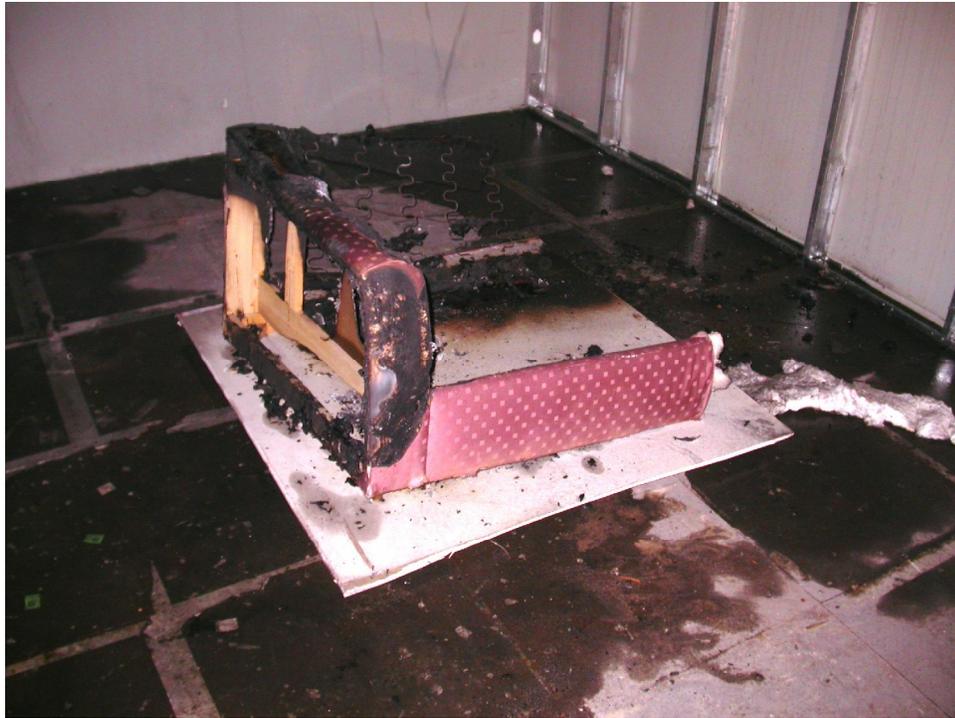
**Figure 7.4 Couch post-test.**

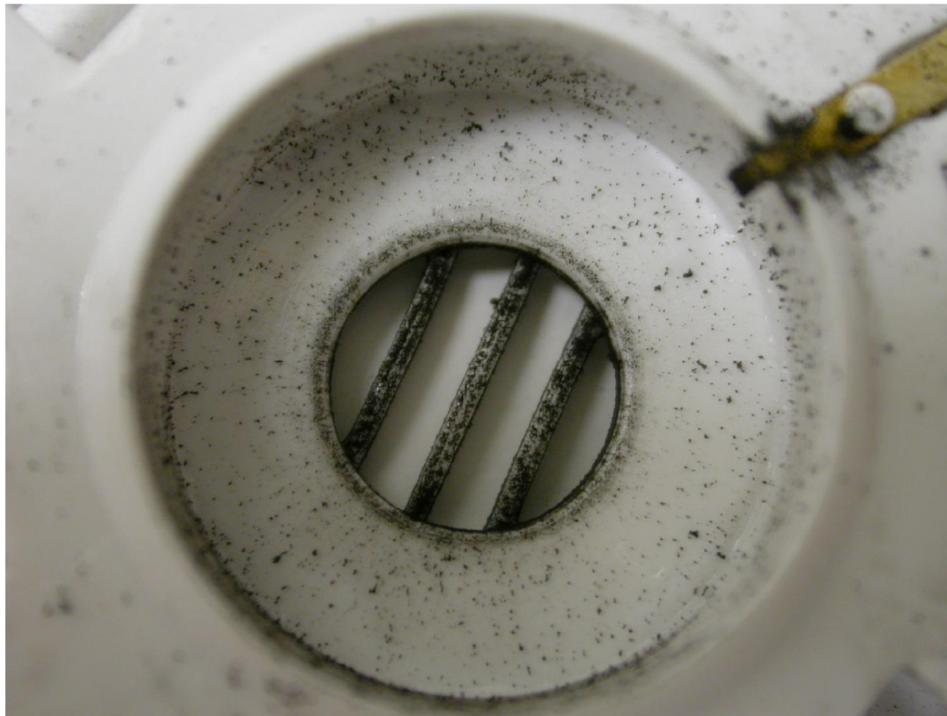
**Figure 7.5 An example of an enhanced soot deposition pattern with ring-like characteristics on the interior face of a FSBI smoke alarm horn opening. This enhanced soot deposition pattern occurred in an alarm that sounded during exposure to a flaming polyurethane source.**

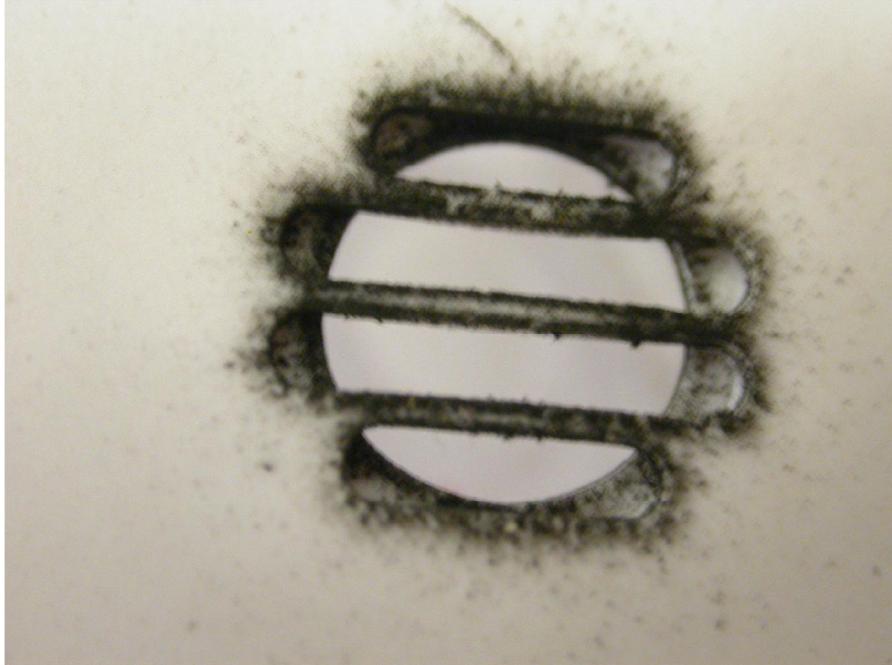
**Figure 7.6** An example of an enhanced soot deposition pattern with radial characteristics on the external face of an FSBI horn opening. This occurred on an alarm that sounded during exposure to a flaming polyurethane source.

After the bulk of the testing had been concluded; the preliminary observations allowed for an initial analysis. It was determined that enhanced soot deposition occurred on the internal, external, and vertical faces of the smoke alarm horn openings. The enhanced deposition of carbonaceous soot appeared macroscopically as deposits in two qualitative patterns: a ring or band pattern that appeared as a solid band of soot deposited in approximately equal density, as described by Worrell, et al., (see Figure 7.5), and a pattern that begins at a higher density and moves to a lower density moving radially away from the horn opening (see Figures 7.6 and 7.7).

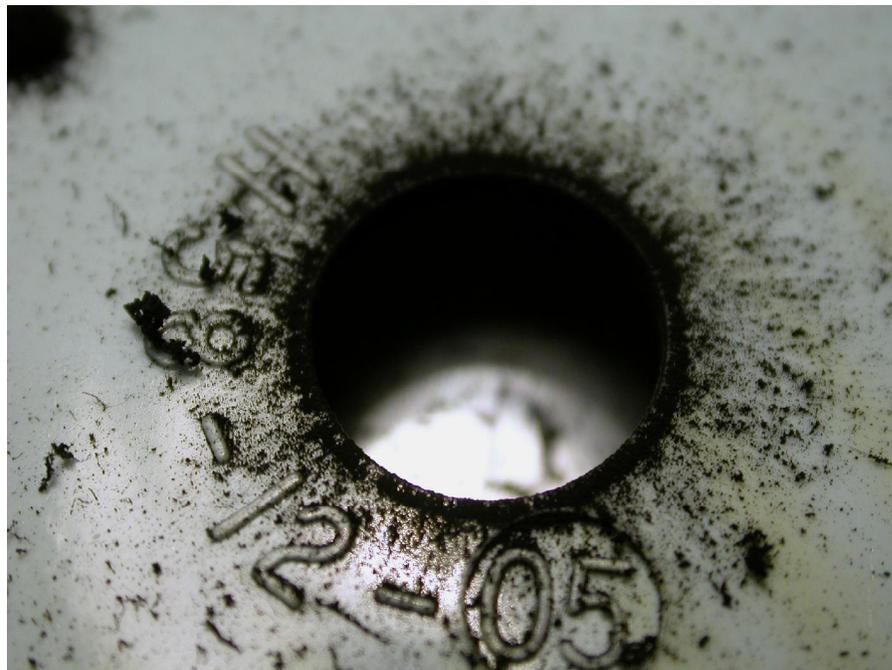
**Figure 7.7** An example of enhanced soot deposition with radial characteristics on the external face of an FGBI smoke alarm horn opening. This pattern is indicative of an alarm which sounded during exposure to the flaming couch fire of Experiment 4.2.

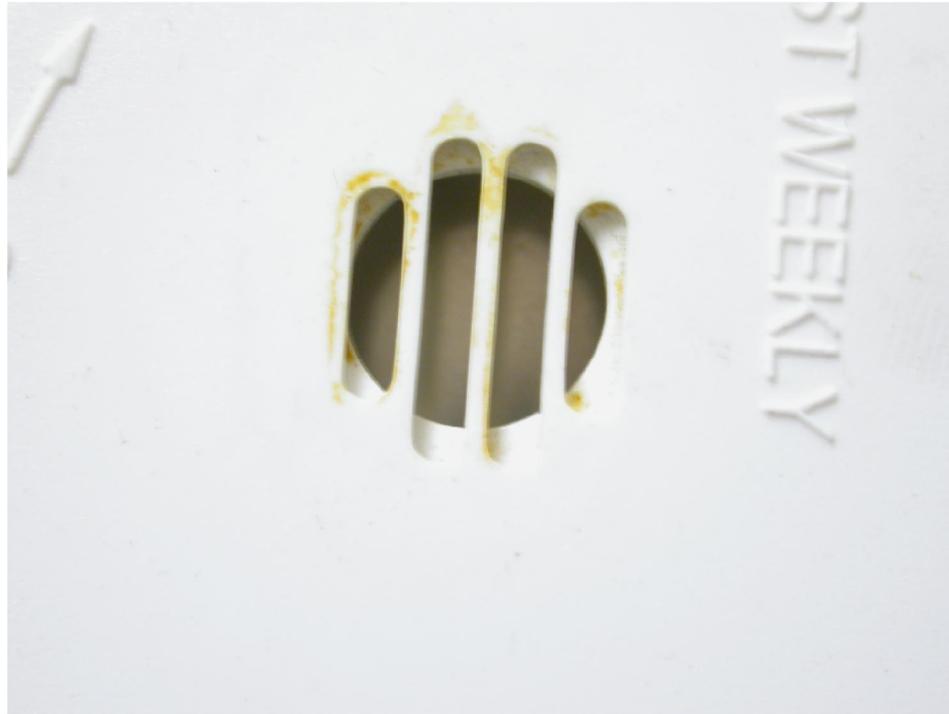
**Figure 7.9 An example of a "Tarry" pattern on the external face of an FSBI style horn opening. This is indicative of a smoke alarm that sounded during exposure to a smoldering polyurethane source.**

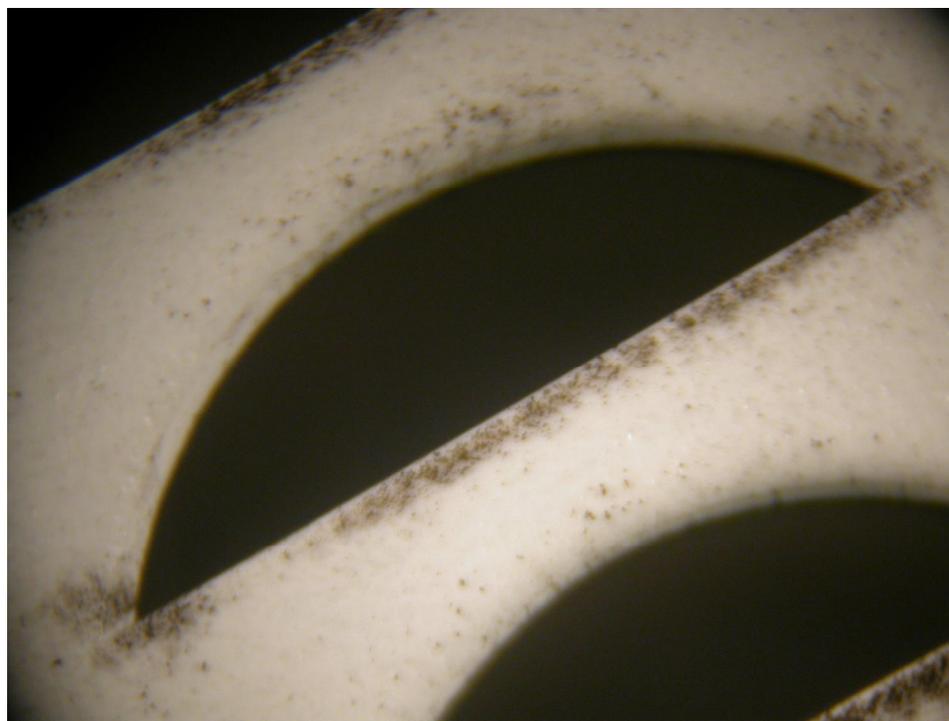
**Figure 7.10 This is enhanced soot deposition occurring in an FBI alarm sounding during exposure to flaming polyurethane. The corners of the enhanced deposition on this alarm is not uniform about the entire circumference, but was found to be comparable to Figure 18 in [Worrell, et al., 2003] and indicative of alarm sounding.**

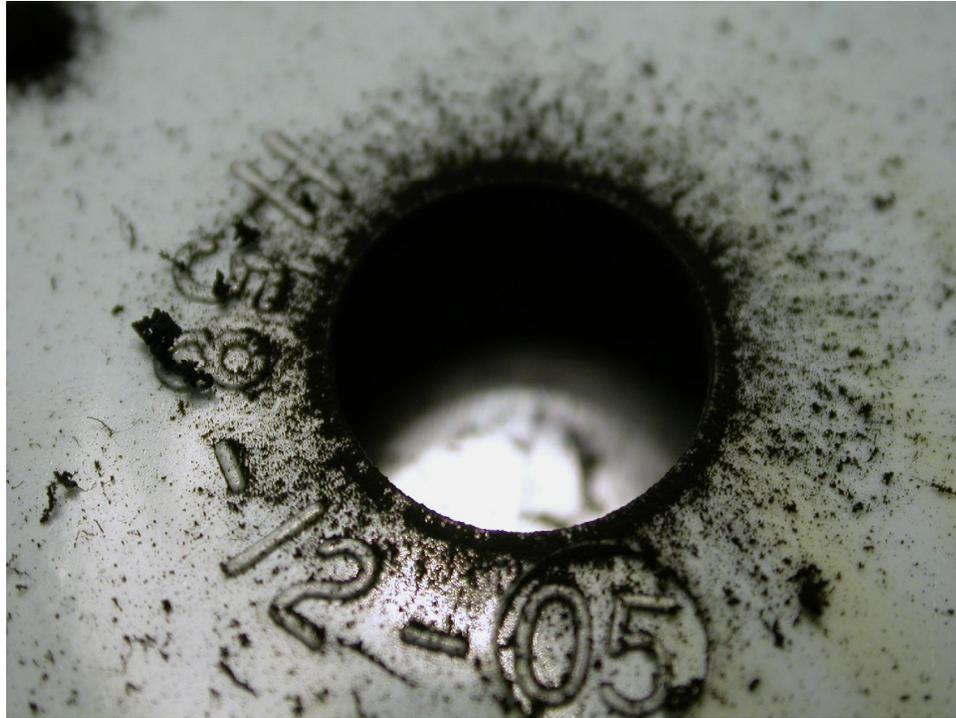
**Figure 7.13 Enhanced soot deposition on the exterior of a used alarm that sounded 45 feet away from the flaming couch fire. The density of the deposition gradually decreases from almost 100% of the area covered directly adjacent to the horn opening to deposition comparable to the ambient soot deposition on the horn. This change along with the radial direction of the soot agglomerates are what is meant by radial characteristics of enhanced deposition.**
