An Investigation of Enhanced Soot Deposition on Smoke Alarm Horns

A Thesis

Submitted to the Faculty of  
Worcester Polytechnic Institute  
In partial fulfillment of a  
Master of Science Degree  
In Fire Protection Engineering

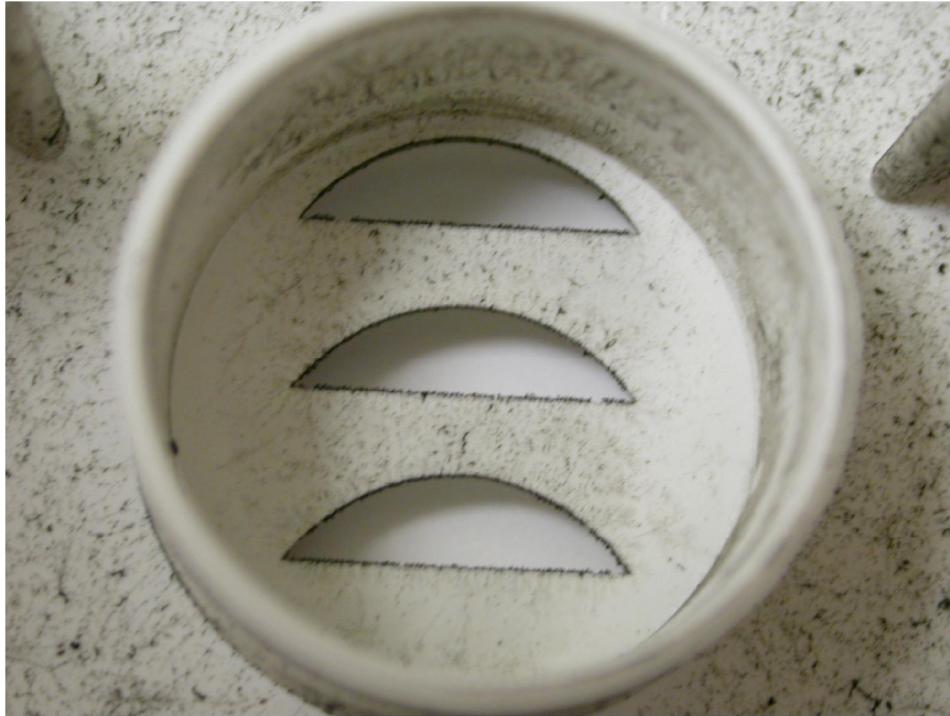
**Figure 7.15 Potentially misleading deposition on the internal face of an FBI style horn opening. This is representative of an alarm that did not sound during exposure to a flaming polyurethane source.**

the entire horn opening. These deposits (see Figure 7.15) would apparently qualify as a pattern as defined by previous studies [Worrell, 2003].

As can be seen in Figure 7.15, the deposition appears as a light ring around the inside edge of the horn opening. The soot deposition is uniform and symmetric and is apparently higher density than the deposition farther from the horn openings but within the horn chamber. Figure 7.16 shows the vertical face of the same alarm and illustrates the deposition hanging into the horn opening and the absence of a vertical face pattern. The soot ring is present on the corner between the internal and vertical faces of the horn opening. Figure 7.17 is an illustration of misleading depositions on an FBI horn chamber cross-section.

The depositions can be seen looking at either the internal face or the vertical face, but do not extend very far onto either of the surfaces. Image analysis of the misleading depositions was completed, in a similar manner to the measurements of the enhanced soot depositions to determine their widths. The misleading depositions were measured perpendicular to the horn opening across the width of the agglomerate ring including the portion that hangs into the smoke alarm horn opening. A sample measurement on the misleading deposition in Figure 7.15 is found in Figure 7.18.

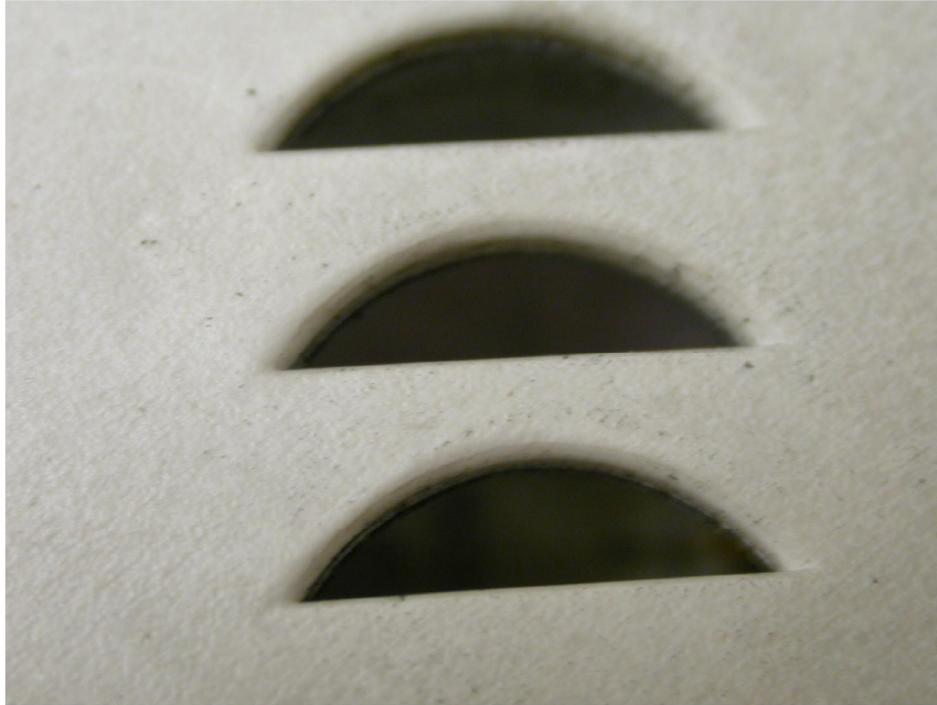
**Figure 7.22** This is the external face of the bottom alarm in Figure 7.21. There is some visible soot deposited but no evidence of enhanced deposition.

alarms were mounted side-by-side one sounded one did not. Figure 7.21 shows the interiors of both alarms. Figure 7.22 shows the external face of the alarm from the pair in 7.21 that did not sound. In Figure 7.22 the internal cover of that same alarm displays distinct contrast between the soot deposited inside and outside the horn chamber. Figures 7.24 and 7.25 further magnify the disparity in soot density inside and outside the horn chamber in the alarm that did not sound.

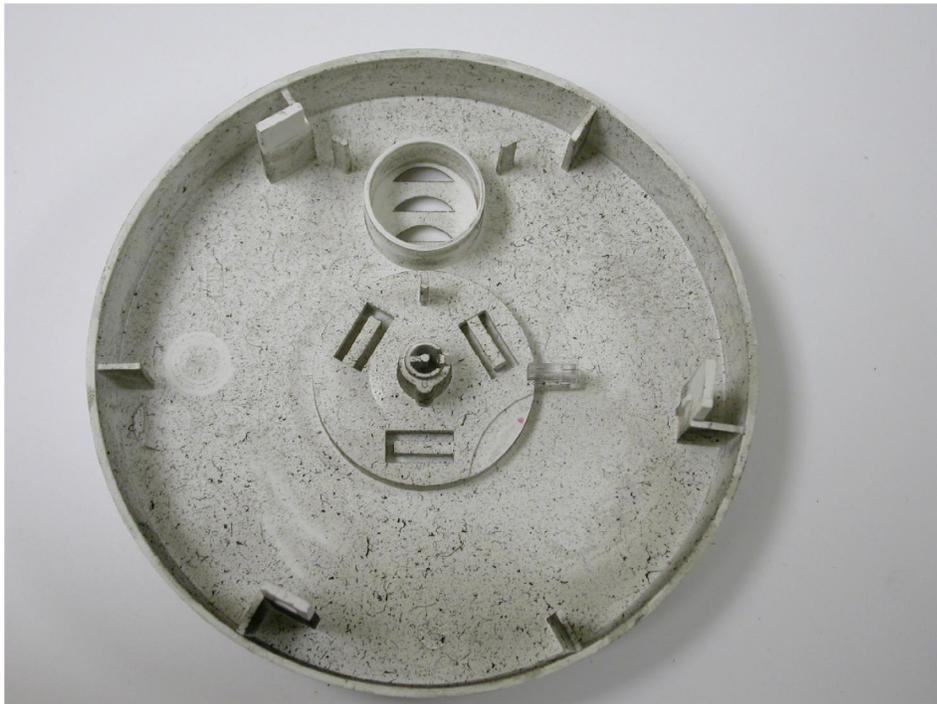
**Figure 7.23** This is the internal cover of the alarm in Figures 7.19 and 7.22 that did not sound. Notice the difference in soot deposition density inside and outside the smoke alarm horn chamber.

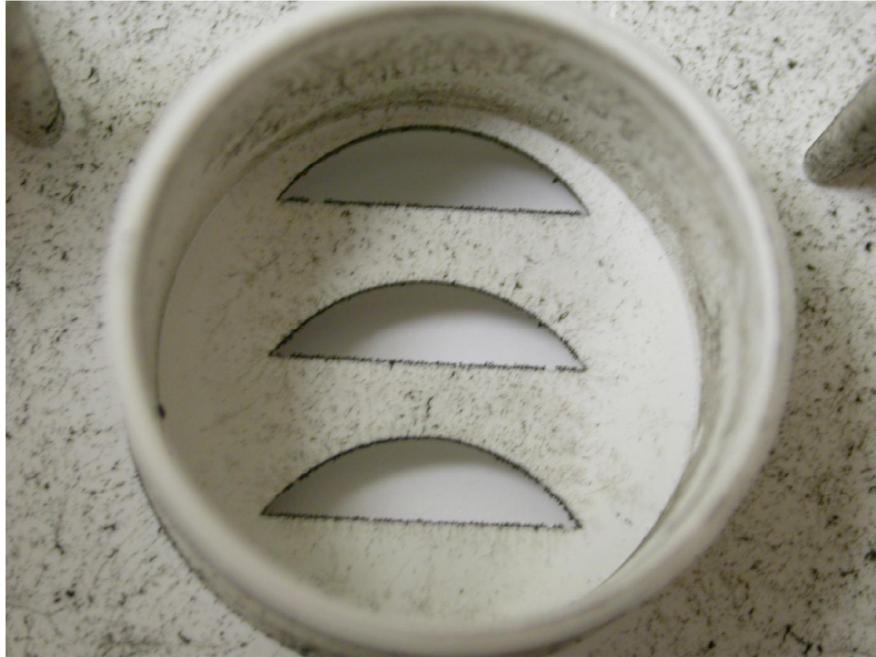
**Figure 7.24** This is the horn chamber of the alarm (shown in Figures 7.21-7.23) that did not sound. Notice the thin ring of soot around the horn openings, but the lower soot density in the horn chamber otherwise. Compare this to Figure 7.25.

Figure 7.26 contains the horn chamber from the sounding alarm in the top portion of Figure 7.21. The similar soot density inside and outside the alarm horn chamber in the alarm that sounded is distinctly contrasted by the difference in soot deposition in and outside the horn chamber of the alarm in Figure 7.24.

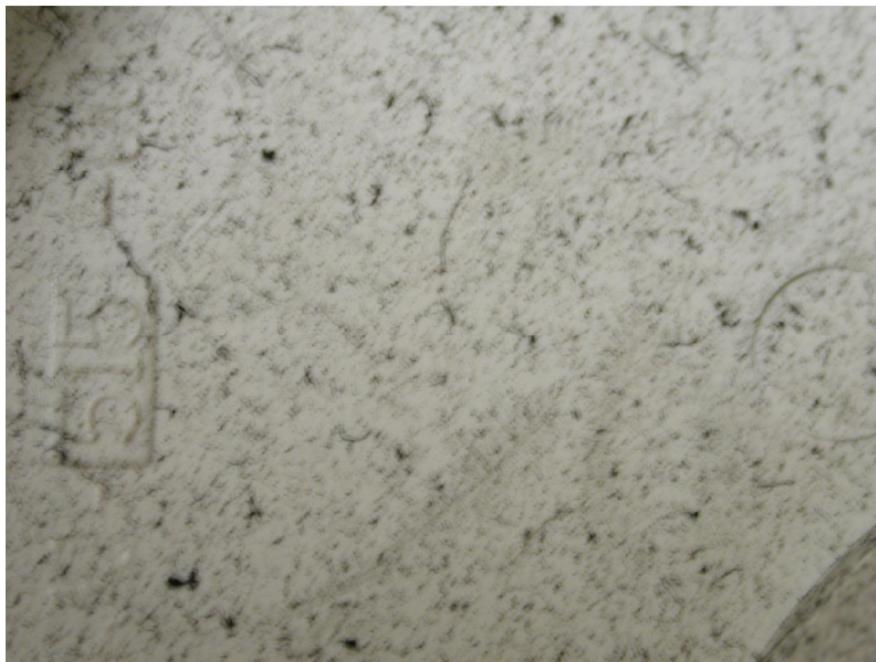
**Figure 7.25** This is the ambient soot deposition on the body of the alarm in Figure 7.24. This photo is taken at the same magnification as the previous figure. Notice the higher density and similar agglomerate size of soot in this figure to the last figure. The difference in deposition density is an indication the alarm did not sound.

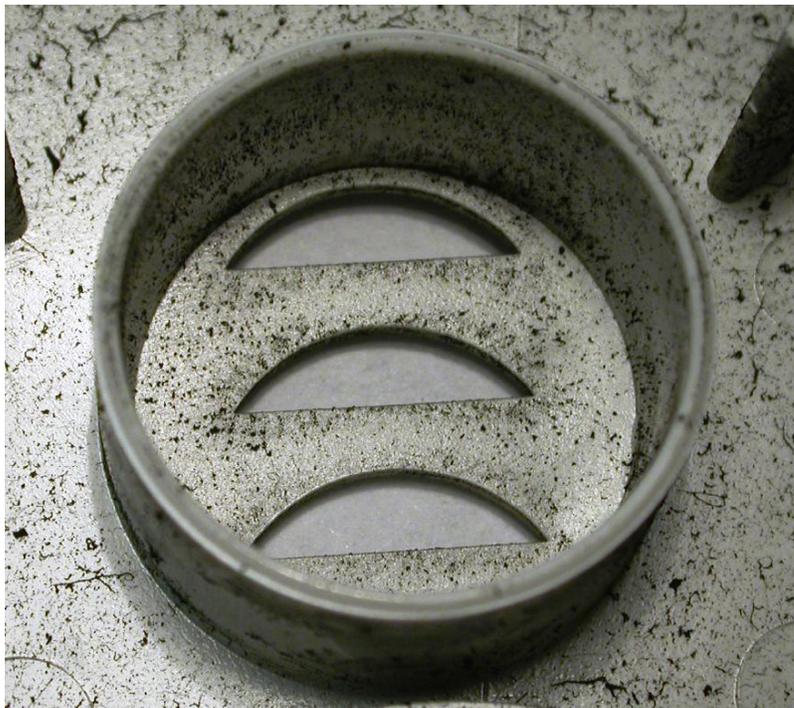
**Figure 7.26** This figure contains the horn chamber to the alarm that sounded during the same exposure as Figure 7.24. Notice the larger soot agglomerates and higher density of soot within this horn chamber than in Figure 7.24. Also, the density within the horn chamber is of equal or greater density to that outside the chamber.

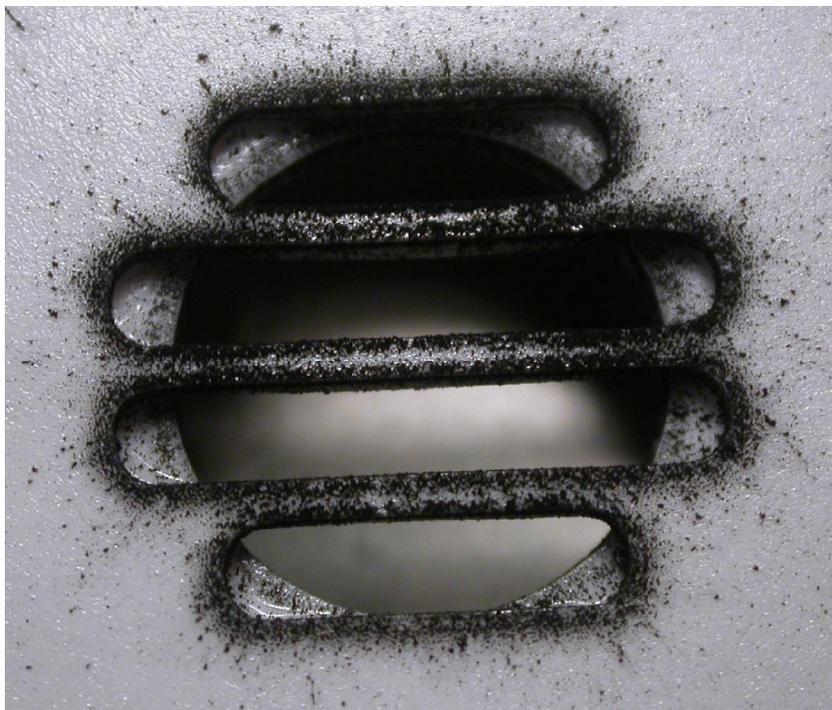
**Figure 7.27** An example of macroscopically observable enhanced soot deposition on the external face of an FSBI alarm. This is representative of the result of an alarm sounding during exposure to a flaming polyurethane exposure.

Patterns of enhanced soot deposition can occur on three faces of the smoke alarm horn opening: the external, internal, and vertical faces. These are most affected by the acoustic field and the induced pulsed flow and accompanying eddies of a sounding alarm. The following series of figures, 7.27-7.30, show a variety of depositions indicative of sounding. Figures 7.27 and 7.28 show the external and internal faces, respectively, of an FSBI alarm that sounded. Figure 7.29 shows the internal face of an FBI alarm that sounded during the cabinet assembly fire. The FGBI alarm pictured in Figure 7.30 has carbonaceous patterns on the external, vertical, and internal faces of the horn opening.

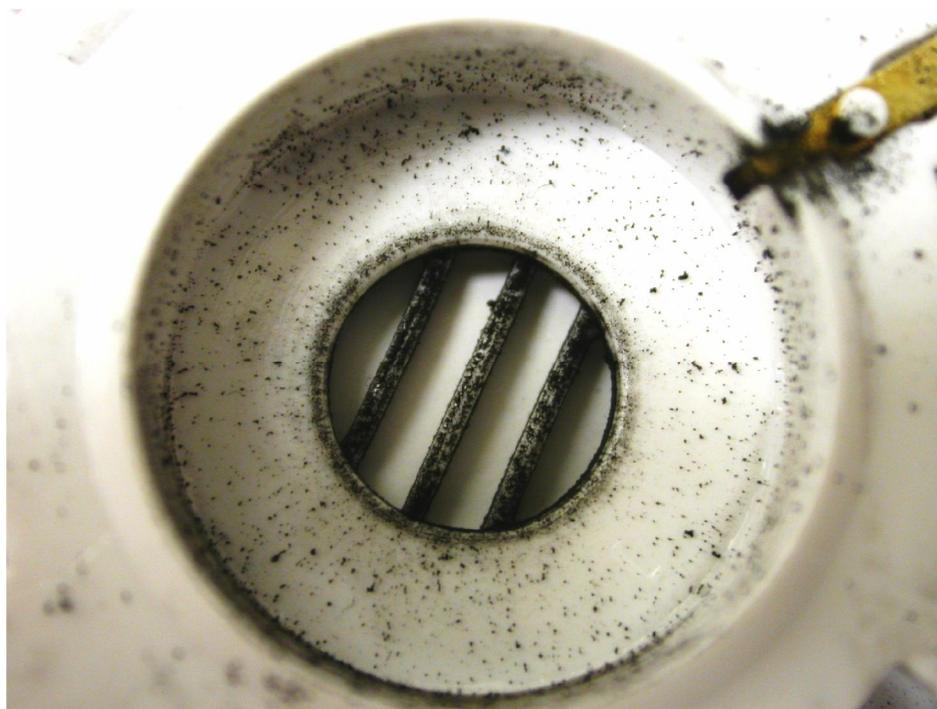
**Figure 7.28** An example of macroscopically observable enhanced soot deposition on the internal face of an FSBI alarm. This is representative of an alarm sounding during exposure to a flaming polyurethane source.

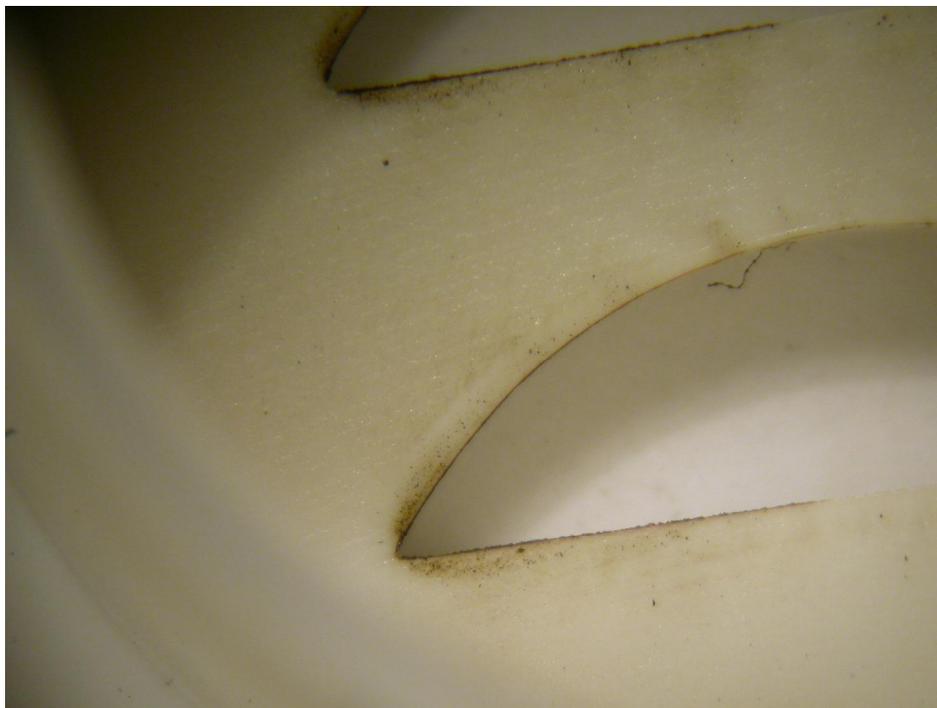
**Figure 7.29** An example of microscopically observable enhanced deposition on the internal face of an FBI horn opening that sounded from a smoldering/flaming cabinet assembly fire.

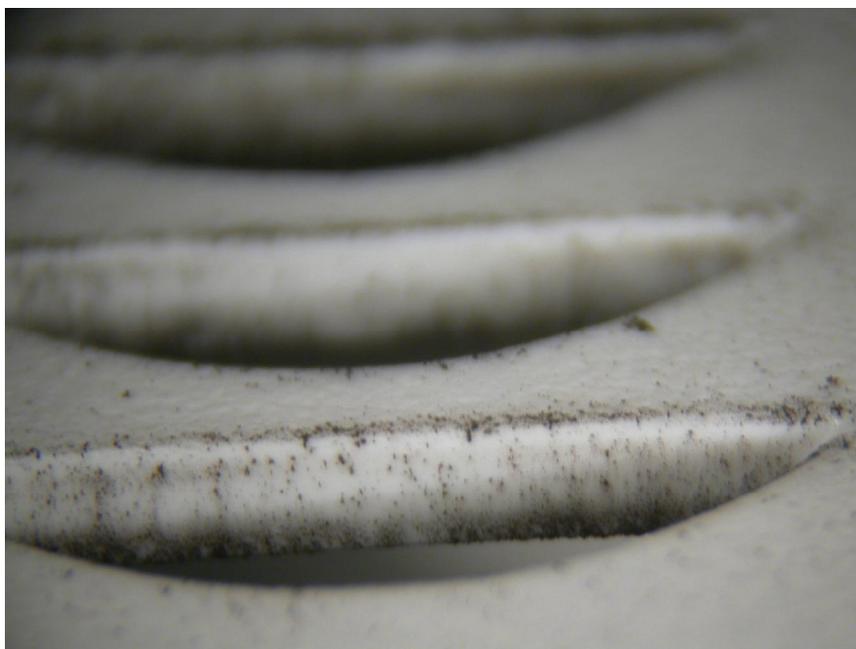
**Figure 7.31** This figure shows enhanced soot deposition on a vertical face of an FBI alarm that sounded during exposure to a flaming polyurethane fire. The deposition starts at higher density close to the internal face and decrease toward the external face. Compare this to Figure 7.32.

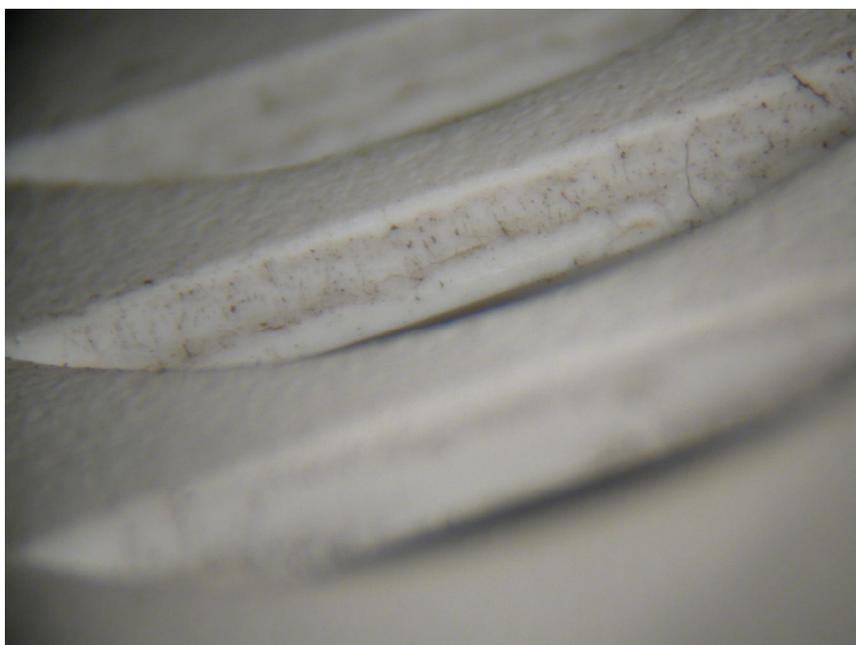
**Figure 7.32** This figure displays soot deposited on the vertical face of an FBI alarm that did not sound during exposure to flaming polyurethane. The deposition does not display any of the characteristics of enhanced deposition seen in Figure 7.31.

The vertical face is the sheer face of the smoke alarm horn opening connecting the external and internal faces (see Figure 7.30). This face is subject to the acoustic field and the induced pulsed flow. Enhanced soot deposition can be found on the vertical face of smoke alarm horn openings proximate to either or both edges (see Figure 7.30). The enhanced deposition will occur on the sheer face and not on the corners between the edges as seen with the misleading depositions (see Section 7.5.4.2). The enhanced depositions on the vertical face displayed both ring and radial characteristics proximate to both edges. In some cases, as in Figure 7.29, separate patterns of enhanced soot deposition were seen proximate to both edges with separation between. Figure 7.31 shows a pattern on the vertical face closest to the internal face of the horn opening only. Enhanced deposition can be more difficult to differentiate on the vertical face than on the internal and external faces, because there is no surface with which to compare soot deposition density. Figure 7.32 shows the deposition on the vertical face of an alarm that did not sound.

The difference between deposition and enhanced soot deposition on the vertical face is similar to that for the internal and external faces, the marked gradation in density being the primary characteristic. Simple deposition on the vertical face was not shown to be a predictive measure of sounding. Only enhanced soot deposition had a positive correlation with alarm sounding.

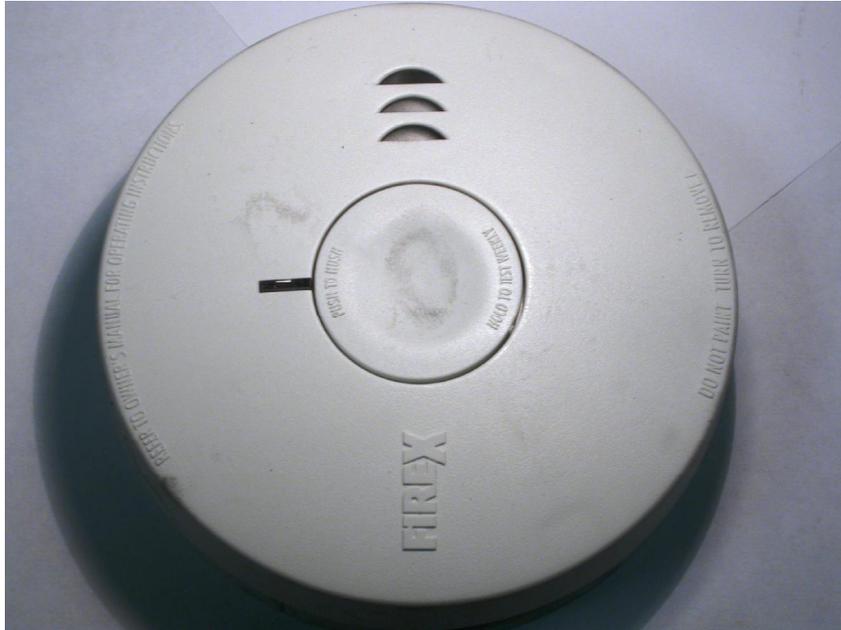
**Figure 13.1** This figure shows an overall view of the exterior of the alarm cover. Some ambient soot deposition is apparent on the alarm cover. There is not however enough soot to determine the direction of bulk flow past the alarm.

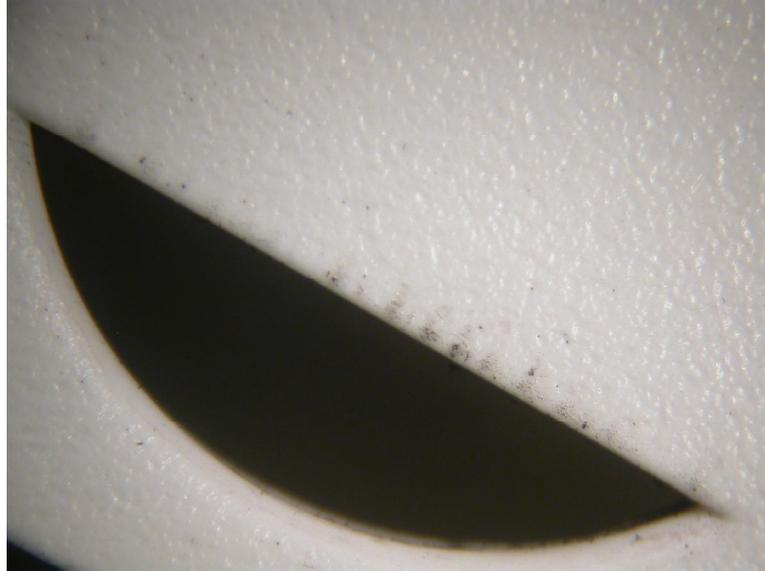
**Figure 13.2** This figure shows the next step in documenting the alarm state. It contains a macroscopic view of the alarm horn openings. There is very little soot apparent at this magnification. There appear to be slight indications of possible enhanced soot deposition on the flat edge of the lowest opening. There is not enough soot to make a conclusive determination of sounding.

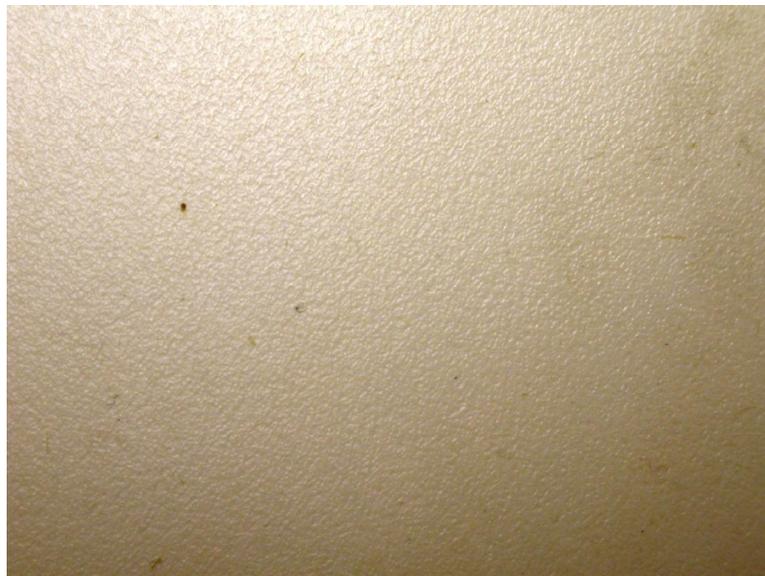
**Figure 13.3** This figure contains a microscopic view of the lowest horn opening from Figure 13.2. The soot deposited on the lower edge of the opening is much more apparent and has some radial characteristics. The deposition changes from higher to lower density moving away from the horn opening. Because the deposition is very light and the only evidence of enhanced soot deposition is directed in the same direction. It can not be conclusively determined that this is evidence of enhanced soot deposition indicative of sounding.

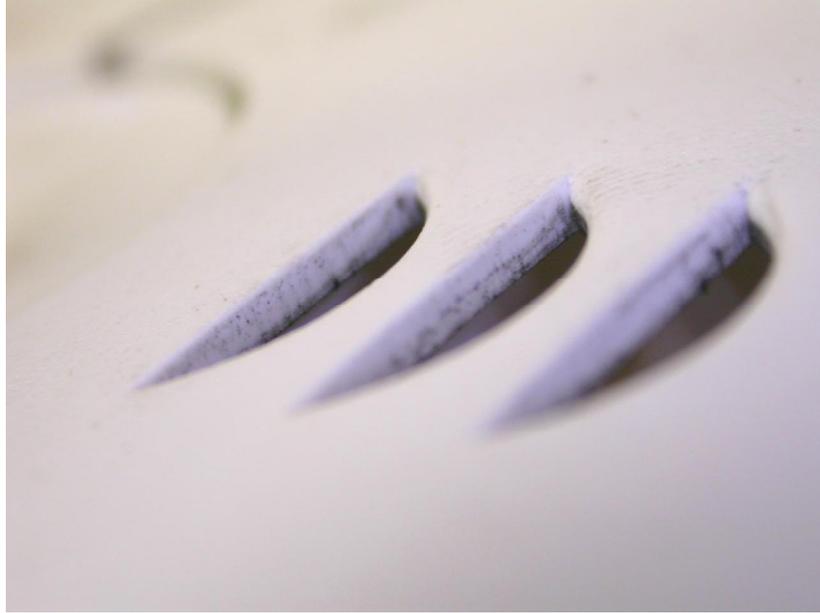
**Figure 13.4** This figure contains the ambient soot deposition on the external cover of the smoke alarm. This photo was taken at the same magnification as Figure 13.3 to allow the comparison of soot deposition density proximate and farther from the horn openings (approximately 2 cm). There is little appreciable soot deposited on the alarm cover compared to the horn opening supporting the identification of enhanced soot deposition indicative of sounding.

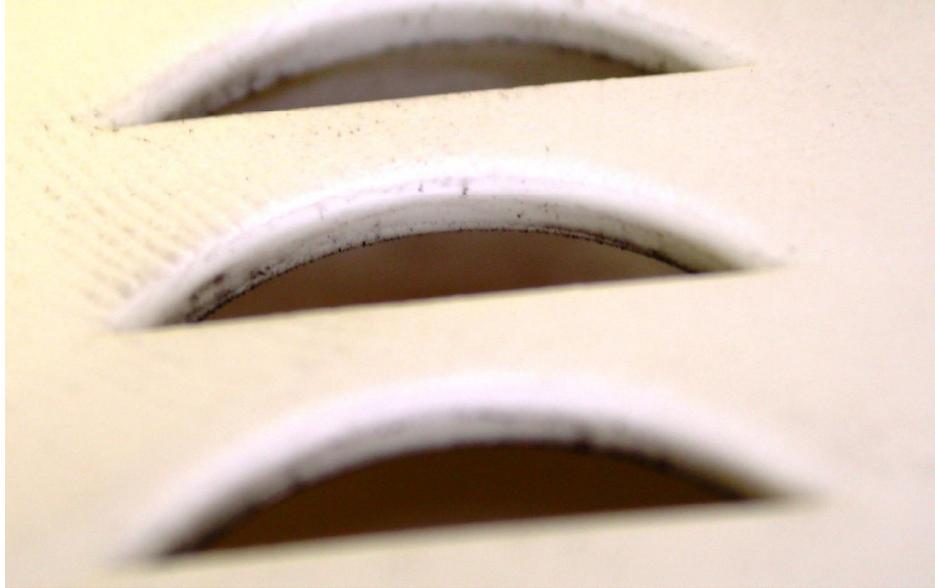
**Figure 13.6 This figure shows another view of a single vertical face of the alarm. The deposition is again denser than was seen on the alarm cover or external face, especially toward the corners of the moon shapes. The deposition density changes from higher to lower density moving from the internal to external face of the horn opening.**

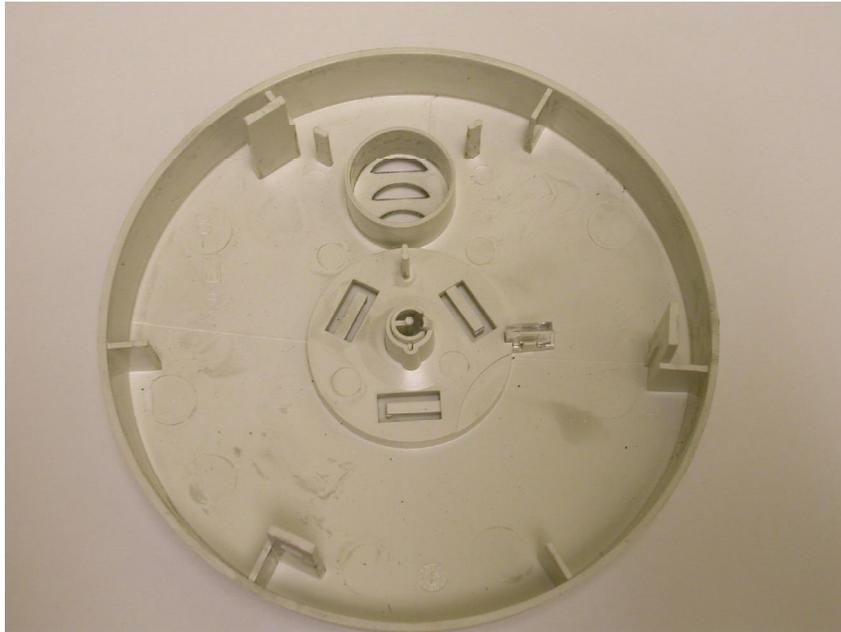
**Figure 13.8** This figure shows a macro view of the components of the smoke alarm after the cover has been removed. There is little evident soot deposition on the alarm components and no evidence of bulk flow of smoke through the alarm.

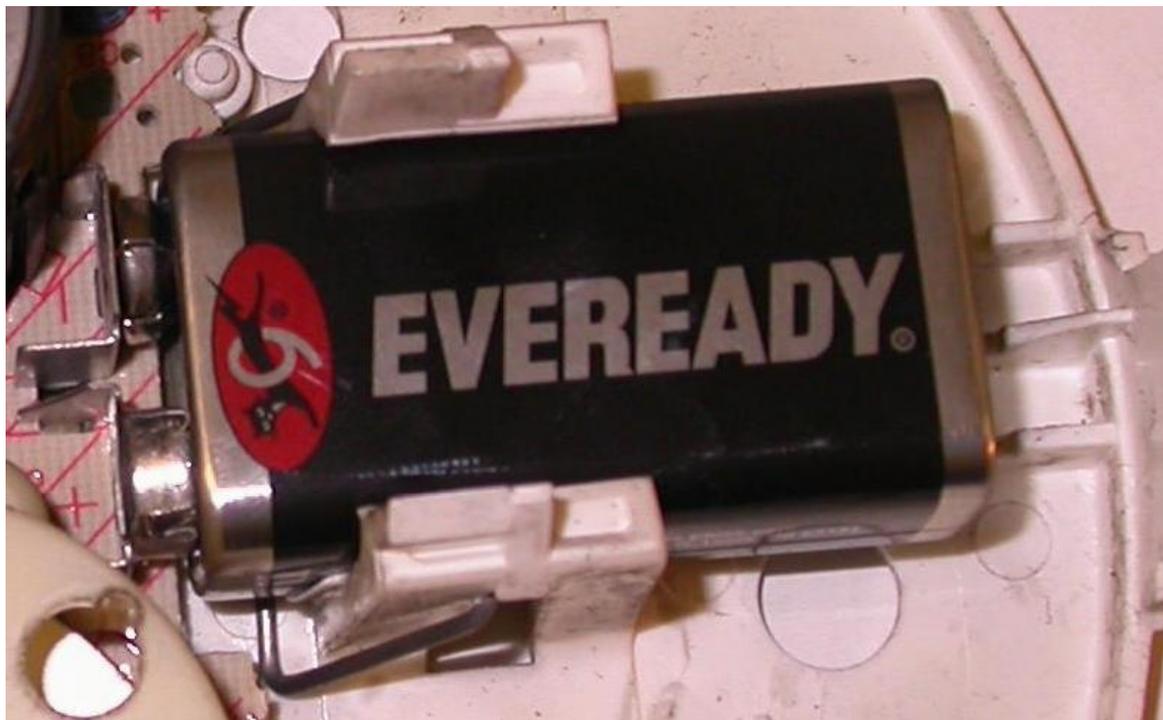
**Figure 14.2 An FGBI alarm with a properly installed battery. The arms that hold the battery in place form a tight seal to the battery and during some higher soot yield exposures yield the patterns seen in Figure 14.3. The alarm battery terminals also fit tightly around the battery terminals allowing for evaluation of soot or lack thereof on both terminal sets.**

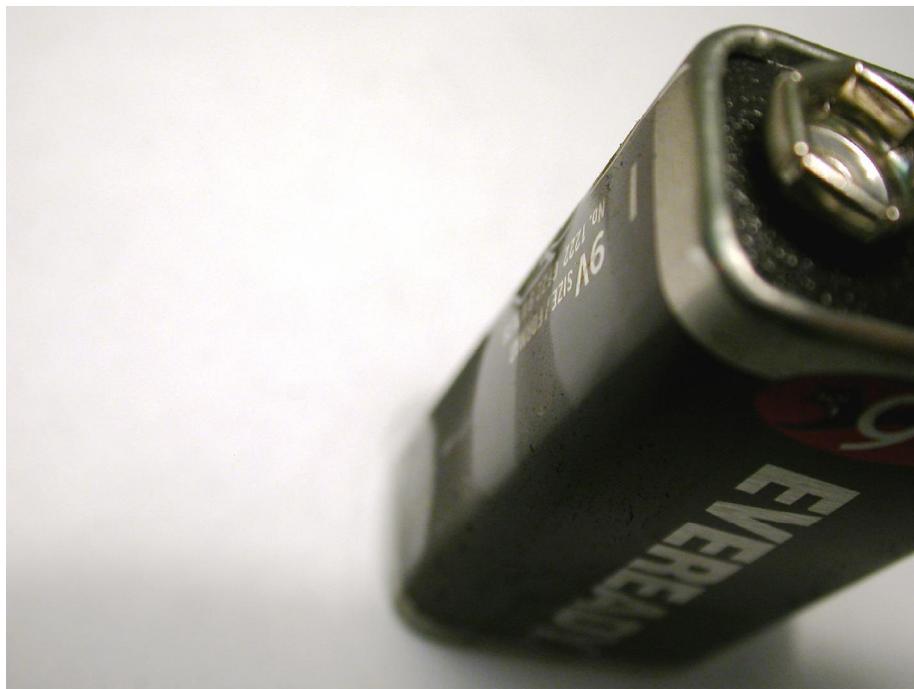
**Figure 14.3** The outline of the battery arms in the soot deposited on the battery installed in an alarm exposed to the flaming couch in Experiment 4.2.

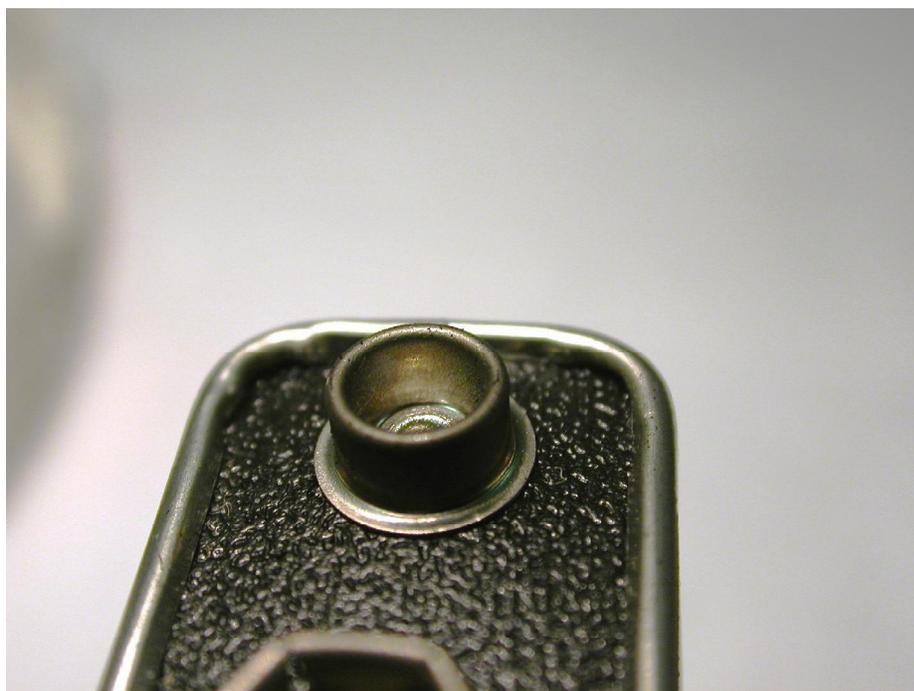
**Figure 14.4** Soot covering a battery terminal from a battery improperly installed in an FGFI alarm exposed in Experiment 4.2: Flaming Couch exposure. Soot could not have collected this way on the terminal of a properly installed battery, see Figure 14.2.

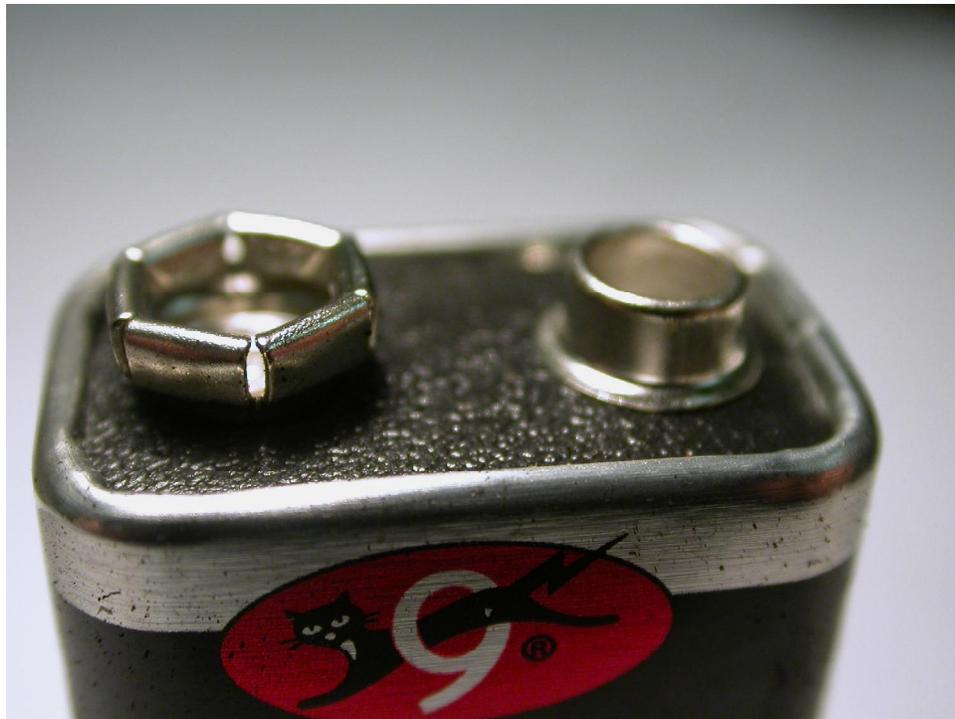
**Figure 14.5 Clean terminals on a properly installed battery from an FGBI alarm exposed to the flaming couch in Experiment 4.2. Compare the lack of deposition to soot deposited on the terminals of an improperly installed battery in Figure 14.4.**

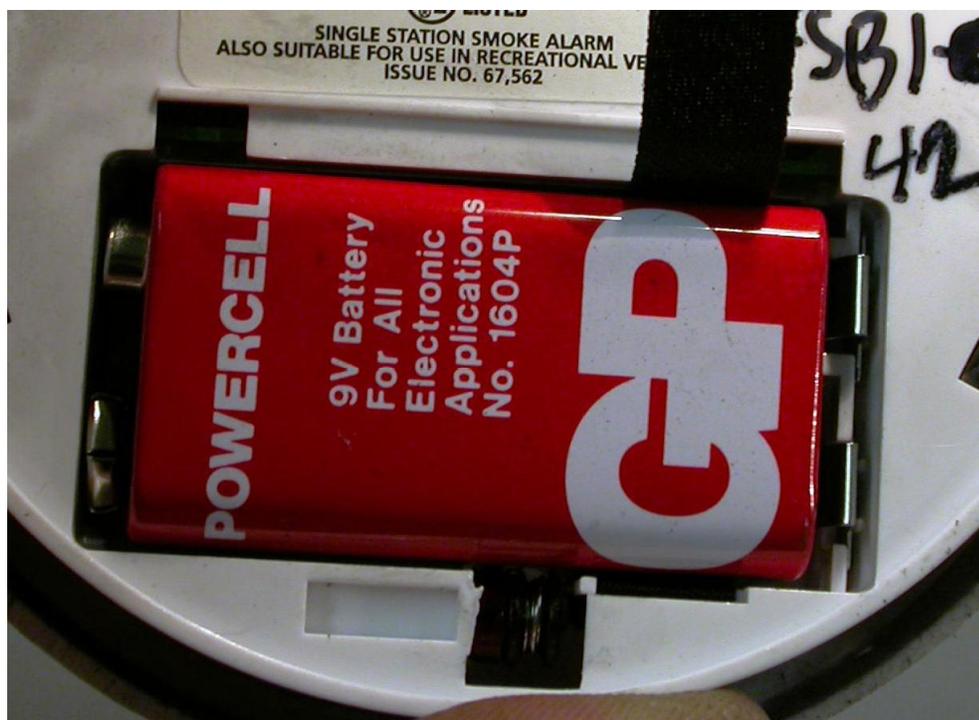
**Figure 14.6 The battery compartment of an FSBI smoke alarm.**

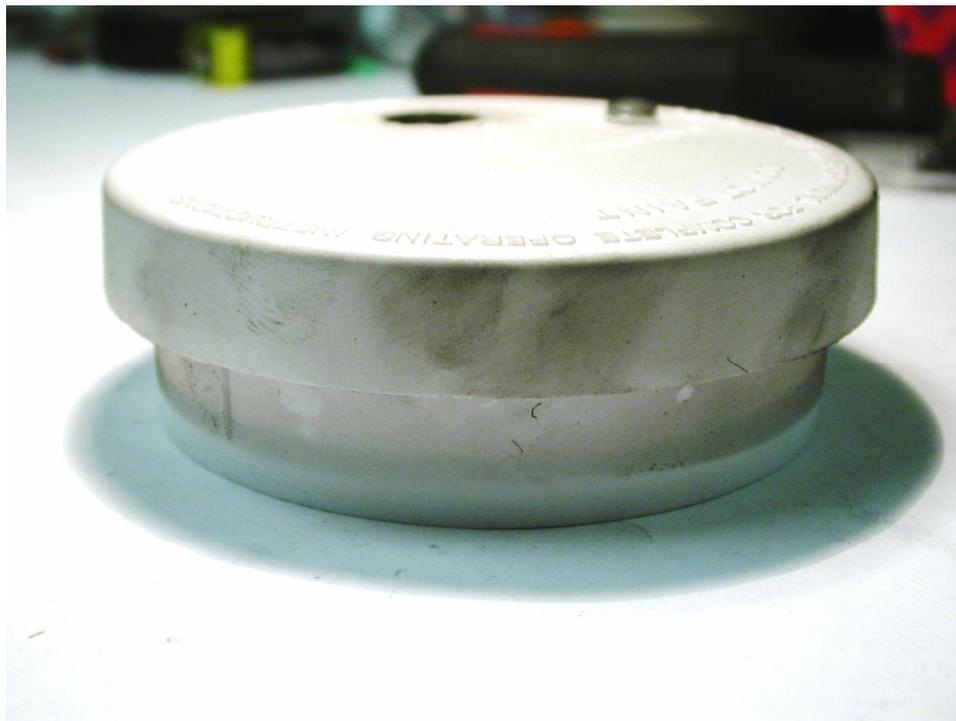
**Figure 14.8 Example of the exterior flow pattern on an FSBI alarm exposed in Experiment 4.2: Flaming Couch Exposure. Note the higher to lower soot density moving from right to left on the alarm cover, signifying smoke flow from right to left across the alarm.**

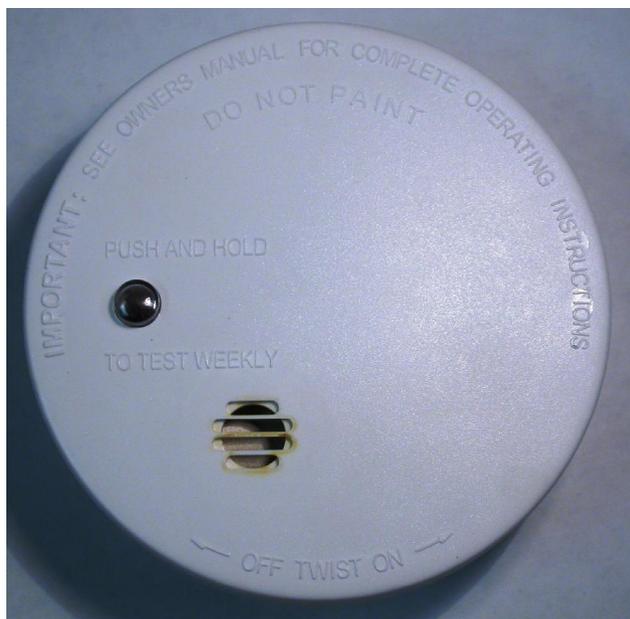
**Figure 16.1** This figure shows the exterior of the alarm cover of an alarm that sounded during exposure to a smoldering polyurethane source. Enhanced soot deposition patterns are visible in this figure around the alarm horn openings.

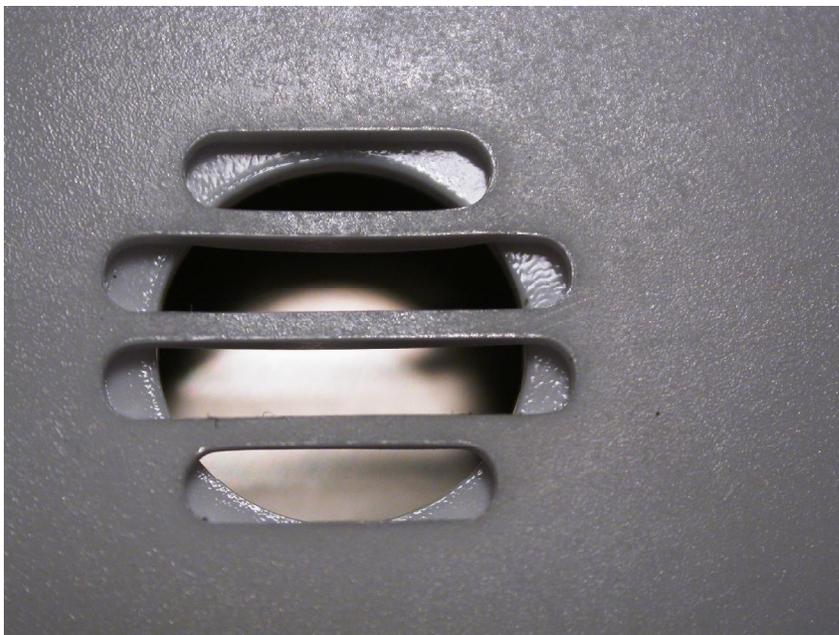
**Figure 16.3** This is a microscopic view of some of the alarm horn openings from the alarm in Figures 16.1-16.3. This alarm sounded during exposure to a smoldering polyurethane fire source. Tarry enhanced soot deposition is visible around the horn openings as orange/brown bands.

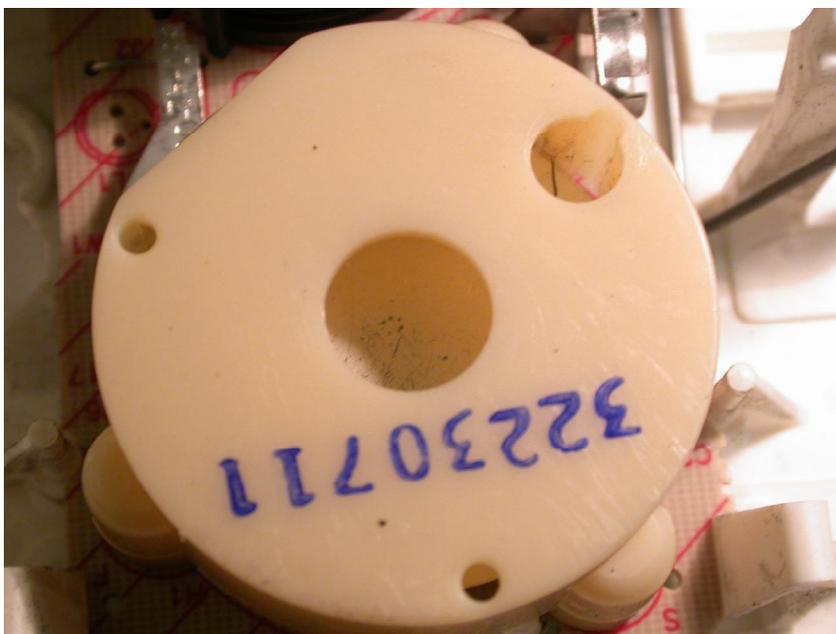
**Figure 16.7** This figure shows external face of an alarm that sounded during exposure to smoldering polyurethane source. There is no evidence of enhanced soot deposition indicative of sounding.

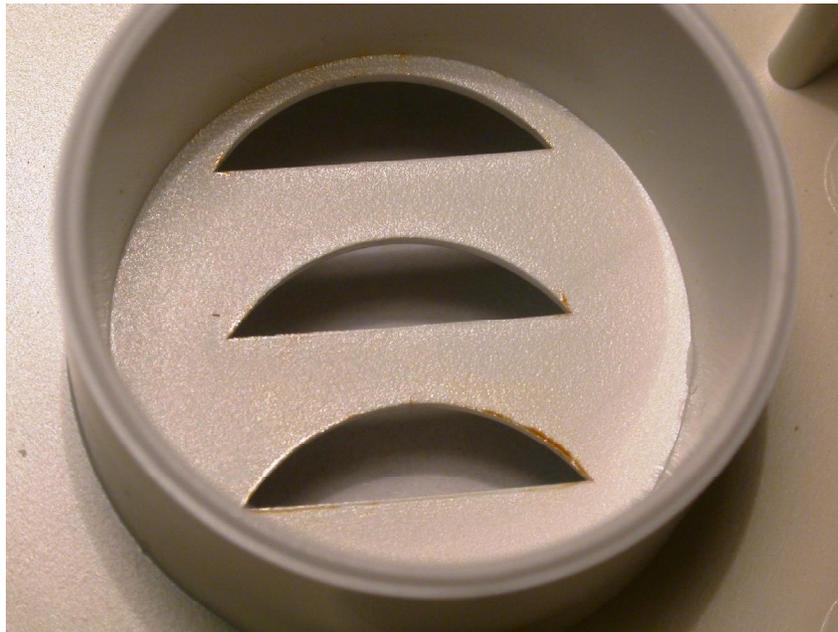
**Figure 16.10** This figure shows a macroscopic view of the internal face of smoke alarm horn openings of an alarm that sounded during exposure to a smoldering polyurethane source. There is evidence of tarry enhanced soot deposition indicative of alarm sounding around the edges of the horn openings.

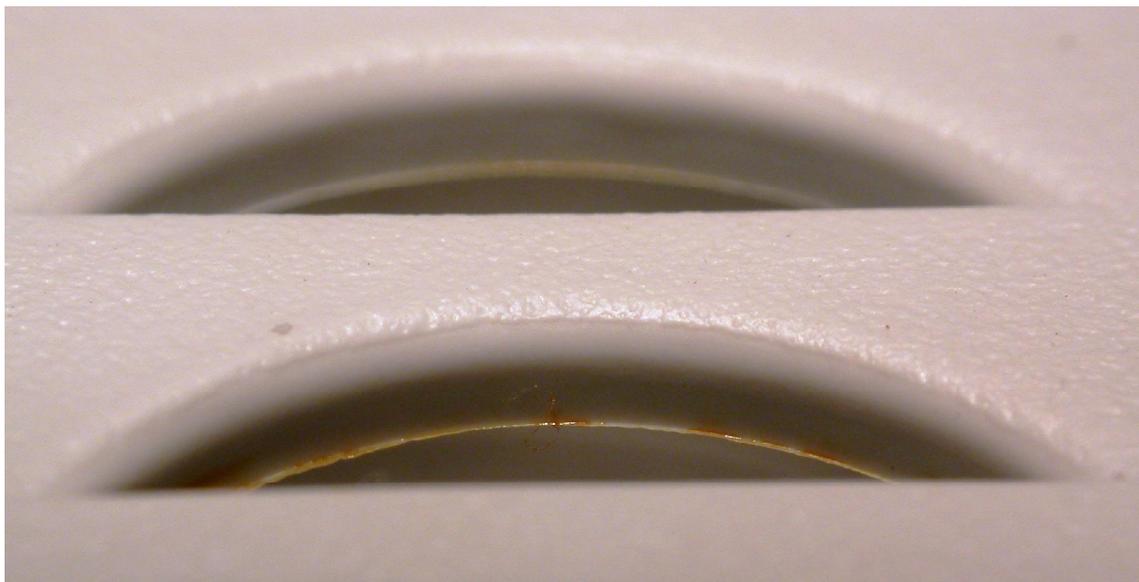
**Figure 16.11** This figure shows a microscopic view of the vertical face of one of the alarm horn openings of the alarm pictured in Figures 16.9-16.10. This alarm sounded during the exposure and tarry enhanced soot deposition is visible as the yellow orange depositions in the corner of the opening.

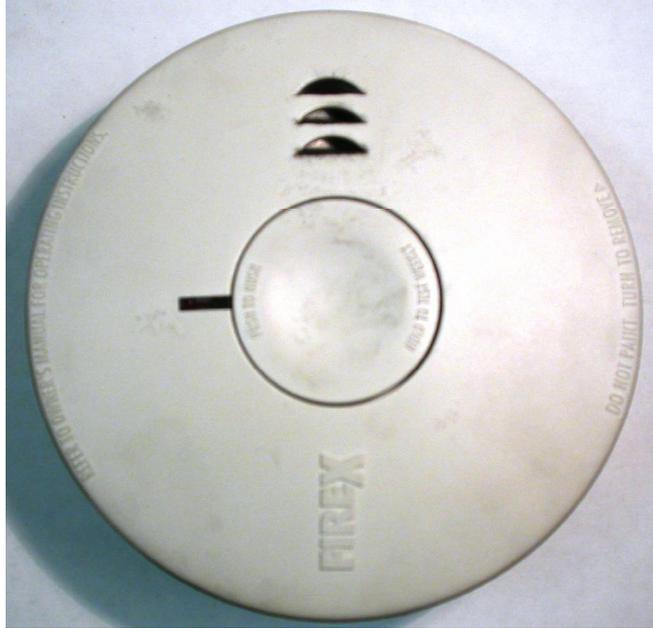
**Figure 17.1** This figure shows the exterior of the alarm cover of an alarm that sounded during exposure to a flaming polyurethane fire source. Enhanced soot deposition patterns with radial characteristics are barely visible in this figure around the alarm horn openings.

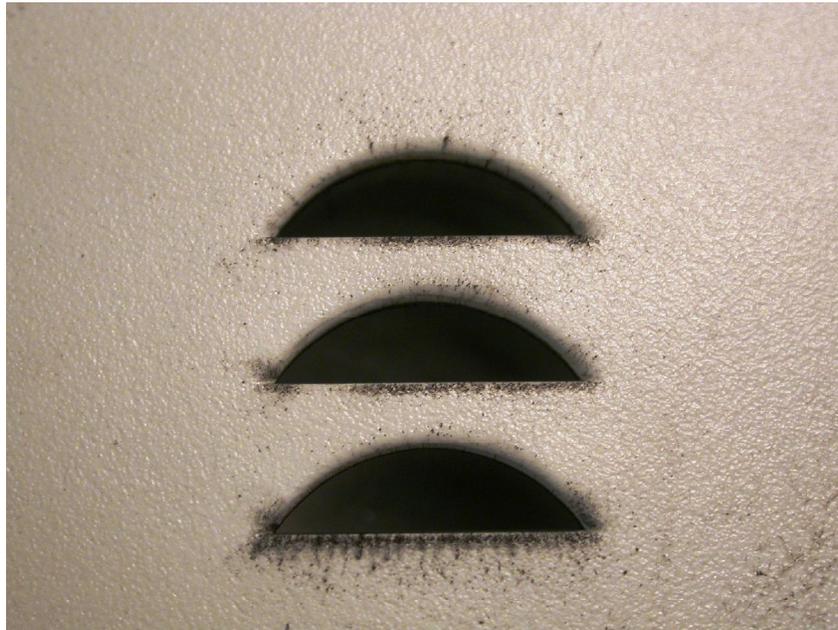
**Figure 17.2** This figure shows a macroscopic view of the exterior face of the alarm horn openings of the same alarm in Figure 17.3. This alarm sounded during exposure to a flaming polyurethane fire source. Enhanced soot deposition is visible in places around each of the moon-shaped openings.

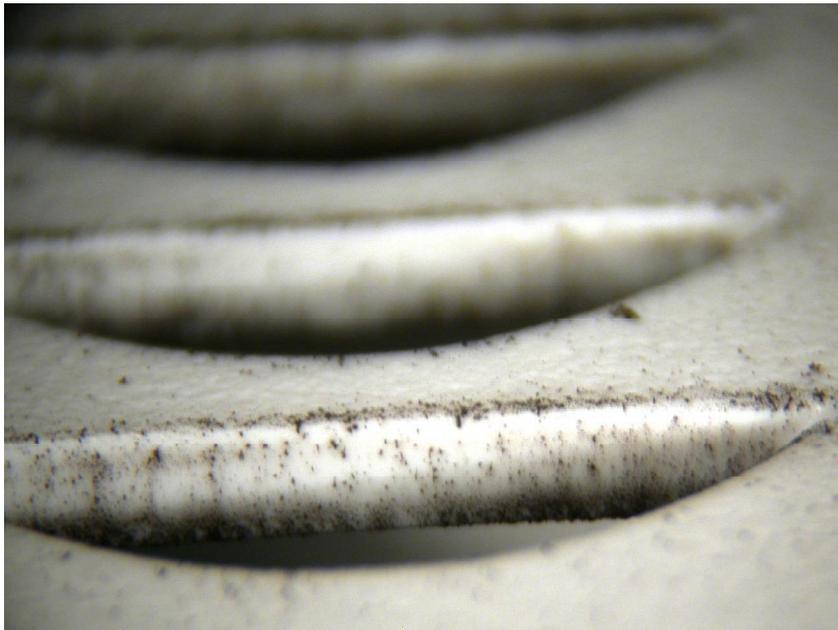
**Figure 17.4** This figure contains a macroscopic view of the vertical faces of the alarm [pictured in Figures 17.1-17.3]. This alarm sounded during exposure to a flaming polyurethane fire source. Enhanced soot deposition is visible on all three vertical faces. The deposition density moves from higher to lower density from the internal to external faces of the horn opening.

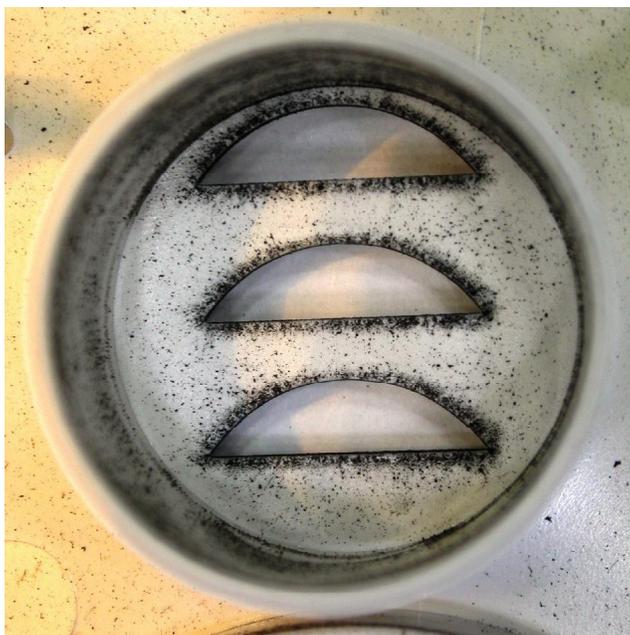
**Figure 17.6** This figure contains a macroscopic view of the interior face of the alarm horn opening of the alarm pictured in Figures 17.1-17.5. Visible is the enhanced soot deposition around the horn openings and the deposition density of equal or greater inside the horn chamber than outside the horn chamber.

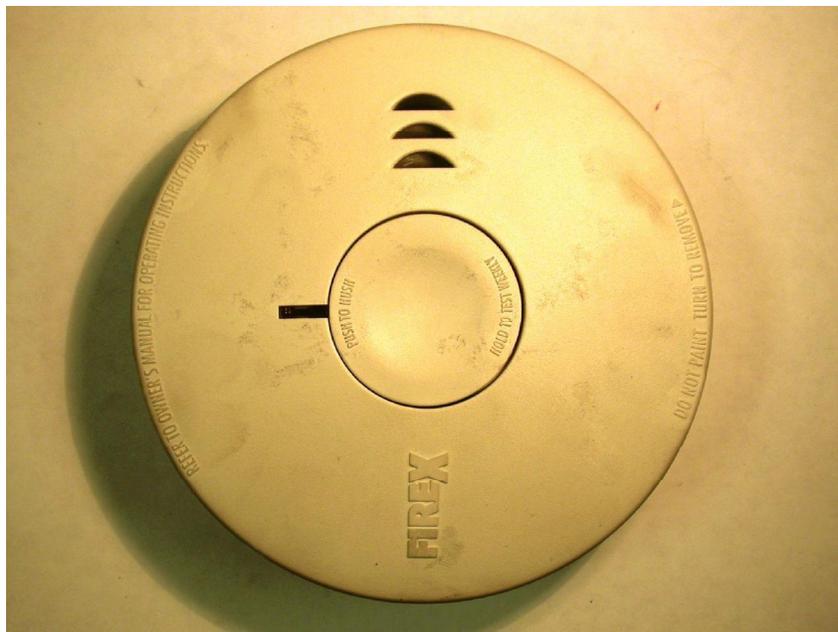
**Figure 17.7** This figure contains the external cover of an alarm that did not sound during exposure to a flaming polyurethane source.
