An Investigation of Enhanced Soot Deposition on Smoke Alarm Horns

A Thesis

Submitted to the Faculty of  
Worcester Polytechnic Institute  
In partial fulfillment of a  
Master of Science Degree  
In Fire Protection Engineering

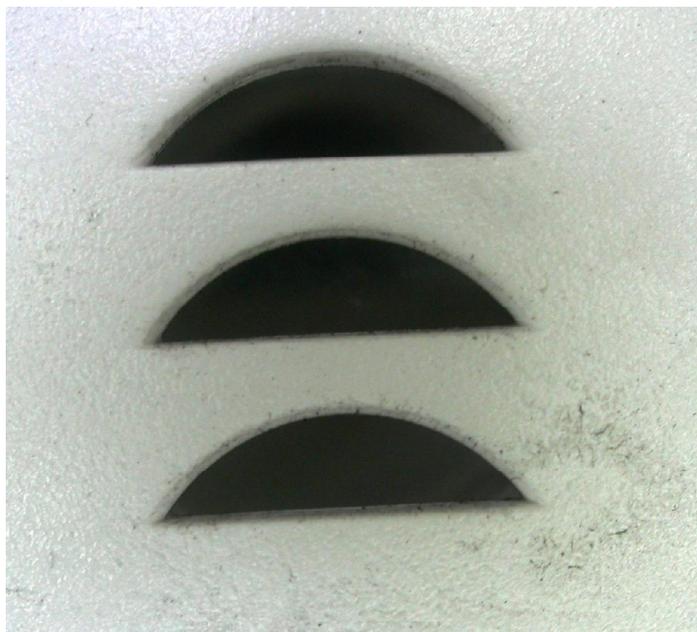
**Figure 17.8** This figure contains a macroscopic view of the external face of the alarm horn openings of the same alarm as in Figure 17.7. There is some visible deposition around the alarm horn openings but it is not of any greater density than the deposition on the cover of the alarm further from openings.

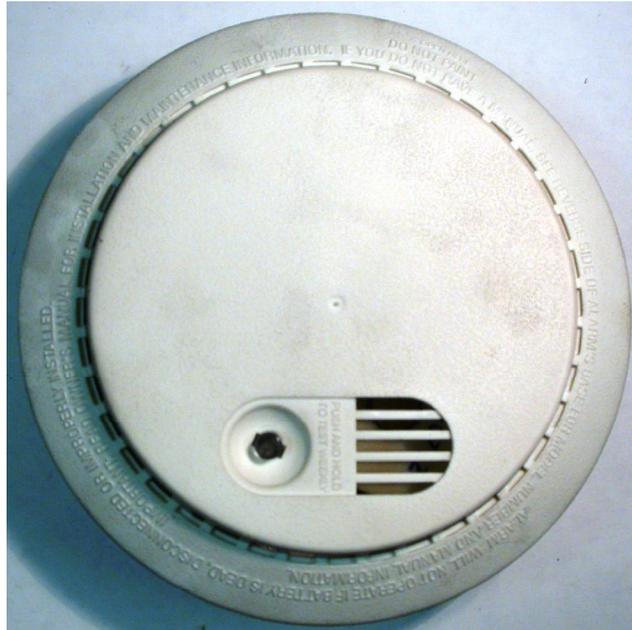
**Figure 17.10** This figure pictures the exterior cover of an FGBI alarm that sounded during exposure to a flaming polyurethane source.

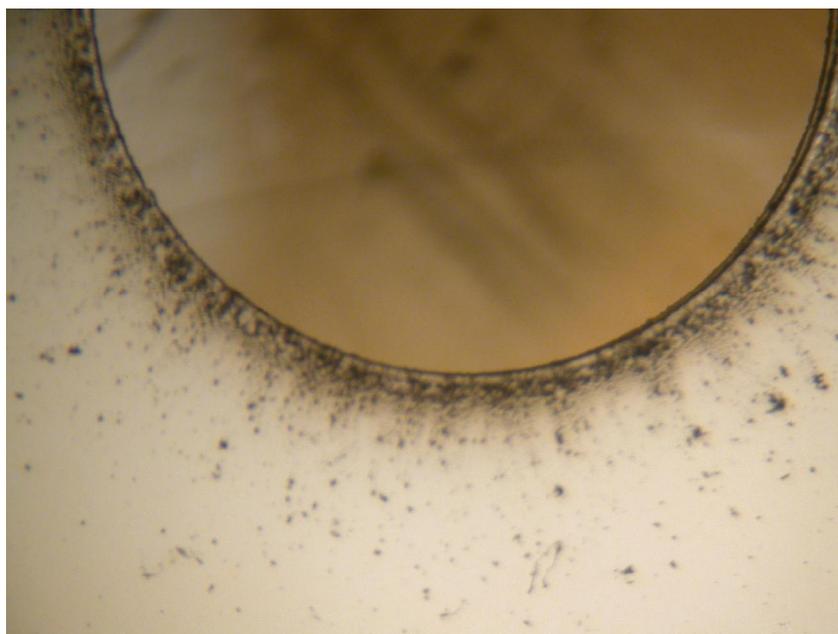
**Figure 17.12** This Figure contains a microscopic view of the external face of the alarm horn opening of the alarm pictured in Figures 17.10-17.11. There is a distinct pattern of enhanced soot deposition on this alarm that sounded during exposure to a flaming polyurethane source.

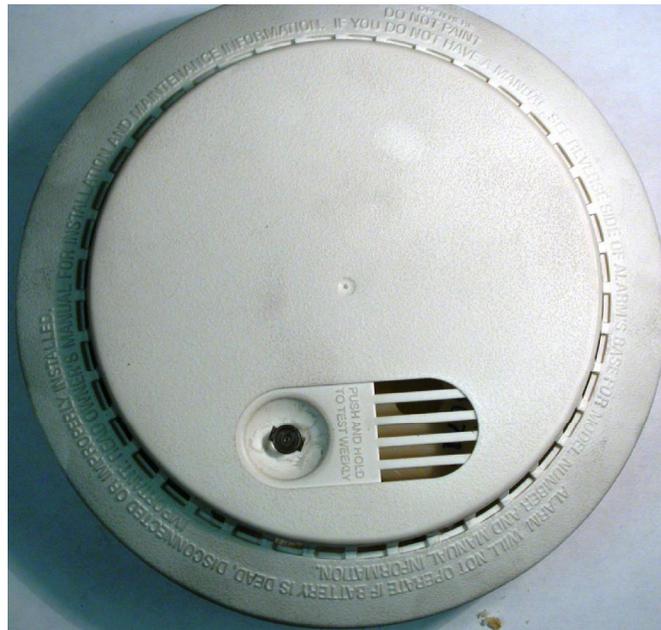
**Figure 17.14** This figure shows the exterior alarm cover of an FGBI alarm that did not sound during exposure to a flaming polyurethane fire.

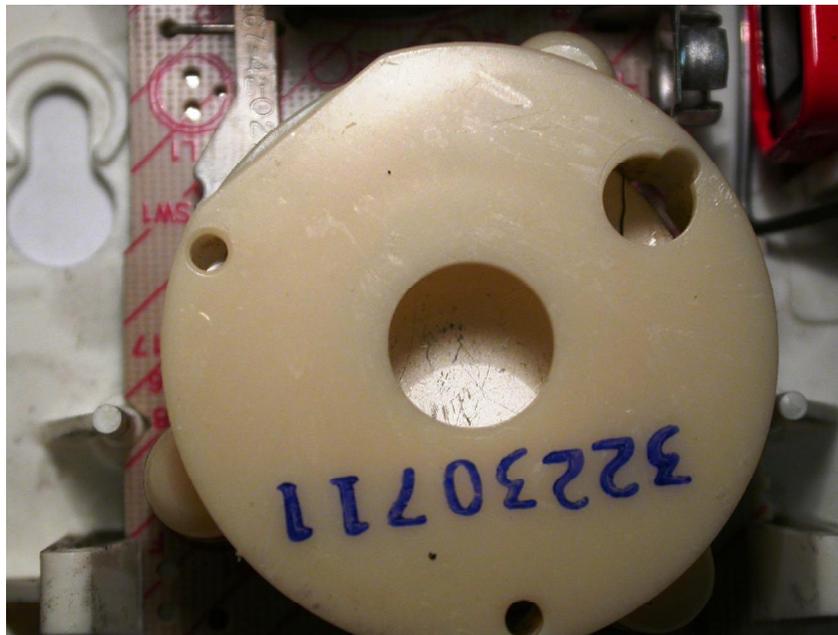
**Figure 17.16** This is a macroscopic view of the horn of the alarm pictured in figures 17.14-17.15. This alarm did not sound during exposure to a flaming polyurethane source and shows no signs of enhanced soot deposition.

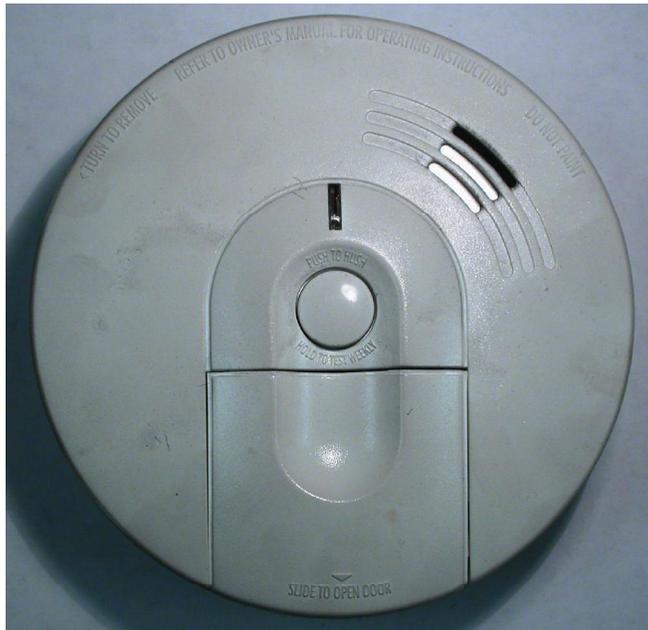
**Figure 17.18** This is the exterior of the cover of an FACI alarm that sounded during exposure to a flaming polyurethane fire.

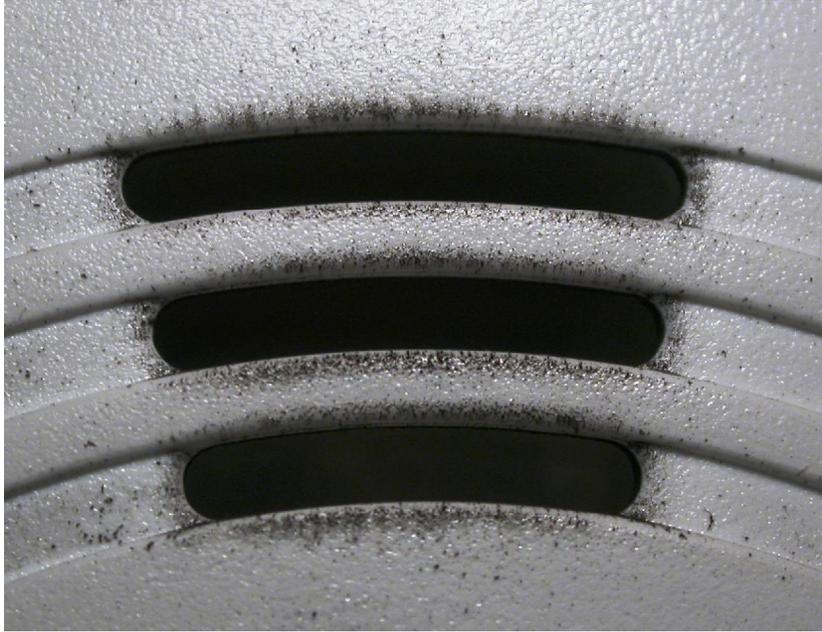
**Figure 17.19** This is a macroscopic view of the external face of the horn openings of the alarm pictured in Figure 17.18. This alarm did sound during exposure to a flaming polyurethane source and shows evidence of enhanced soot deposition.

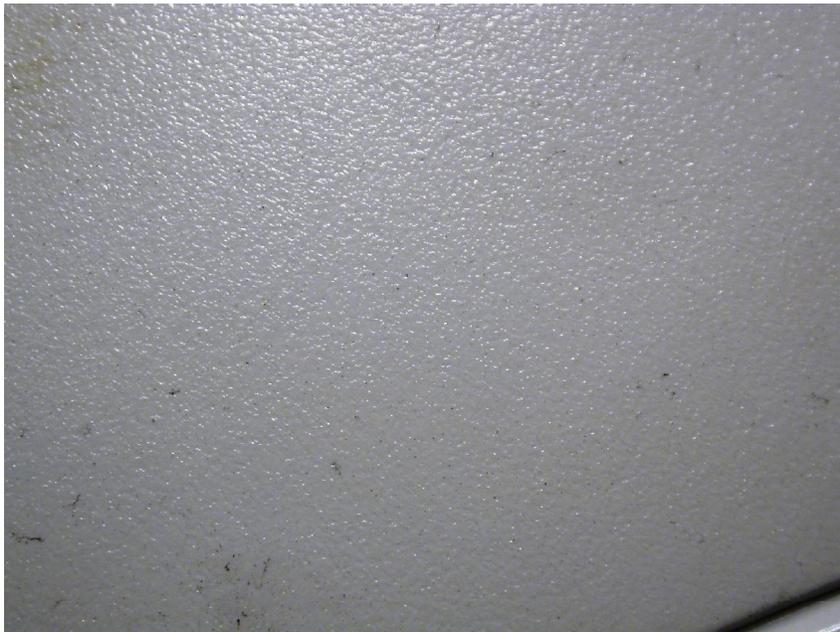
**Figure 17.20** This figure shows the level of ambient soot deposited on the cover of the alarm pictured in Figures 17.14-17.19 (photo at the same magnification as Figure 17.19). The density of soot deposited farther from the opening is lower than the density of soot in the pattern of enhanced soot deposition from the previous figure.

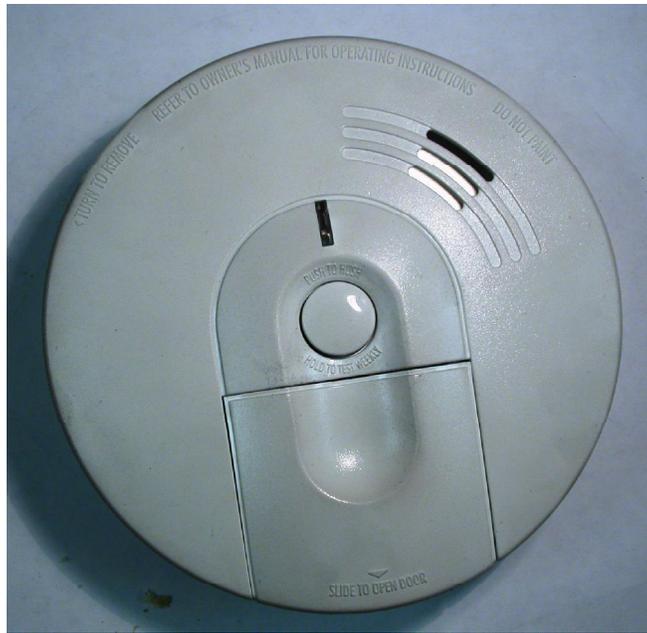
**Figure 17.21** This figure pictures the external cover of an FACI alarm that did not sound during exposure to a flaming polyurethane source.

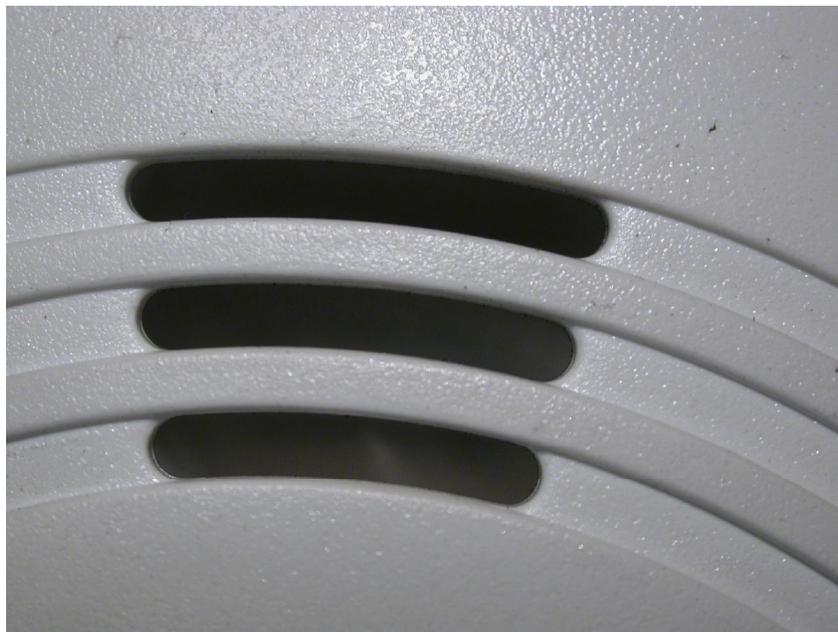
**Figure 17.22** This figure shows a macroscopic view of the external face of the alarm horn opening of the FACI alarm pictured in Figure 17.21. There is no indication of enhanced soot deposition, as this alarm did not sound during exposure to the flaming polyurethane fire.

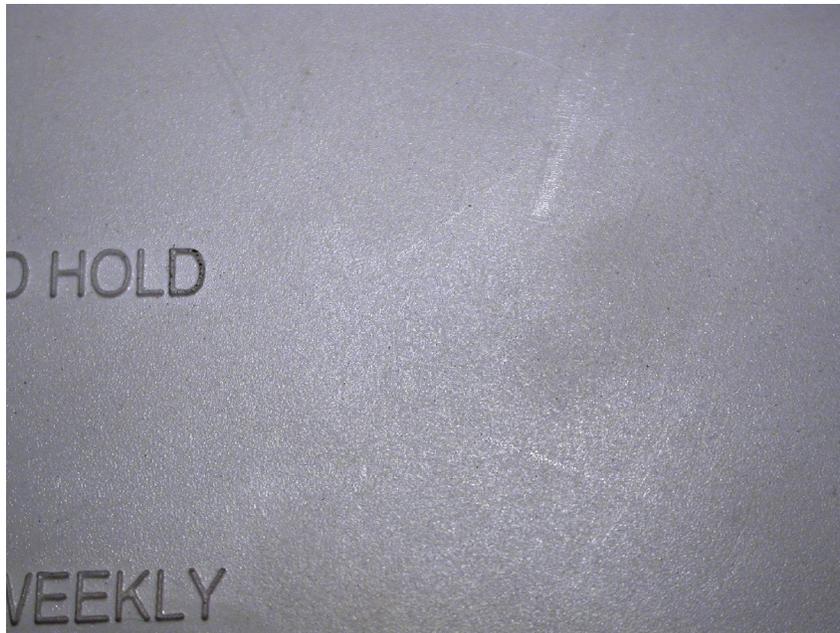
**Figure 17.28** This is a macroscopic view of the external face of the alarm horn opening from the alarm pictured in Figure 17.27. This alarm does not display evidence of enhanced soot deposition, as it did not alarm.

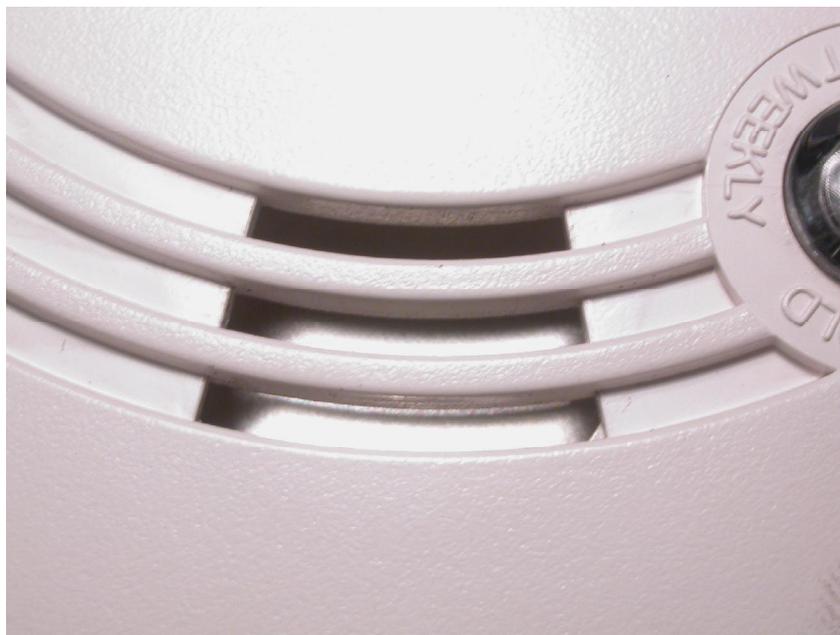
**Figure 17.31** This is the exterior cover of a Photo alarm that sounded during exposure to a flaming polyurethane fire.

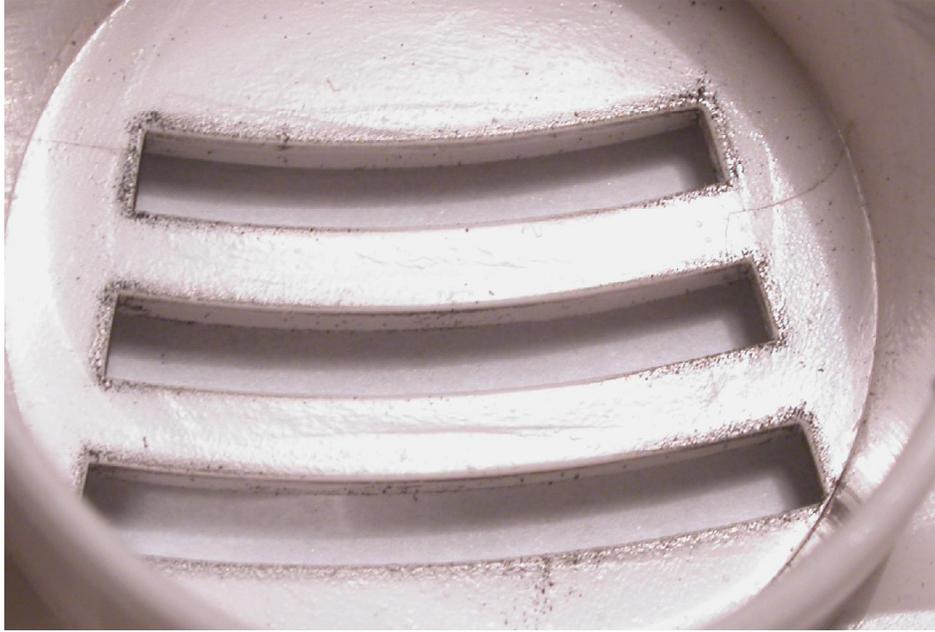
**Figure 17.34** This is a view of the interior of the alarm from Figures 17.31-17.33.

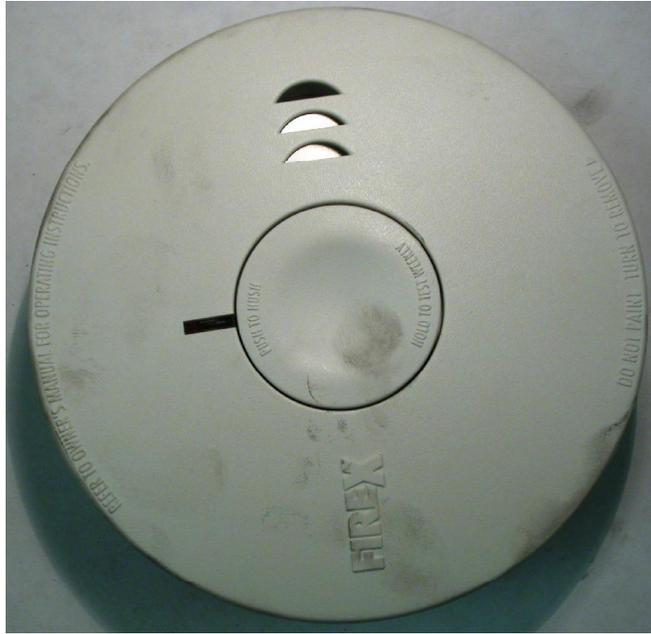
**Figure 17.35** This is a macroscopic view of the interior face of the alarm pictured in Figures 17.31-17.34. There are rings of enhanced soot deposition visible around the horn openings. The enhanced soot deposition is more distinct on the interior face than the exterior face, Figure 17.32.

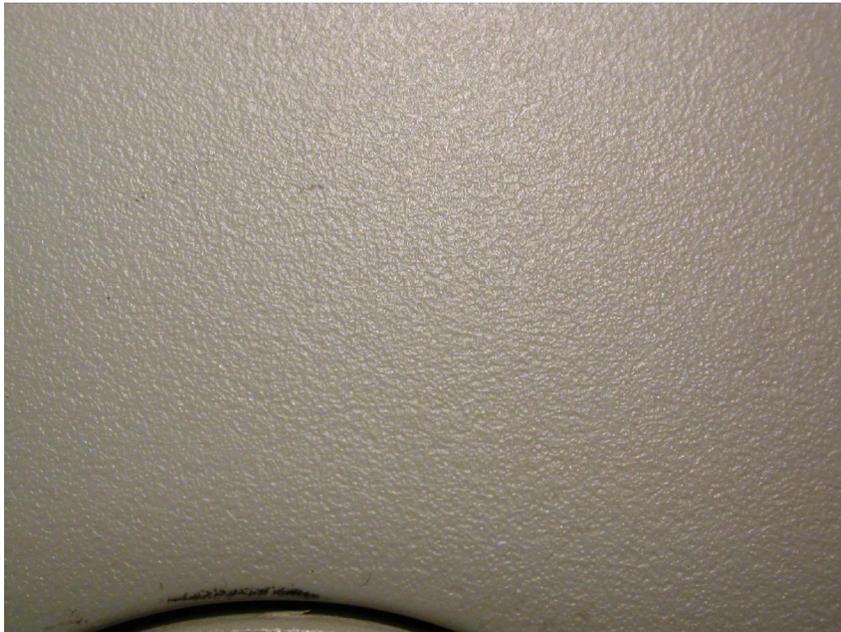
**Figure 18.3** This is a microscopic view of the alarm horn openings of Figure 18.2. There is no evidence of enhanced soot deposition on the vertical surface. This case did not present sufficient evidence to yield a determination.

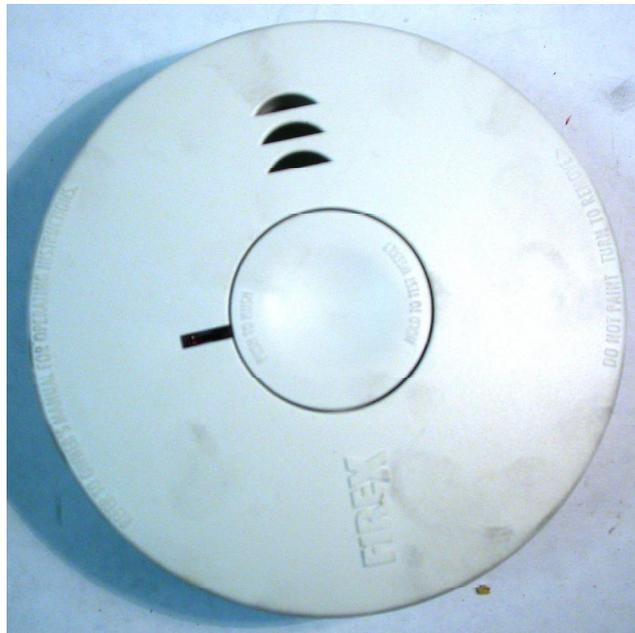
**Figure 18.4** This figure shows the ambient deposition on the exterior cover of the alarm in Figures 18.1-18.3.

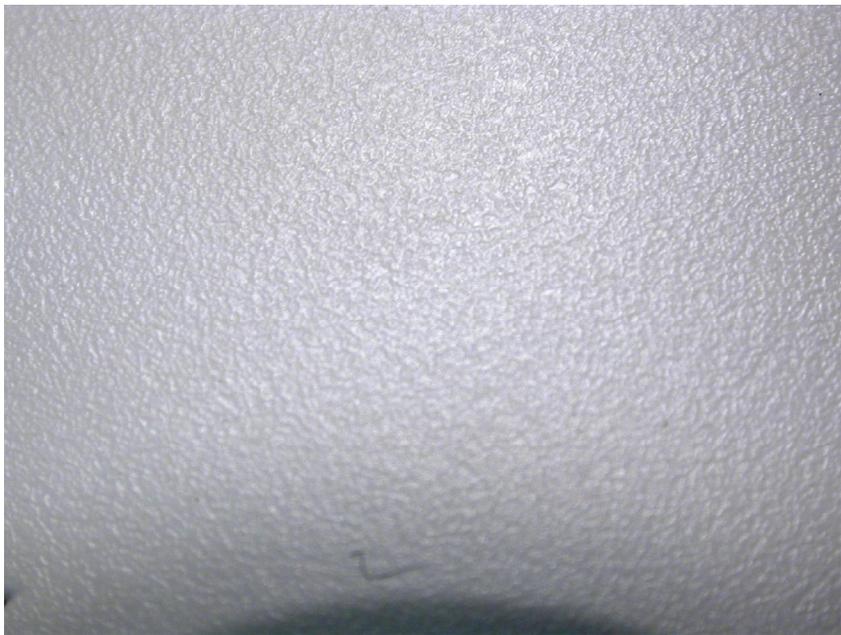
**Figure 18.7 This is a microscopic view of a horn opening pictured in Figure 18.6. This alarm did not sound and does not show evidence of enhanced soot deposition.**

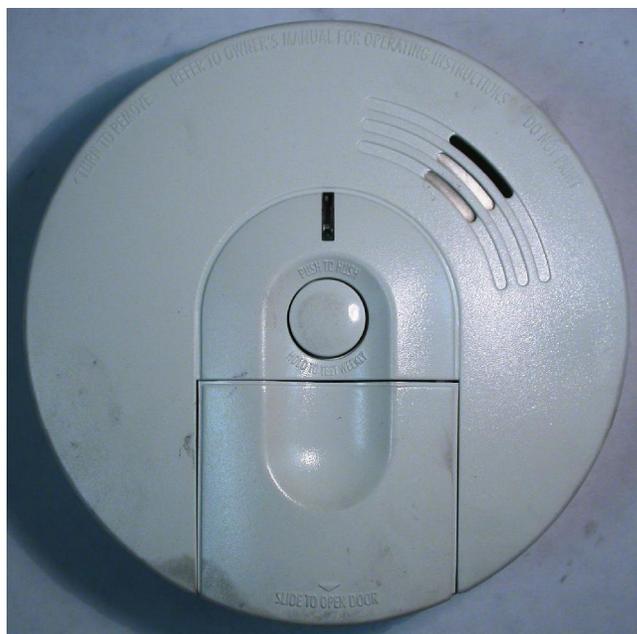
**Figure 18.8 This figure shows the ambient soot deposited on the exterior cover of the alarm that did not sound during exposure to a flaming wood fire.**

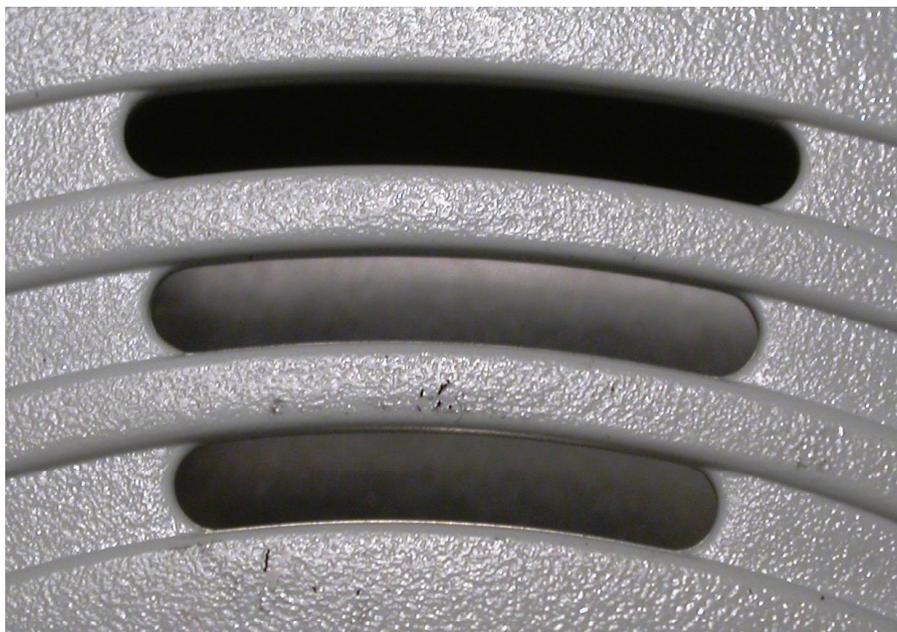
**Figure 18.9** This figure shows an overview of an FACI alarm that sounded during exposure to a flaming wood fire.

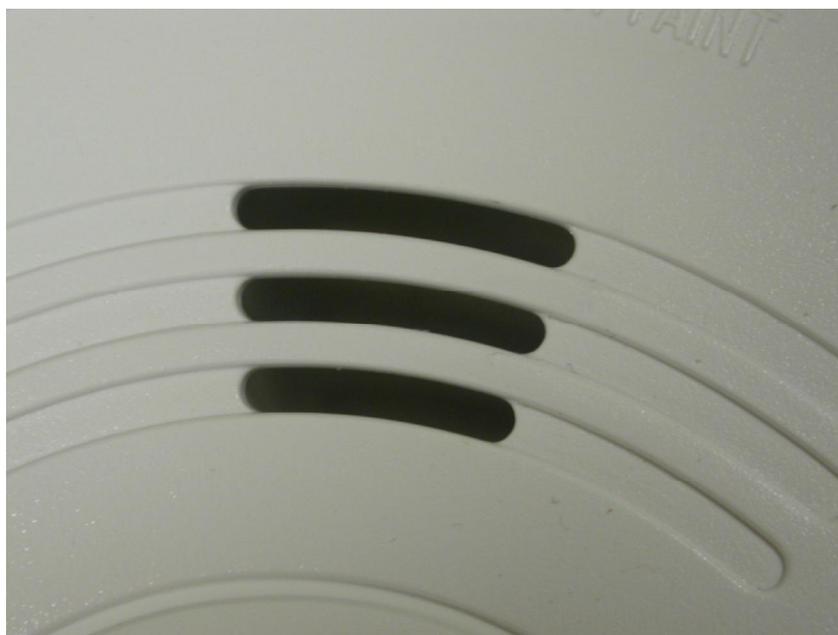
**Figure 19.3** This figure shows the exterior cover of an FACI alarm that sounded during multiple nuisance exposures.

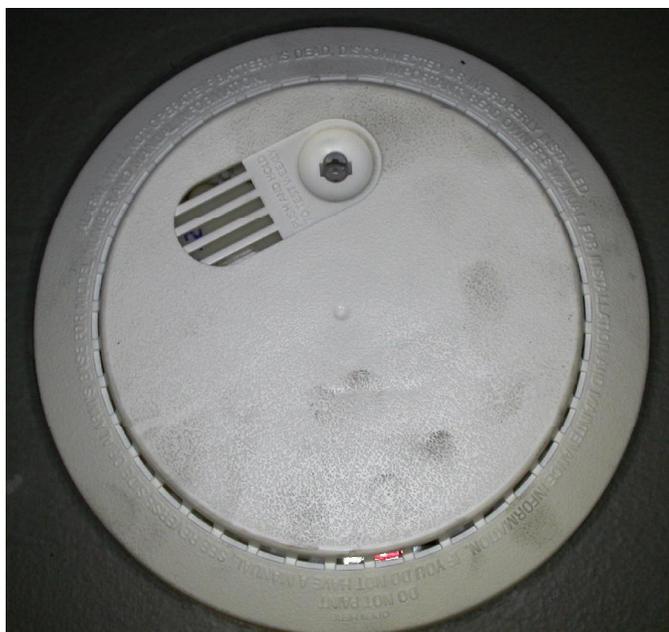
**Figure 19.4** This figure is a macroscopic view of the alarm horn openings of the alarm pictured in Figure 19.3. This alarm sounded during multiple nuisance exposures but does not show evidence of enhanced soot deposition.

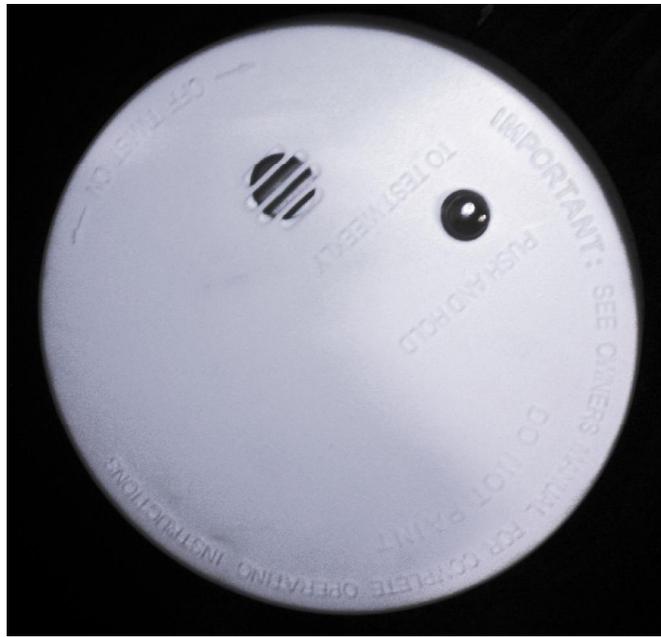
**Figure 19.6** This figure is a macroscopic view of the alarm horn openings of the alarm pictured in Figure 19.5. This alarm sounded during multiple nuisance exposures but does not show evidence of enhanced soot deposition.

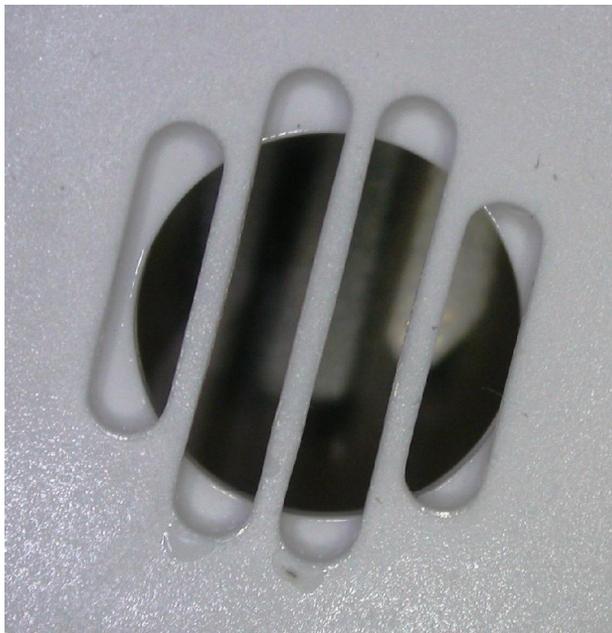
**Figure 19.7** This figure shows the exterior cover of an FSBI alarm that sounded during multiple nuisance exposures.

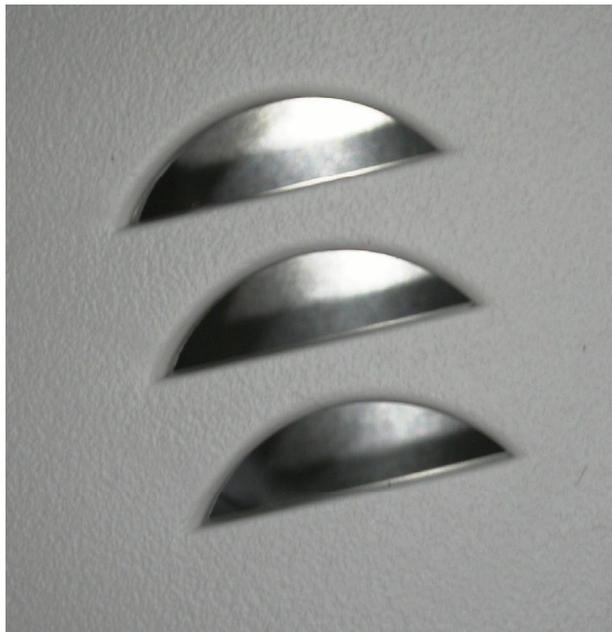
**Figure 20.1** This figure shows the cover of an FBI alarm that sounded during exposure to a smoldering cable fire.

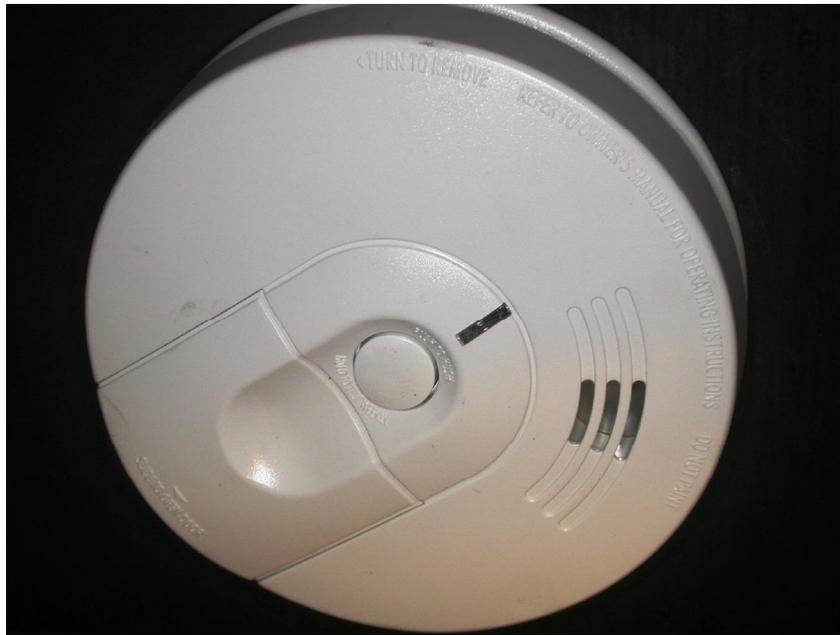
**Figure 20.2** This is a macroscopic view of the alarm horn openings from the alarm pictured in Figure 20.1. This alarm sounded but does not show any evidence of enhanced soot deposition.

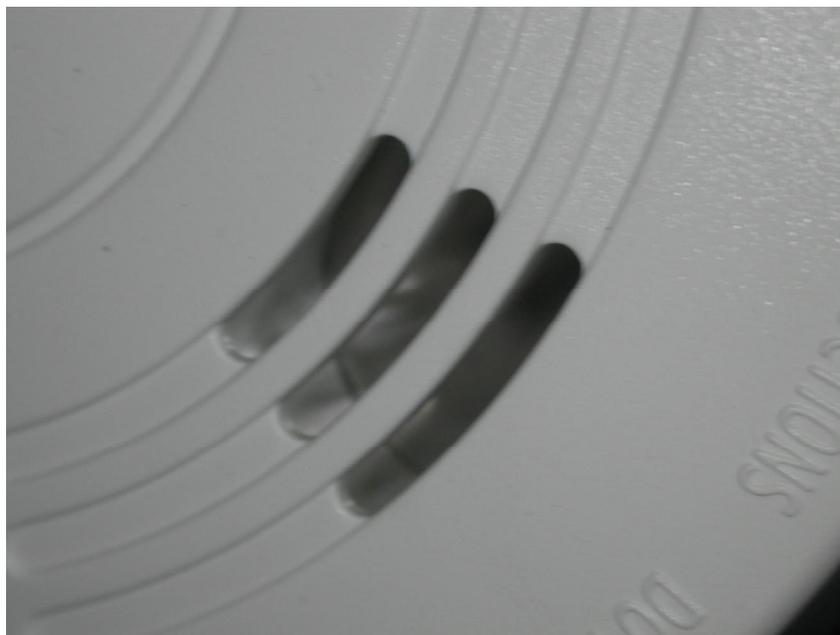
**Figure 20.3** This figure shows the cover of an FACI alarm that sounded during exposure to a smoldering cable fire.

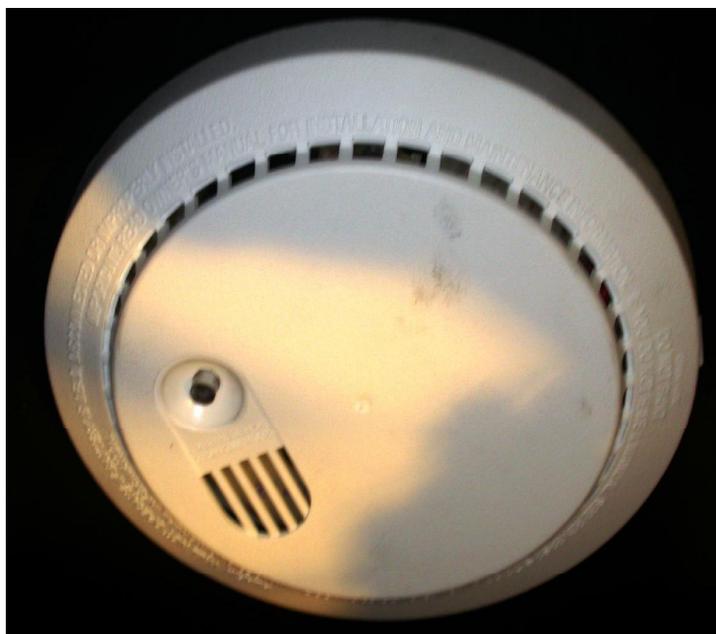
**Figure 20.4** This is a macroscopic view of the alarm horn openings from the alarm pictured in Figure 20.3. This alarm sounded but does not show any evidence of enhanced soot deposition.

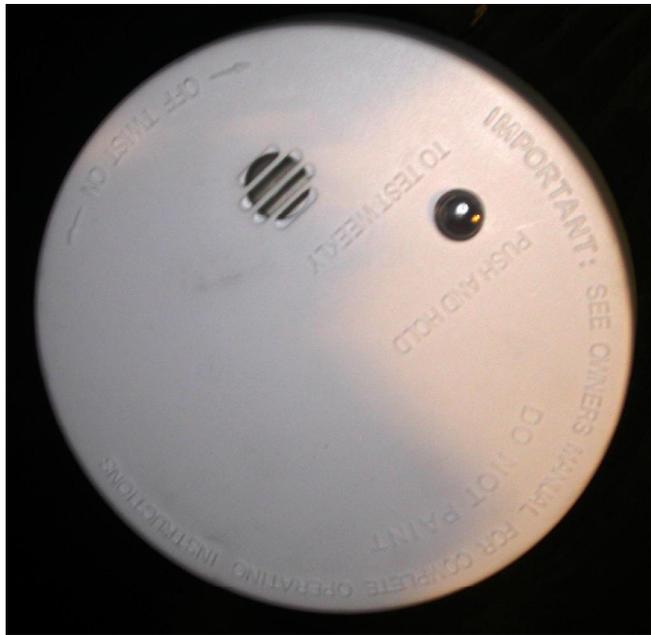
**Figure 20.6** This is a macroscopic view of the alarm horn openings from the alarm pictured in Figure 20.5. This alarm sounded but does not show any evidence of enhanced soot deposition.

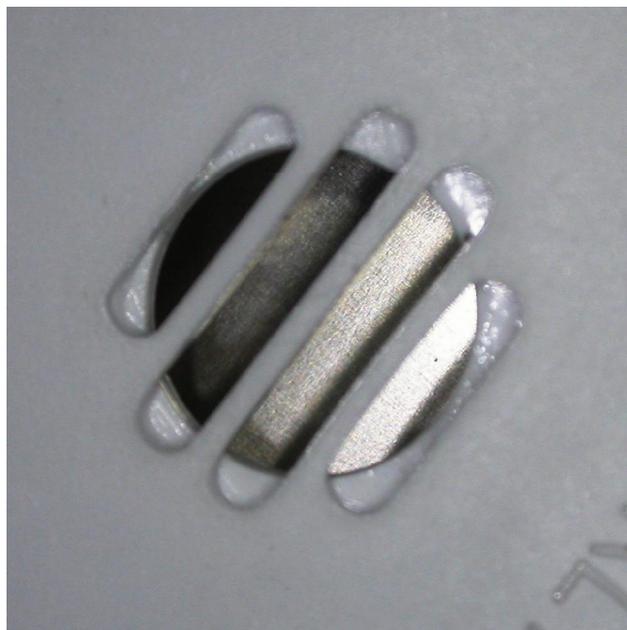
**Figure 20.7** This figure shows the cover of an FSBI alarm that sounded during exposure to a smoldering cable fire.

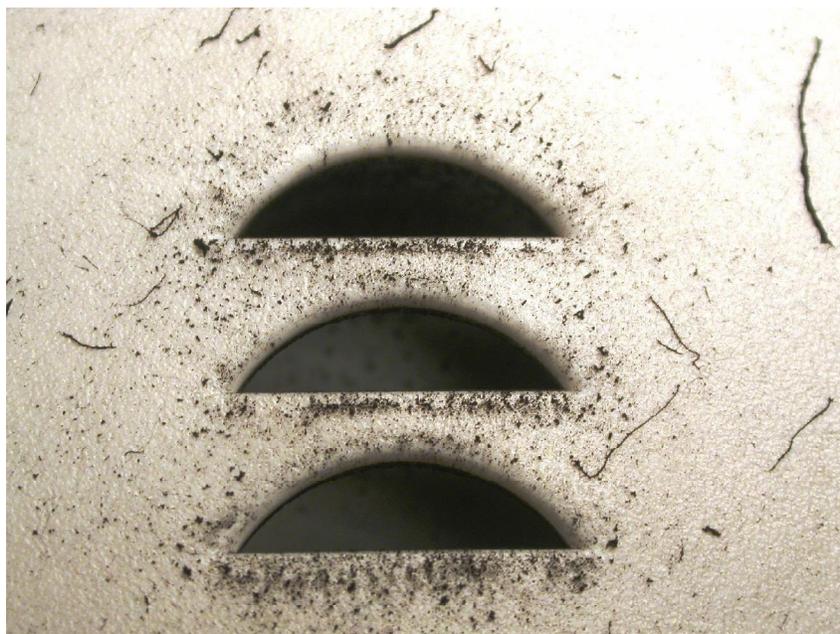
**Figure 21.1** This figure shows the exterior cover of an FBI alarm that sounded during exposure to a flaming box with cups fire. Enhanced soot deposition is visible around the horn openings.

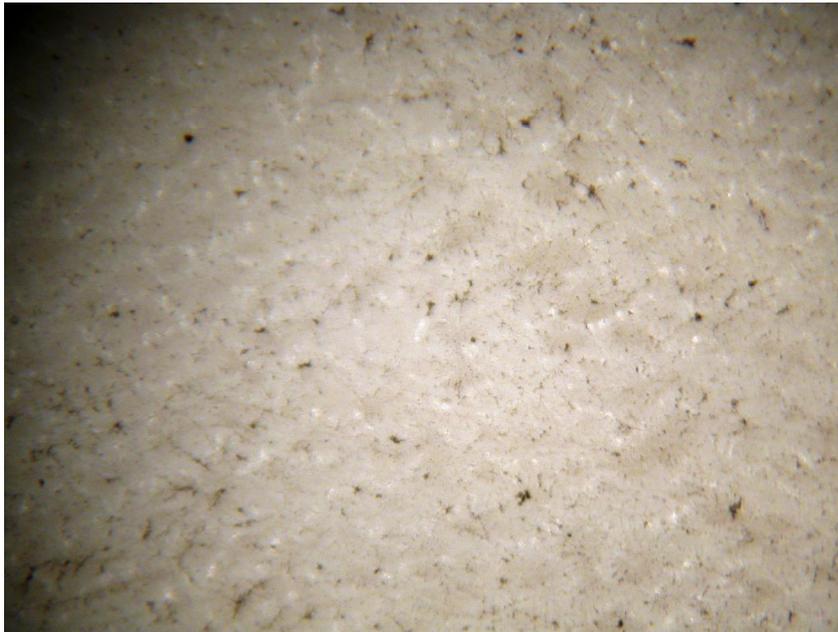
**Figure 21.3 This is a microscopic view of the corner of one of the alarm horn openings from Figure 21.2. Enhanced soot deposition is evident from the larger soot agglomerates and higher deposition density near the opening.**

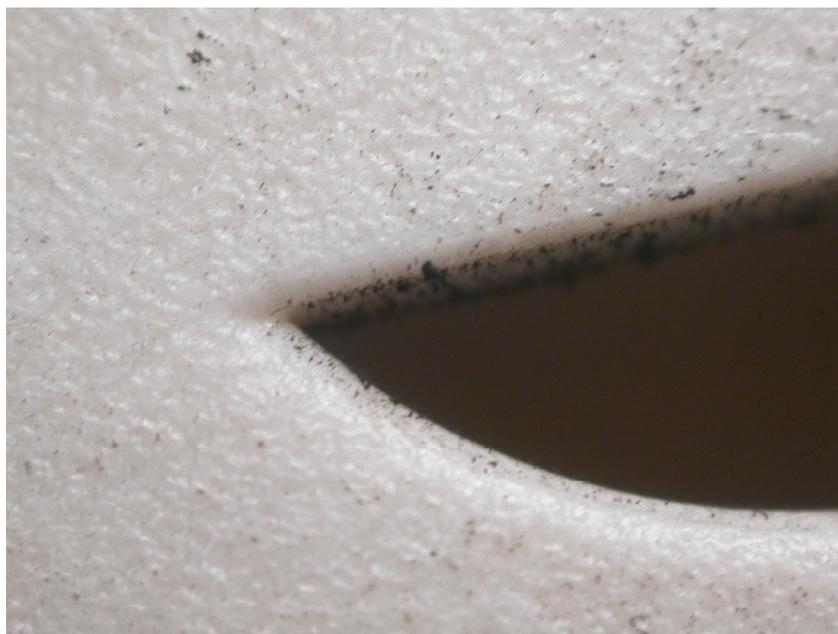
**Figure 21.7 This is a macroscopic view of the horn openings from the alarm pictured in Figure 21.6. This alarm did not sound during the exposure but there is ambient soot deposition on the vertical face of the alarm.**

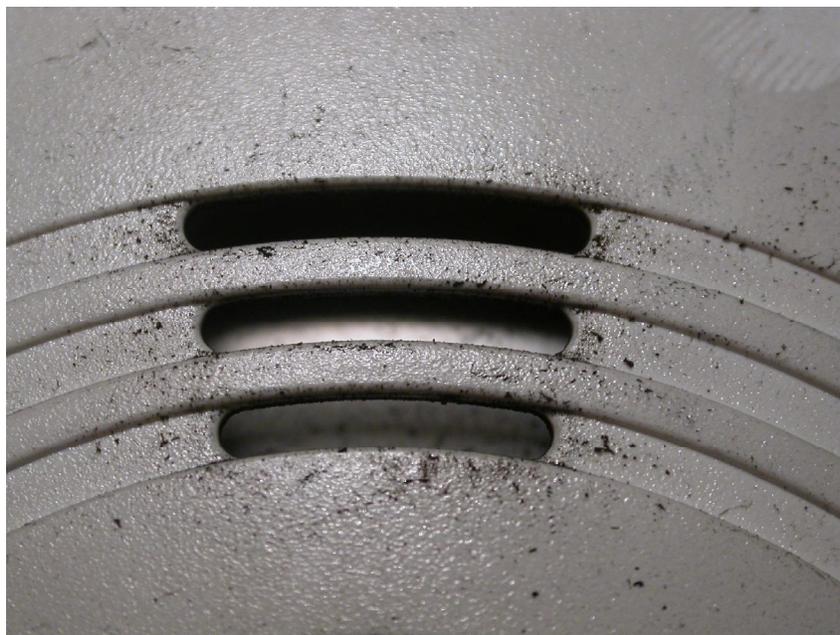
**Figure 21.9** This figure shows the exterior of the alarm cover of an FACP alarm that sounded during exposure to a flaming box with cups fire.

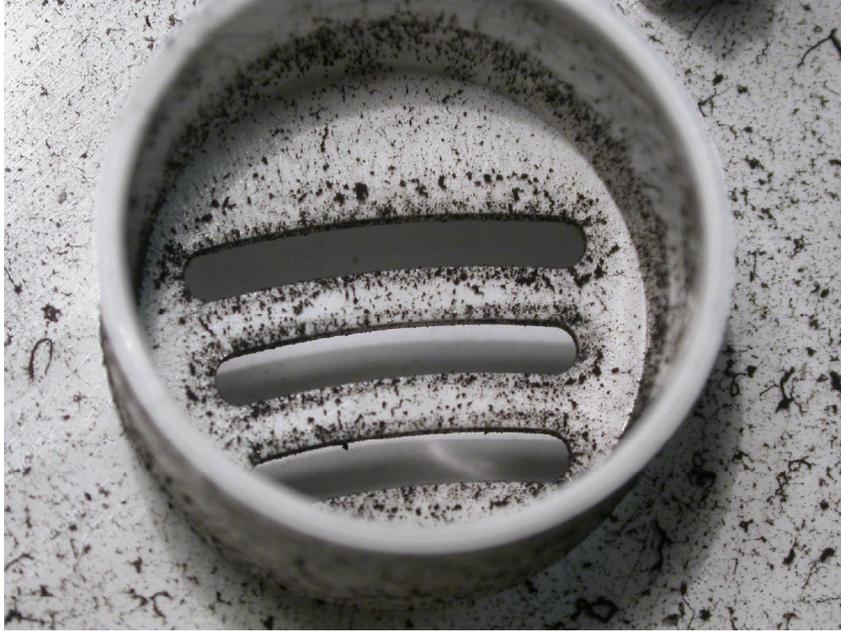
**Figure 21.10** This is a macroscopic view of the horn openings from the alarm pictured in Figure 21.9. This alarm sounded during the exposure and shows some evidence of enhance soot deposition.

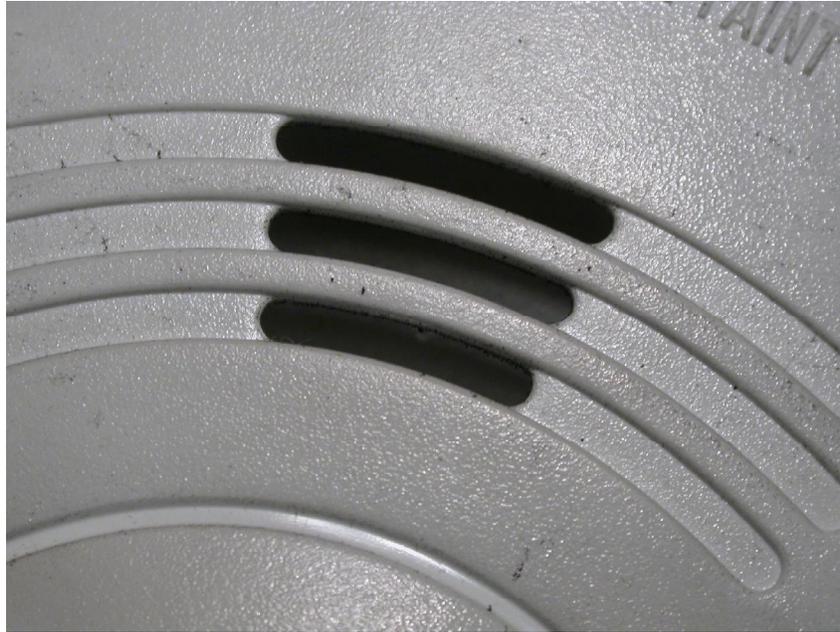
**Figure 21.12** This figure shows the exterior of the alarm cover of an alarm that did not sound during exposure to a flaming box with cups fire.

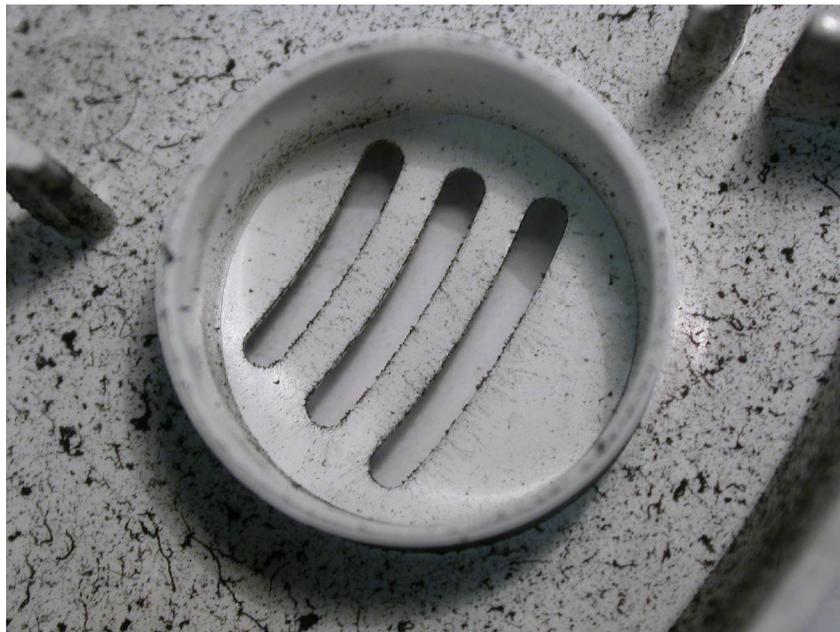
**Figure 21.13** this is a macroscopic view of the horn openings from the alarm pictured in Figure 21.12. This alarm did not sound and does not show evidence of enhanced soot deposition.

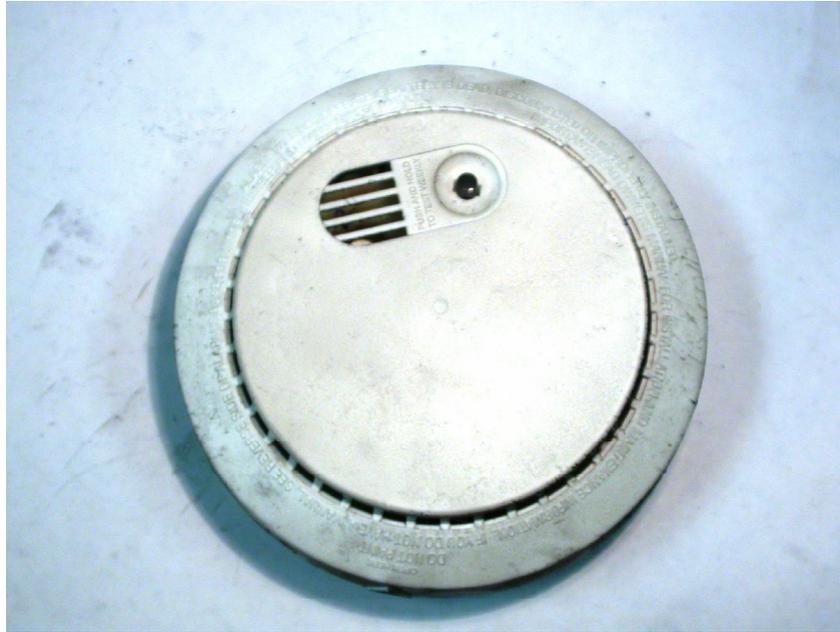
**Figure 21.15** This figure shows the external cover of an FGBI alarm that sounded during exposure to a flaming box with cups fire.

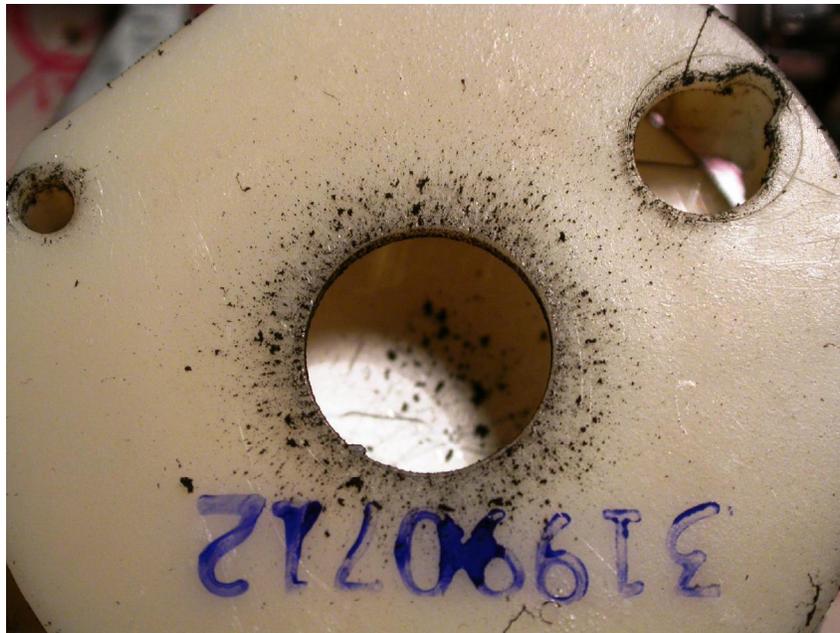
**Figure 21.17** This is a macroscopic view of the horn opening of the alarm pictured in Figures 21.15 and 21.16. Evidence of enhanced soot deposition indicates that the alarm sounded during the exposure.

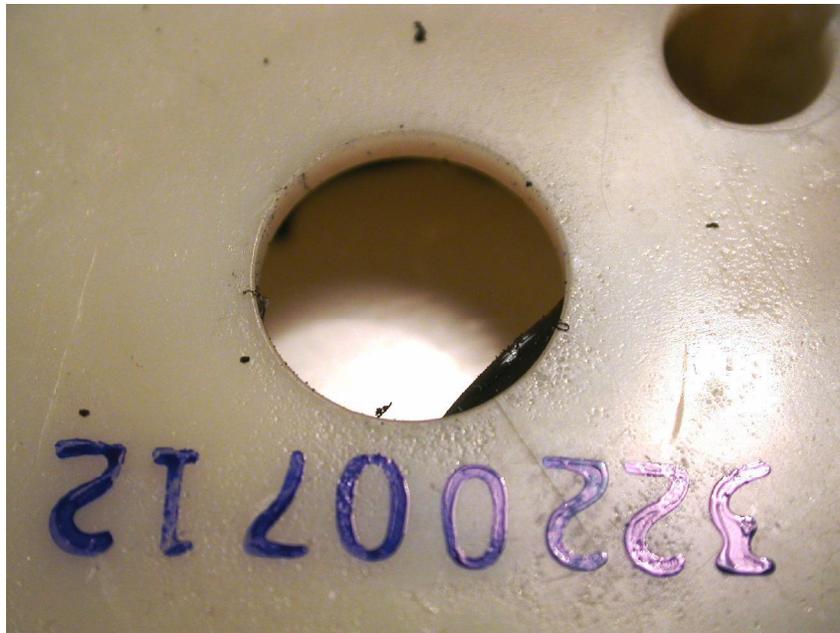
**Figure 21.21** This figure is a macroscopic view of the horn opening of the alarm from Figure 21.20. This alarm did not sound and does not show evidence of enhanced soot deposition.

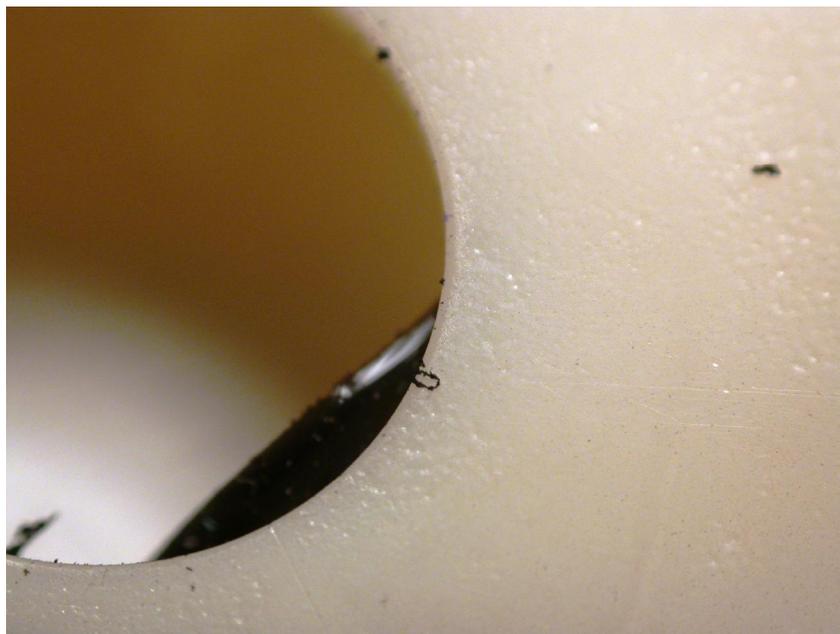
**Figure 21.22** This is a microscopic view of the horn opening pictured in Figures 21.20 and 21.21. this alarm did not sound and shows no evidence of enhanced soot deposition.

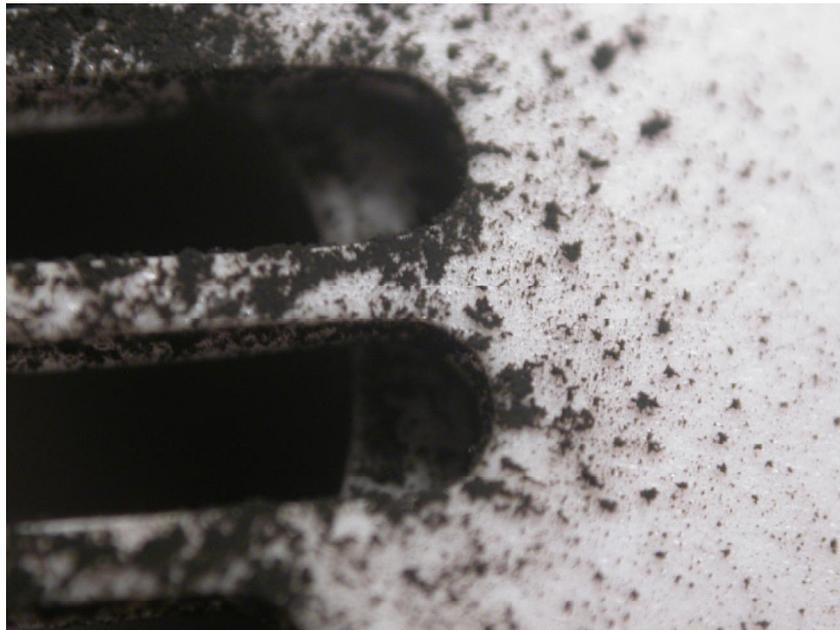
**Figure 21.24** This is a microscopic view of the alarm horn openings from Figure 21.23. This shows the high density of soot deposition and larger agglomerates closer to the horn openings.

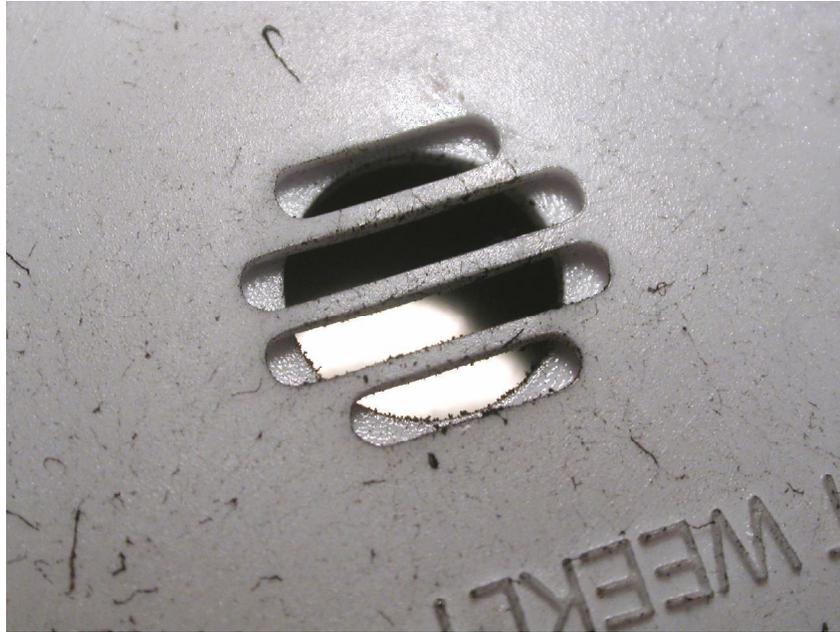
**Figure 21.25** This is a macroscopic view of the alarm horn openings from an FSBI alarm that did not sound during exposure to a flaming box filled with cups. There is soot deposited around the horn openings of the same size and density as that deposited away from the horn openings.
