An Investigation of Enhanced Soot Deposition on Smoke Alarm Horns

A Thesis

Submitted to the Faculty of  
Worcester Polytechnic Institute  
In partial fulfillment of a  
Master of Science Degree  
In Fire Protection Engineering

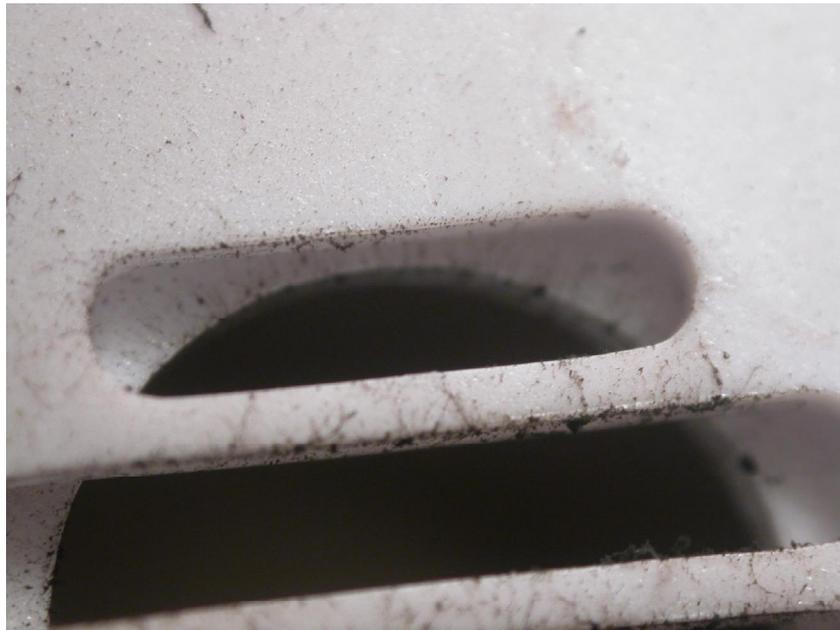
**Figure 21.26** This is a microscopic view of the alarm horn openings from Figure 21.26. This alarm did not sound shows soot deposition commensurate with exposure to a high soot yield fire, but not enhanced soot deposition indicative of sounding.

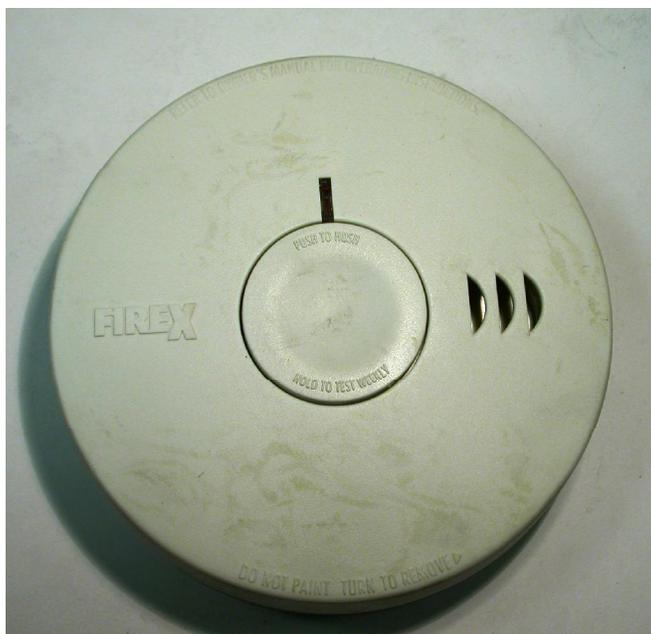
**Figure 22.1** This figure shows the external cover of an FBI alarm sounded during exposure to the smoldering to flaming cabinet assembly.

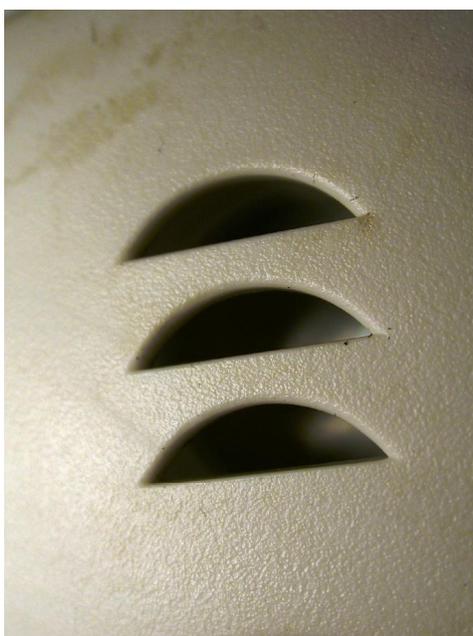
**Figure 22.2** This figure shows a macroscopic view of the horn openings from the alarm in Figure 22.1. This alarm sounded but shows only the slightest evidence of enhanced deposition at the corner of the upper right horn opening.

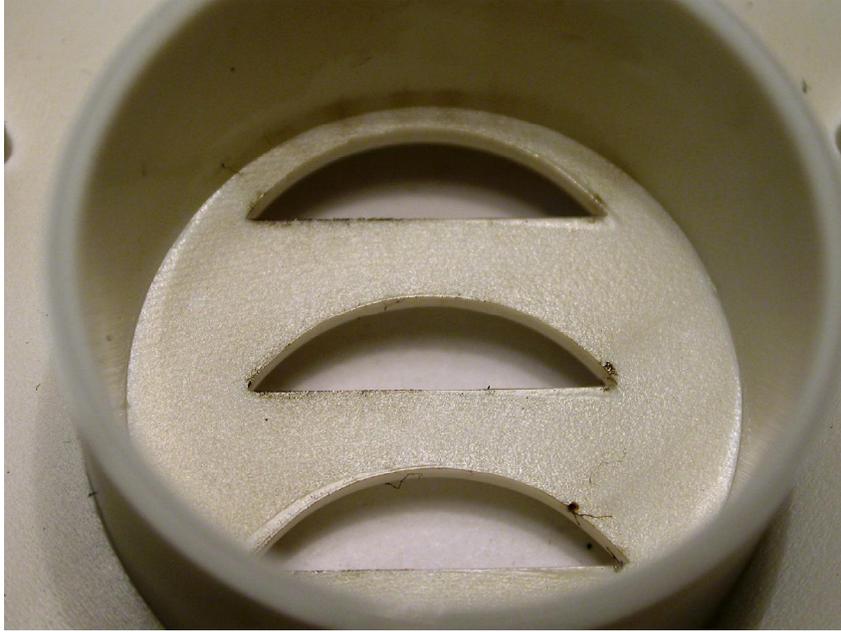
**Figure 22.3 This is a macroscopic view of the internal face of the horn openings of the alarm pictured in Figures 22.1 and 22.2. There is evidence of enhanced deposition along the flat edges and corners of the horn openings.**

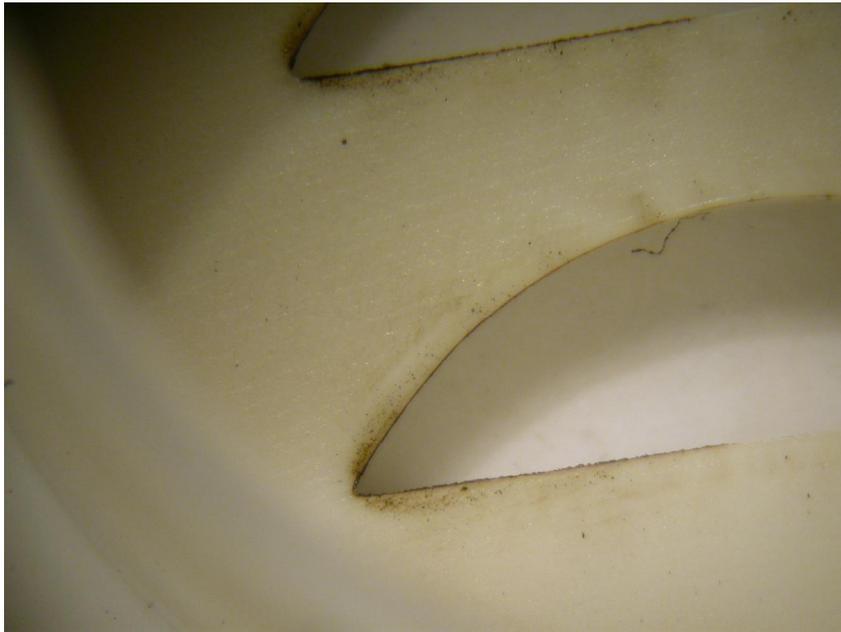
**Figure 22.4 This is a microscopic view of one of the alarm horn openings from Figure 22.3. There is evidence of enhanced deposition consistent with the tarry deposition indicative of alarm sounding.**

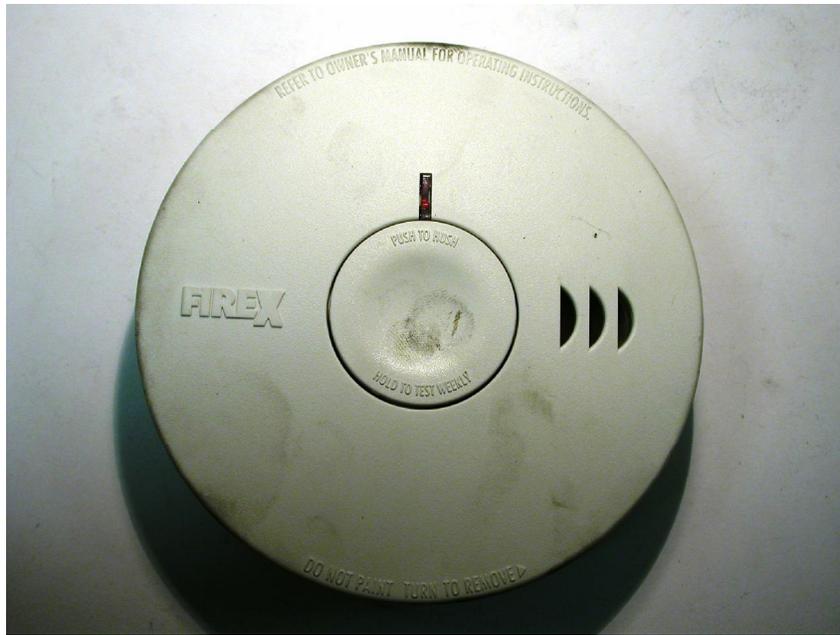
**Figure 22.5** This figure shows the alarm cover of an FBI alarm that did not sound during exposure to the smoldering to flaming cabinet assembly.

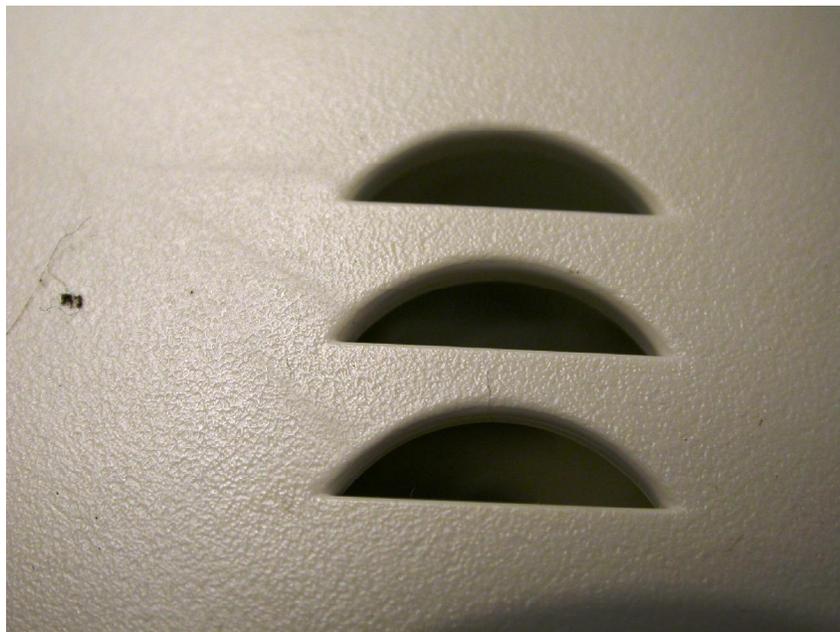
**Figure 22.6** This is a macroscopic view of the alarm horn openings from the alarm pictured in figure 22.5. This alarm did not sound during the exposure and shows no evidence of enhanced deposition.

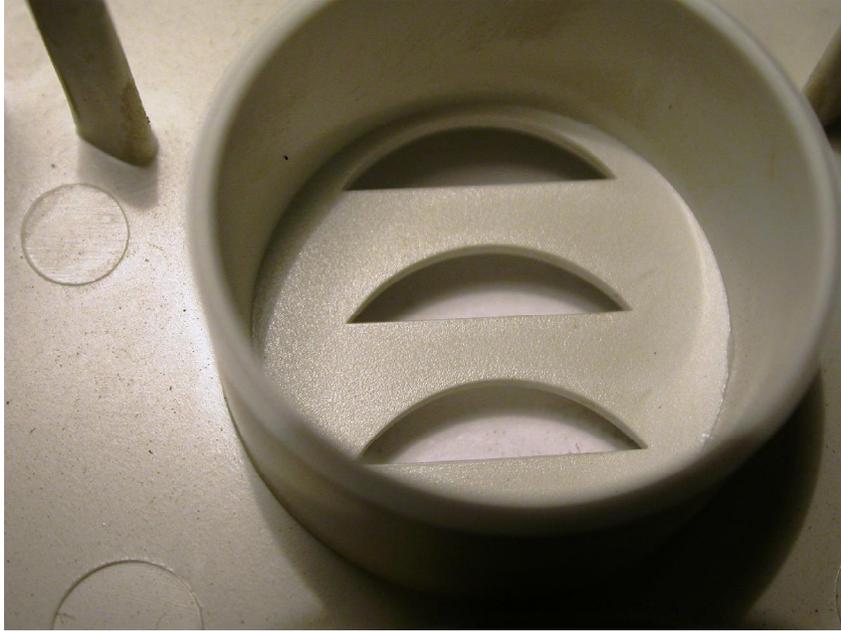
**Figure 22.7** This figure shows a macroscopic view of the internal face of the alarm horn openings from Figures 22.5 and 22.6. There is no evidence of enhanced deposition consistent with the fact that the alarm did not sound.

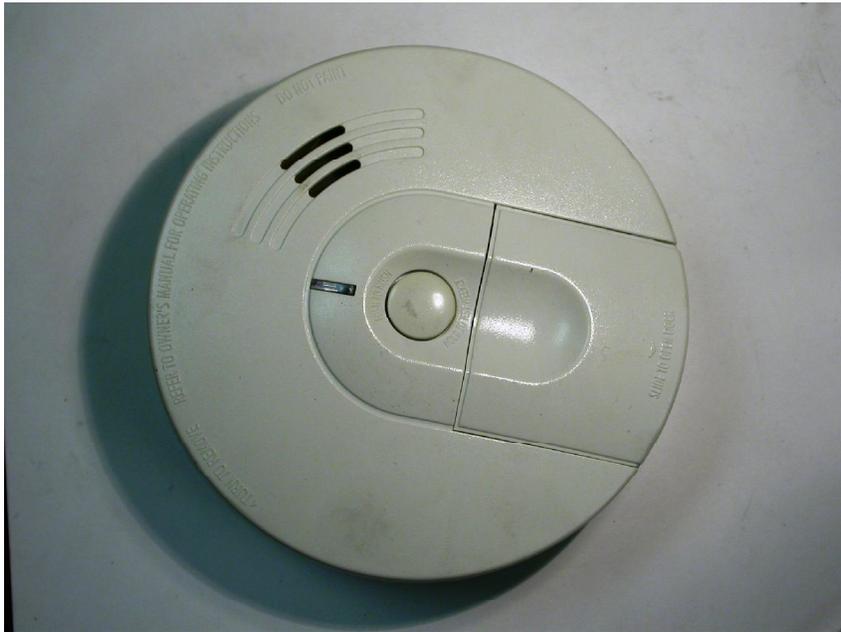
**Figure 22.8** This figure shows the external cover of an FACI alarm sounded during exposure to the smoldering to flaming cabinet assembly.

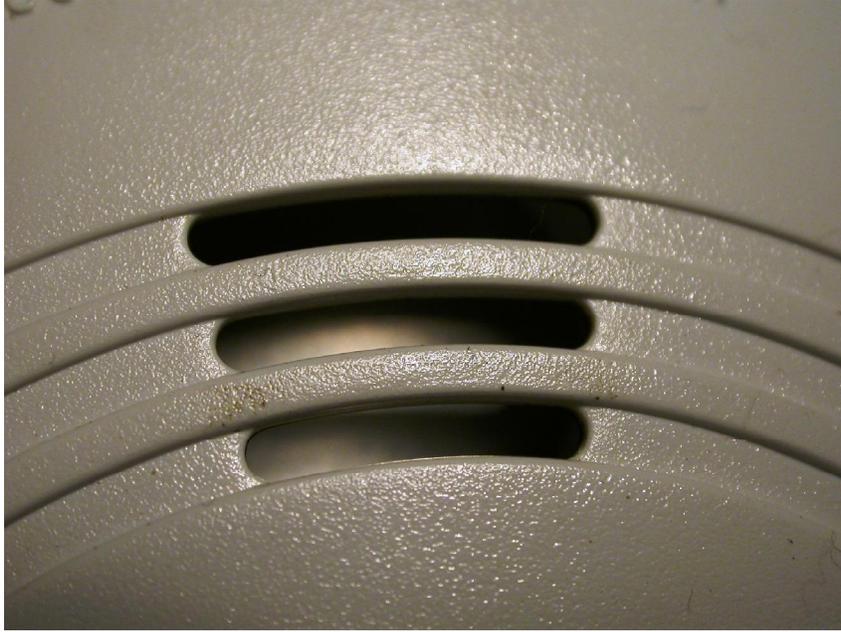
**Figure 22.9** This figure shows a macroscopic view of the horn openings from the alarm in Figure 22.8. This alarm sounded but shows only the slightest evidence of enhanced deposition.

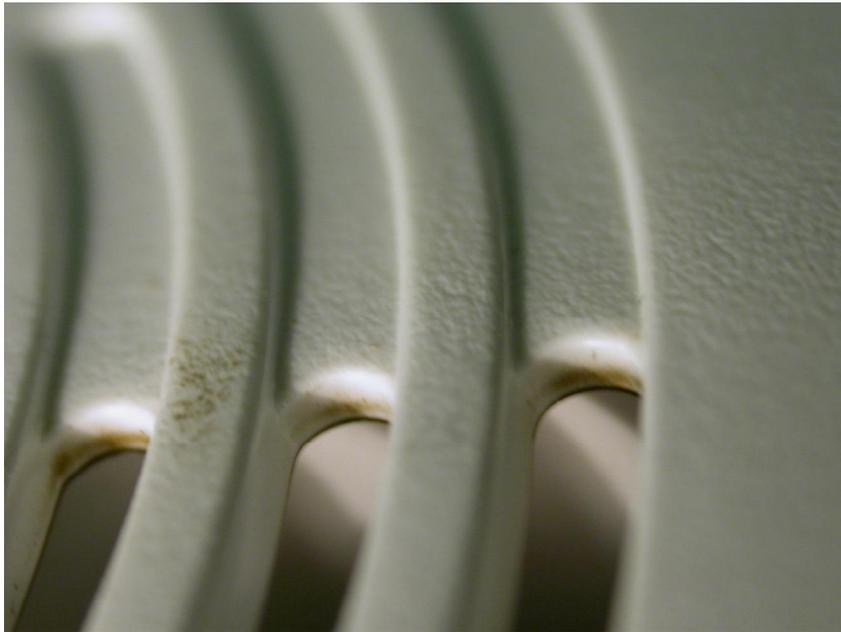
**Figure 22.10** This figure shows a macroscopic view of the vertical faces of the horn openings of the alarm pictured in Figures 22.8 and 22.9. There is evidence of enhanced depositions on all three of the vertical faces pictured.

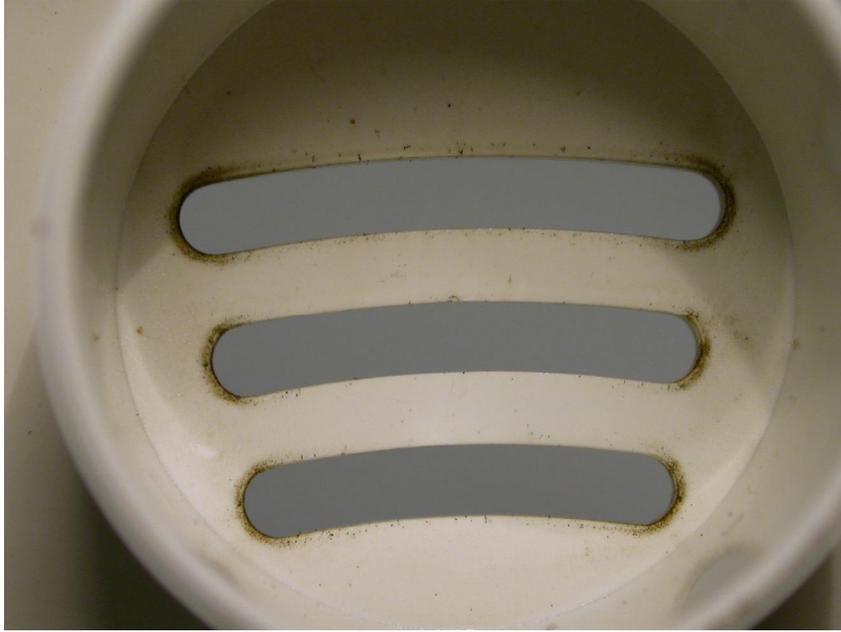
**Figure 22.11** This is a macroscopic view of the internal faces of the alarm horn openings from Figures 22.8-22.10. There is evidence of enhanced deposition around all three of the horn openings that was not apparent around the external faces.

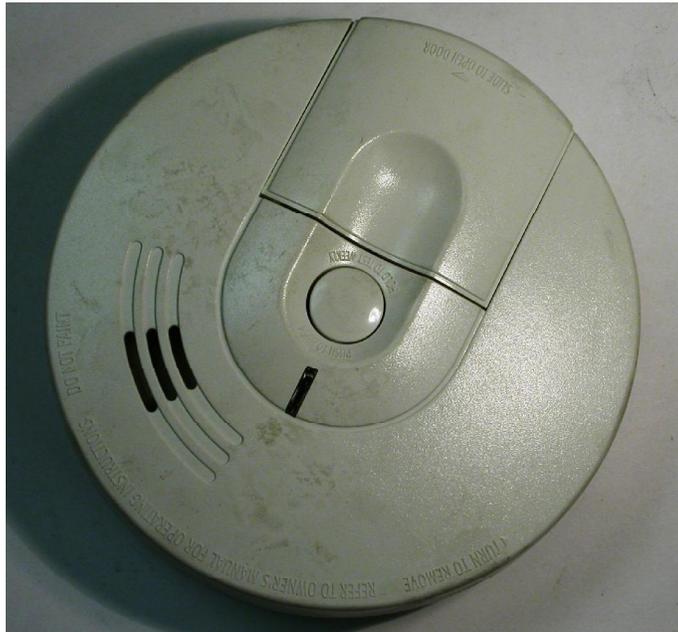
**Figure 22.12** This figure shows the external cover of an FACI alarm that did not sound during exposure to the smoldering to flaming cabinet assembly.

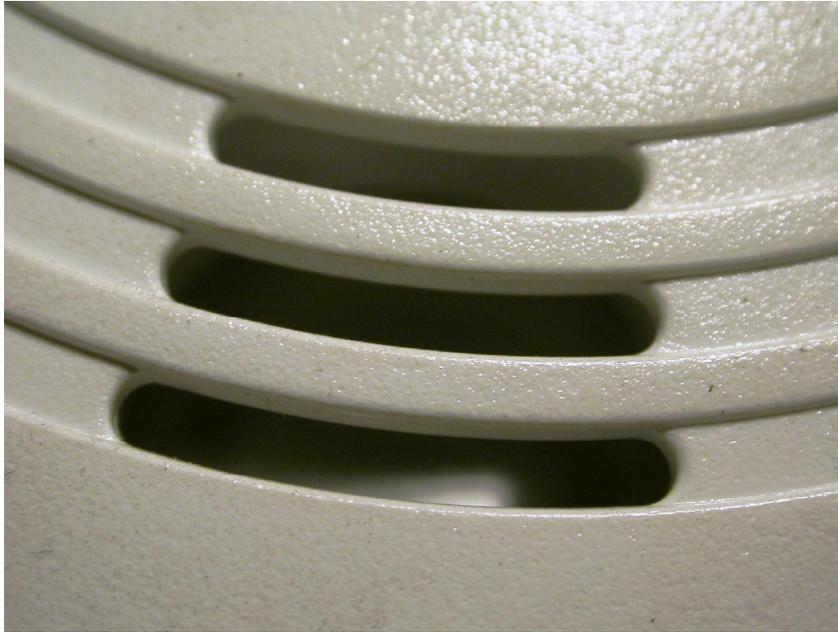
**Figure 22.13** This figure shows a macroscopic view of the horn openings from Figure 22.12. This alarm did not sound and does not show any evidence of enhanced depositions.

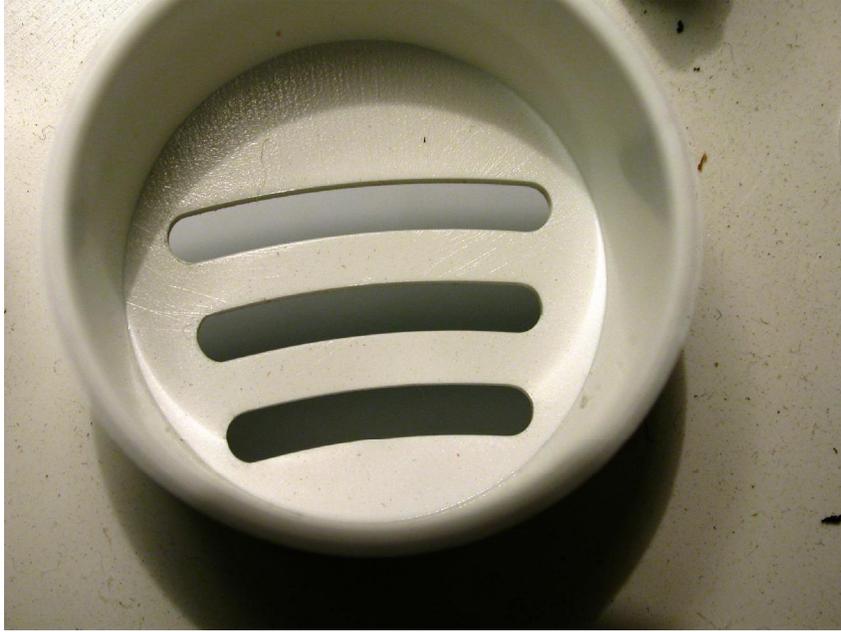
**Figure 22.15 This is a macroscopic view of the internal faces of the alarm horn openings from Figures 22.12-22.14. There is no evidence of enhanced deposition consistent with the fact that the alarm did not sound.**

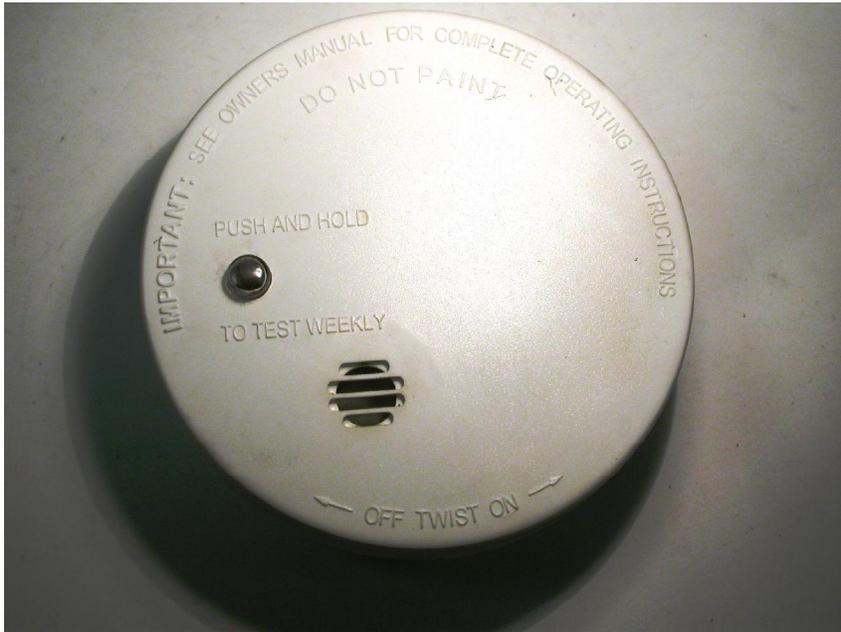
**Figure 22.16 This figure shows the external cover of an FSBI alarm that sounded during exposure to the smoldering to flaming cabinet assembly.**

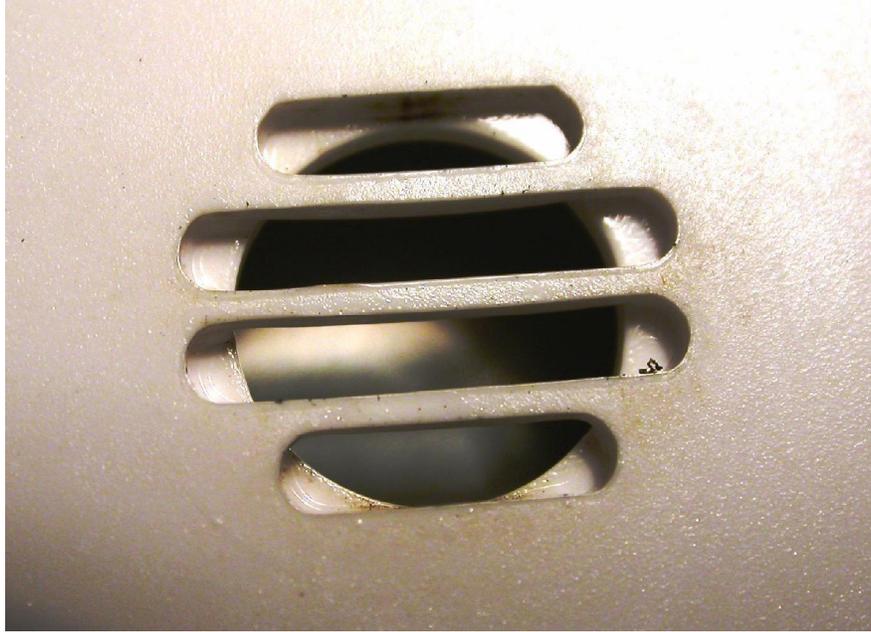
**Figure 22.17** This figure shows a macroscopic view of the horn openings from Figure 22.16. (Compare to Figures 20.20 and 20.25)

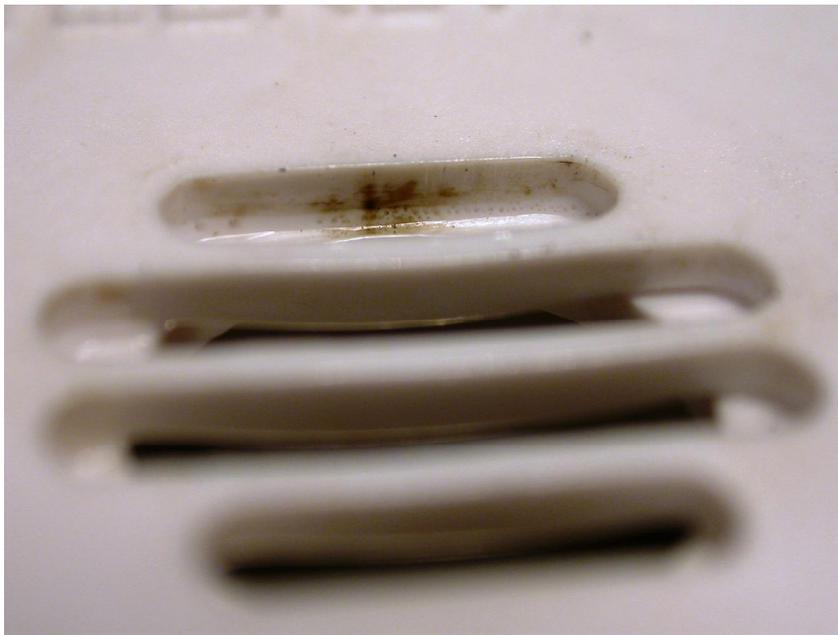
**Figure 22.18** This figure shows the vertical faces of the alarm from Figure 22.17. There are spots of enhanced depositions consistent with the fact that the alarm sounded.

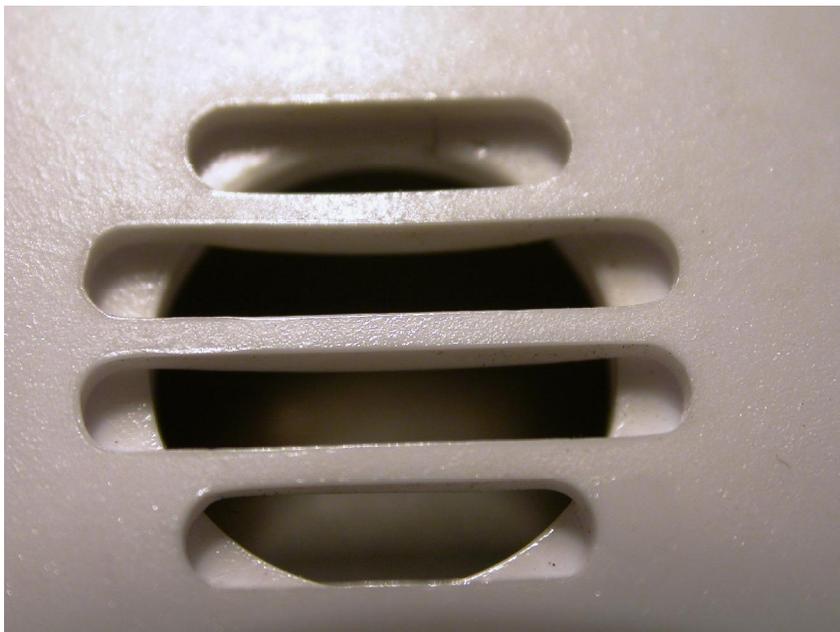
**Figure 22.20** This figure shows a macroscopic view of the horn openings from Figure 22.19. This alarm did not sound and does not show any evidence of enhanced depositions.

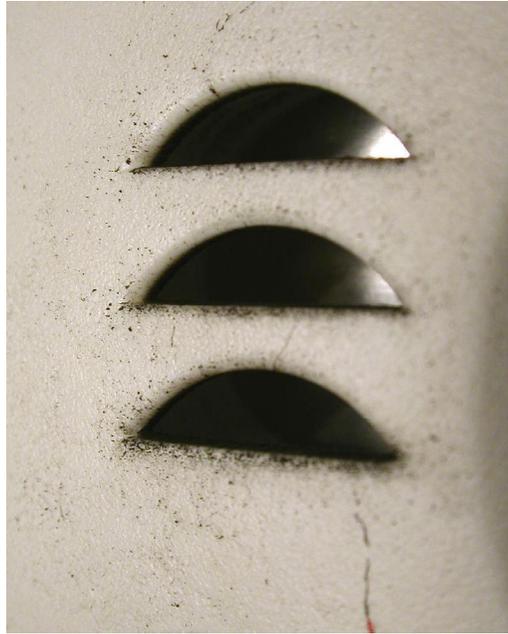
**Figure 23.1 Macroscopic view of the external face of the alarm horn openings of an alarm that sounded during exposure to a flaming couch. Enhanced soot deposition is apparent on the flat edges of the moon-shapes.**

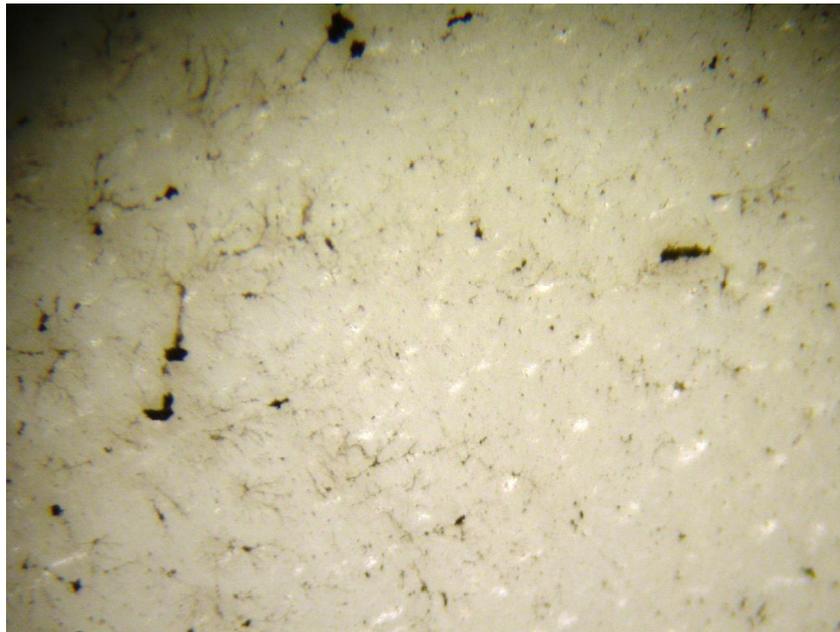
**Figure 23.2 This figure shows the ambient soot deposited on the cover of the alarm from Figure 23.1. This soot is less dense than that in enhanced depositions.**

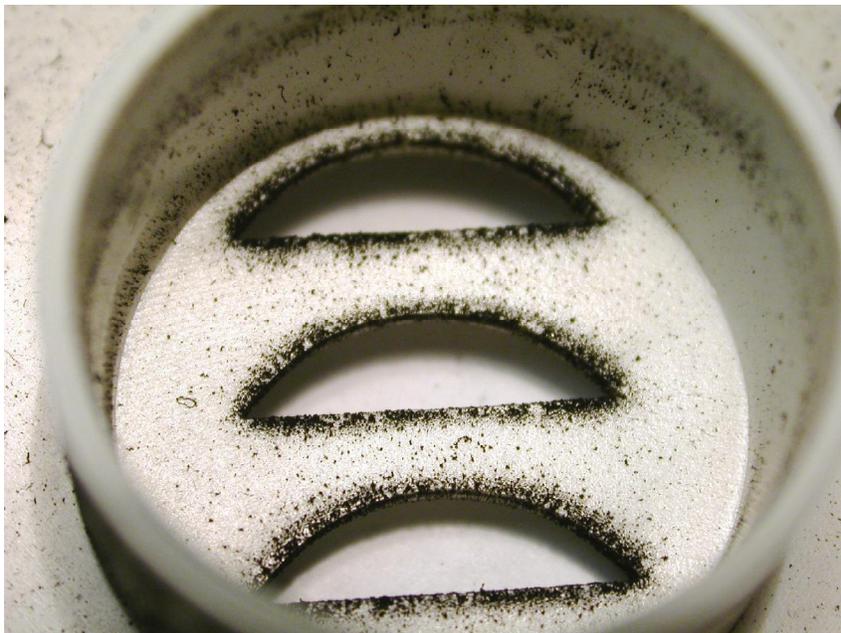
**Figure 23.4** This is a macroscopic view of the interior face of the alarm horn opening from Figures 23.1-23.3. The enhanced soot deposition is more developed on the interior face than the exterior face.

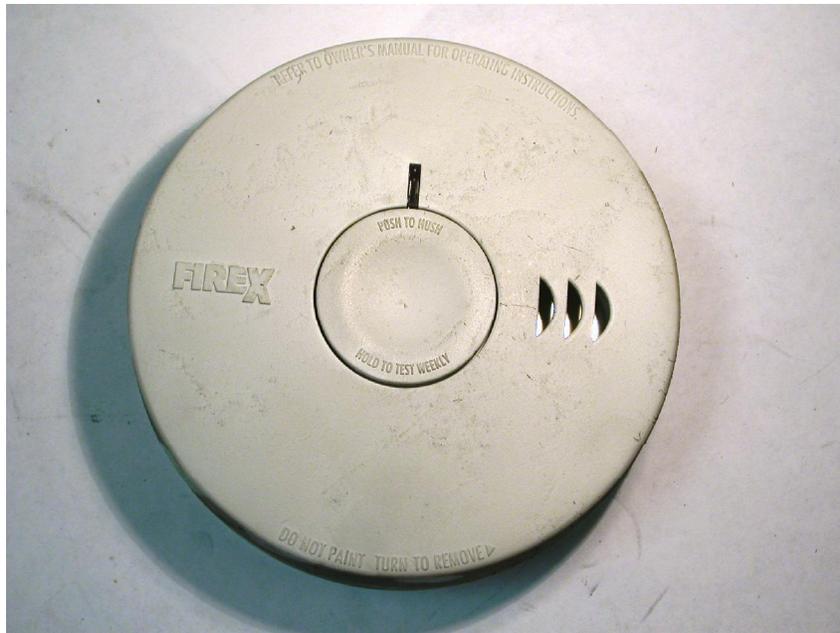
**Figure 23.5 This is the external cover of an FBI alarm that did not sound during exposure to the flaming couch.**

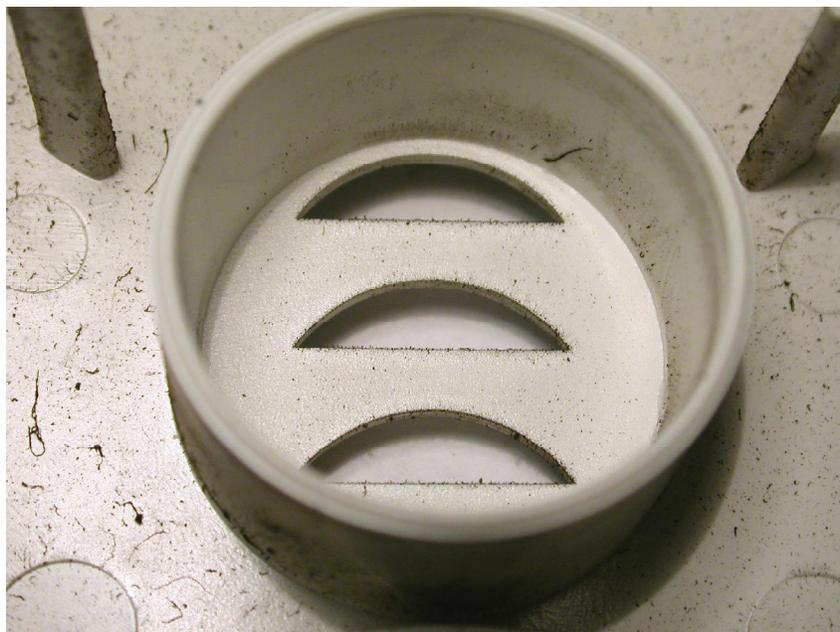
**Figure 23.6 This is a macroscopic view of the interior face of the horn openings of the alarm from Figure 23.5. This alarm did not sound and there is no enhanced soot deposition indicative of sounding. Although there is some soot deposition on the edges the soot deposition density inside the horn chamber is less dense than that deposited outside the horn chamber.**

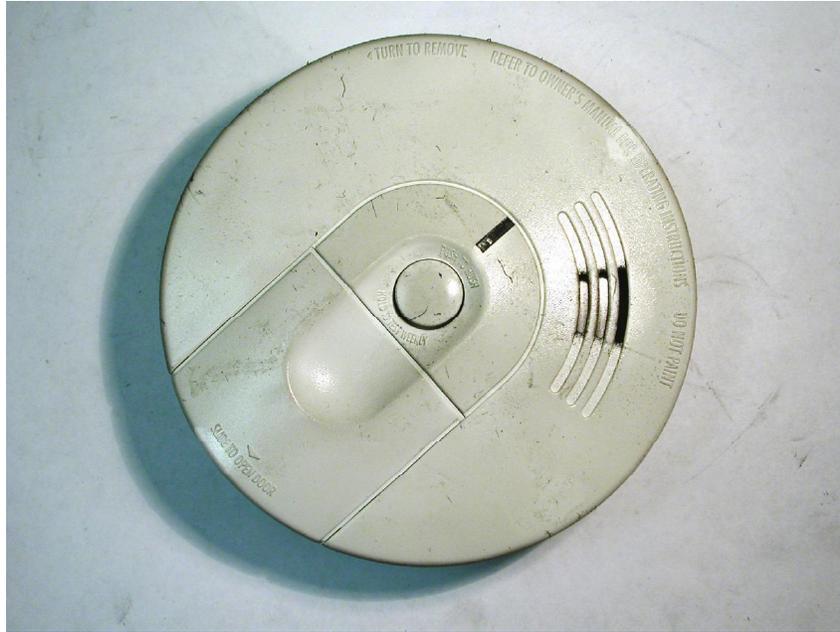
**Figure 23.7** This figure shows the external cover of an FACI alarm that sounded during exposure to the flaming couch section.

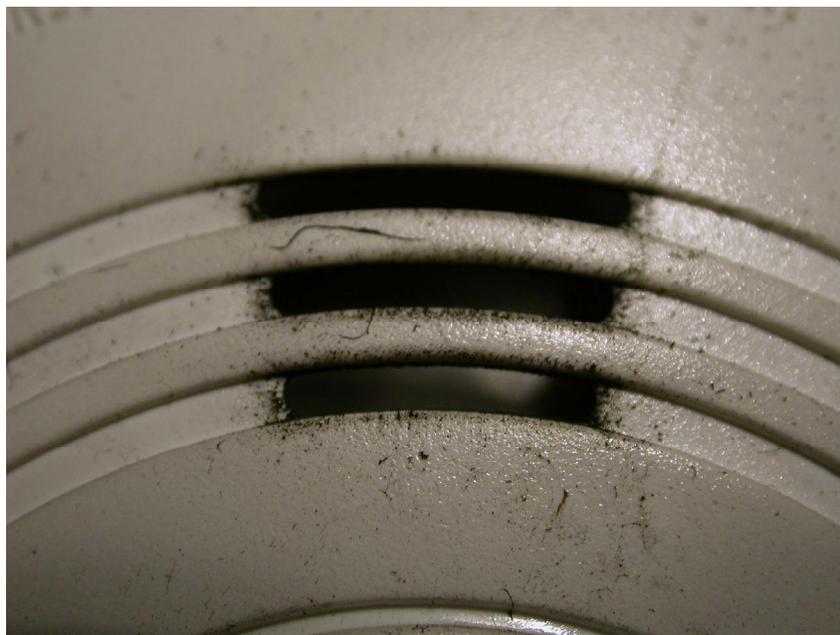
**Figure 23.8** This is a macroscopic view of the horn openings from the alarm in Figure 23.7. Enhanced deposition is apparent around portions of all of the horn openings.

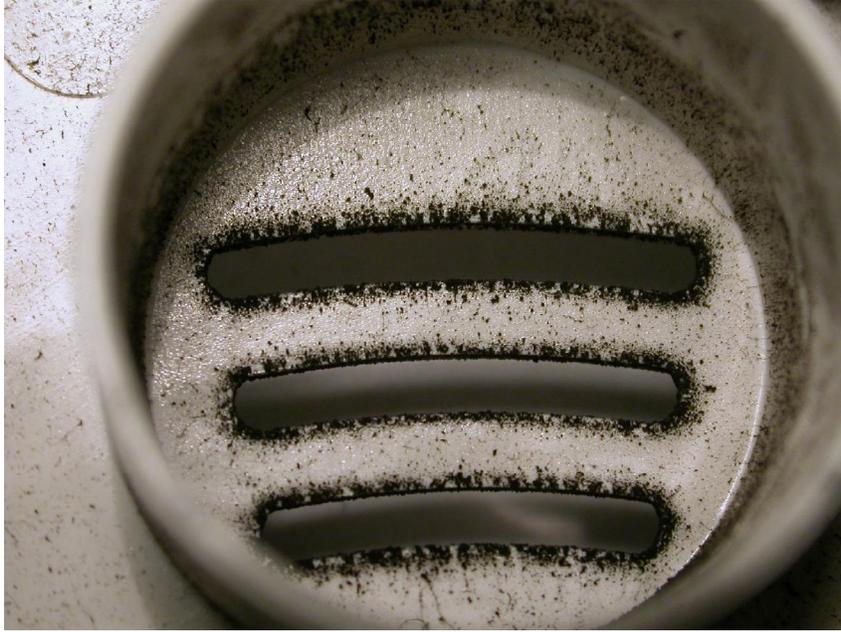
**Figure 23.9** This figure shows the internal face of the alarm horn openings from Figure 23.8. The enhanced soot deposition is more developed on the internal face than the external face, evidence of the alarm sounding. There is also more soot deposited inside the horn chamber than outside.

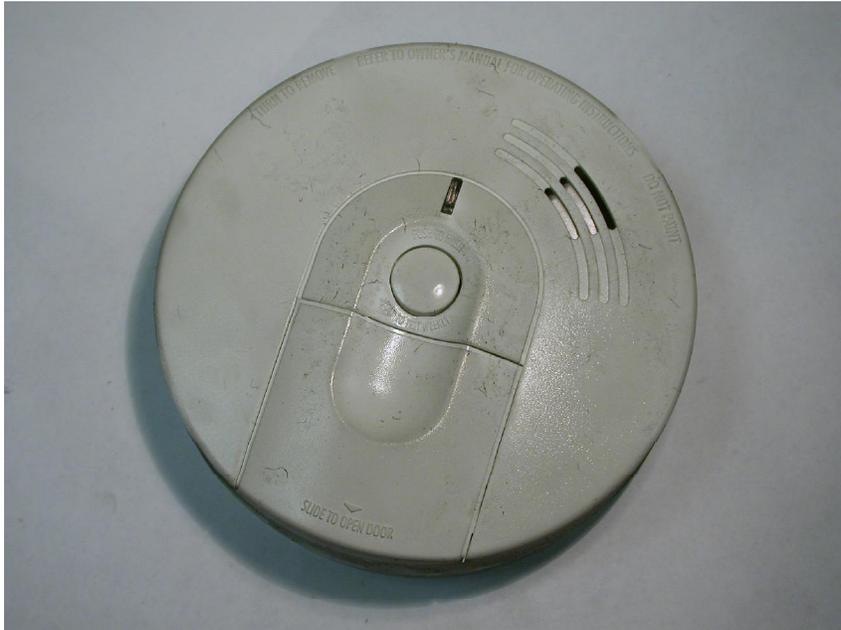
**Figure 23.10** This is the external cover of an FACI alarm that did not sound during exposure to the flaming couch fire.

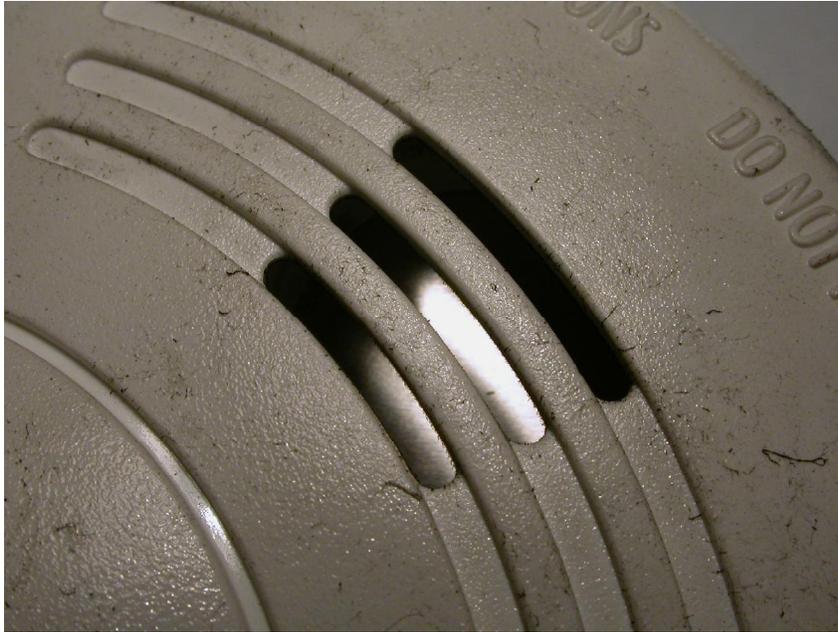
**Figure 23.11** This is a macroscopic view of the horn openings from the alarm in Figure 23.10. This alarm did not sound and does not show any enhanced soot deposition.

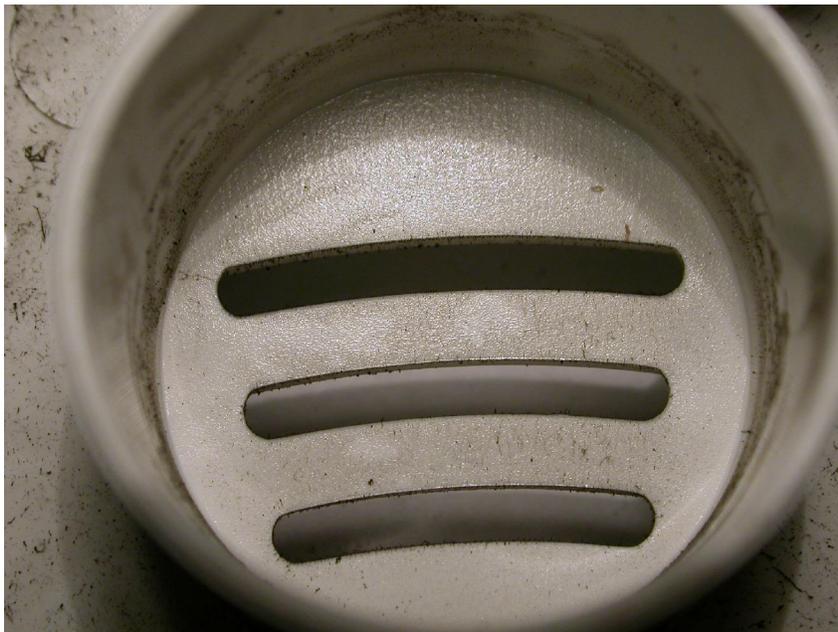
**Figure 23.12** This is a macroscopic view of the horn openings from Figures 23.9-23.10. This alarm did not sound during the exposure and does not show evidence of enhanced deposition. The soot deposited on the internal face of the alarm is similar in density inside and outside horn chamber on the same face.

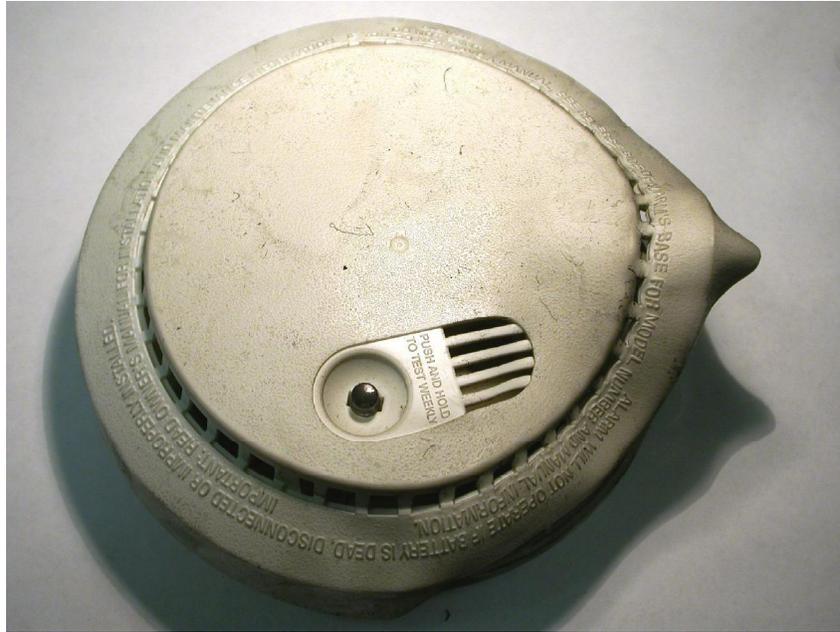
**Figure 23.13** This figure shows the external cover of the an FGBI alarm that sounded during exposure to the flaming couch section. The alarm cover was distorted by the elevated temperatures of the upper layer.

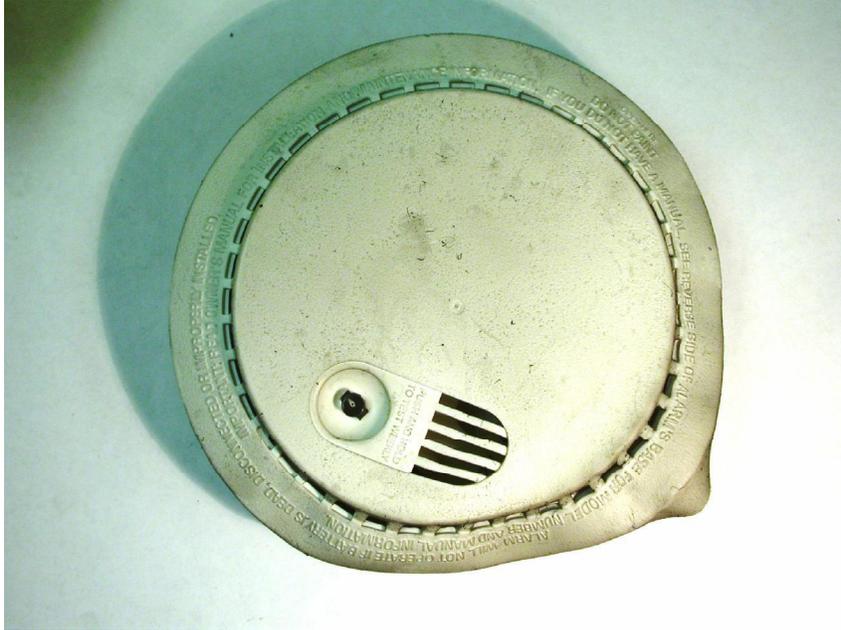
**Figure 23.17** This is the external cover of an FGBI alarm did not sound during exposure to the flaming couch fire. The cover was distorted by the elevated temperatures of the upper layer.

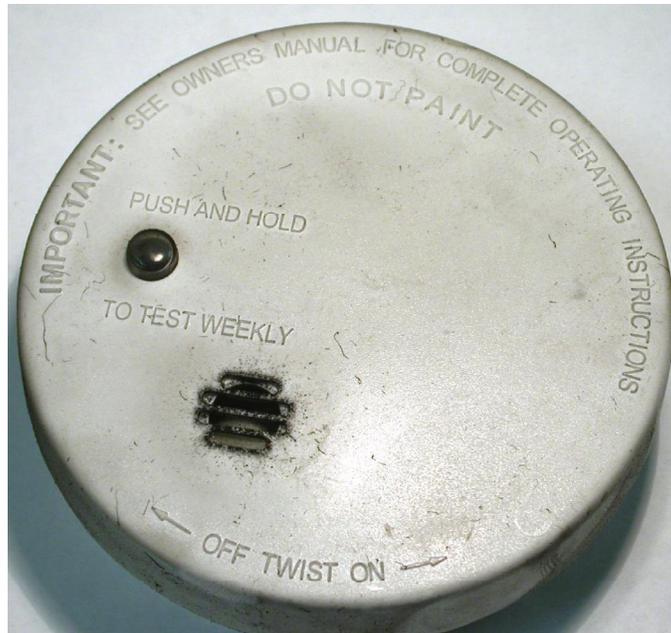
**Figure 23.19** This figure shows and FSBI alarm that sounded during exposure to the flaming couch fire. Enhanced deposition indicative of alarm sounding is visible in around the horn openings.

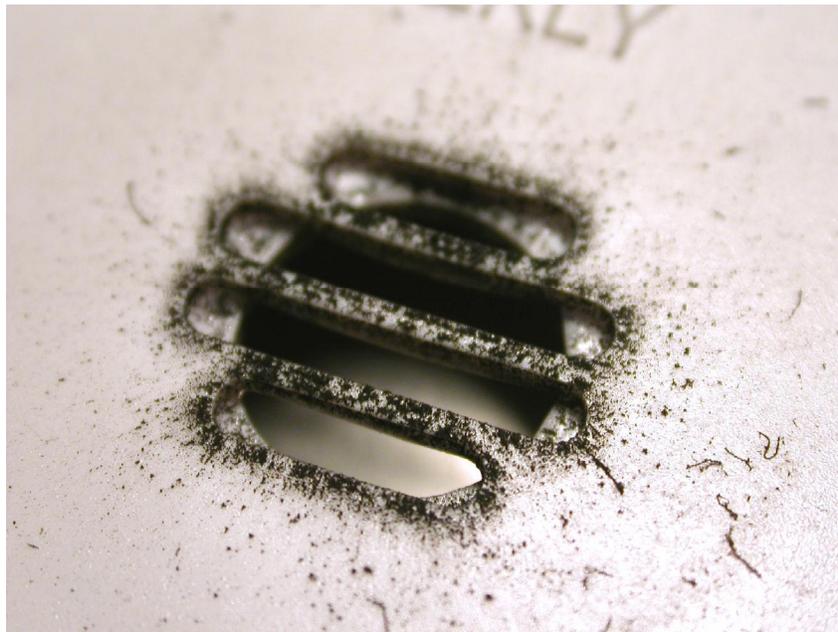
**Figure 23.20** This is a macroscopic view of the horn openings of the alarm in Figure 23.19. The alarm sounded during the fire exposure which is indicated through the enhanced soot deposition around the horn openings.

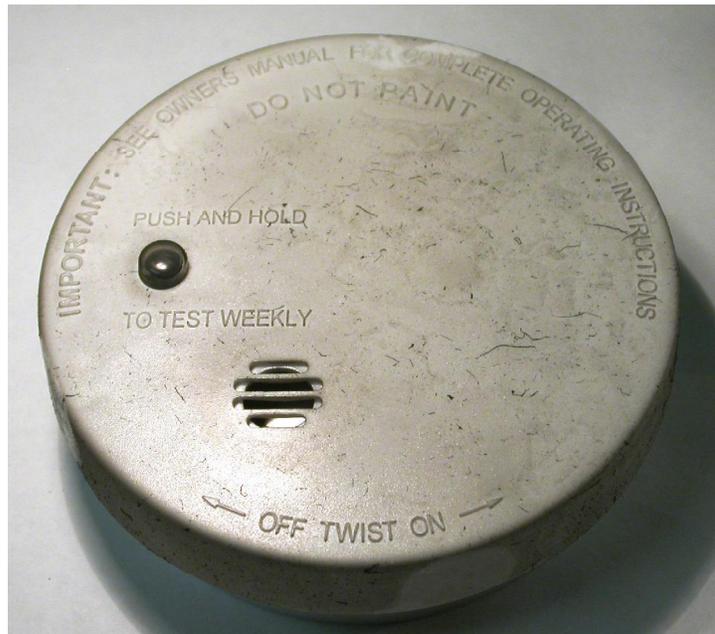
**Figure 23.22** This figure shows the cover of an FSBI alarm that did not sound during exposure to the flaming couch. The cover has soot deposited consistent with a high soot yield fire, but no signs of enhanced deposition.

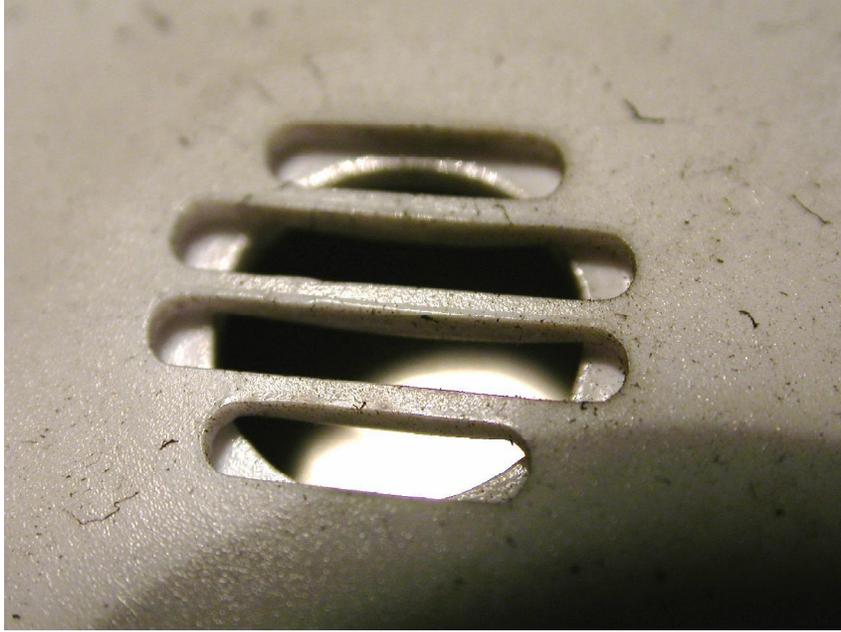
**Figure 23.23** This is a macroscopic view of the horn openings of the alarm from Figure 23.22. This alarm did not sound and does not have enhanced deposition.
